IDAHO STATE FIRE MARSHAL'S OFFICE

FIRE INVESTIGATION REPORT

Case Name: 68 Highland High School
Case Number: 04212368
Date of Fire: April 21, 2023

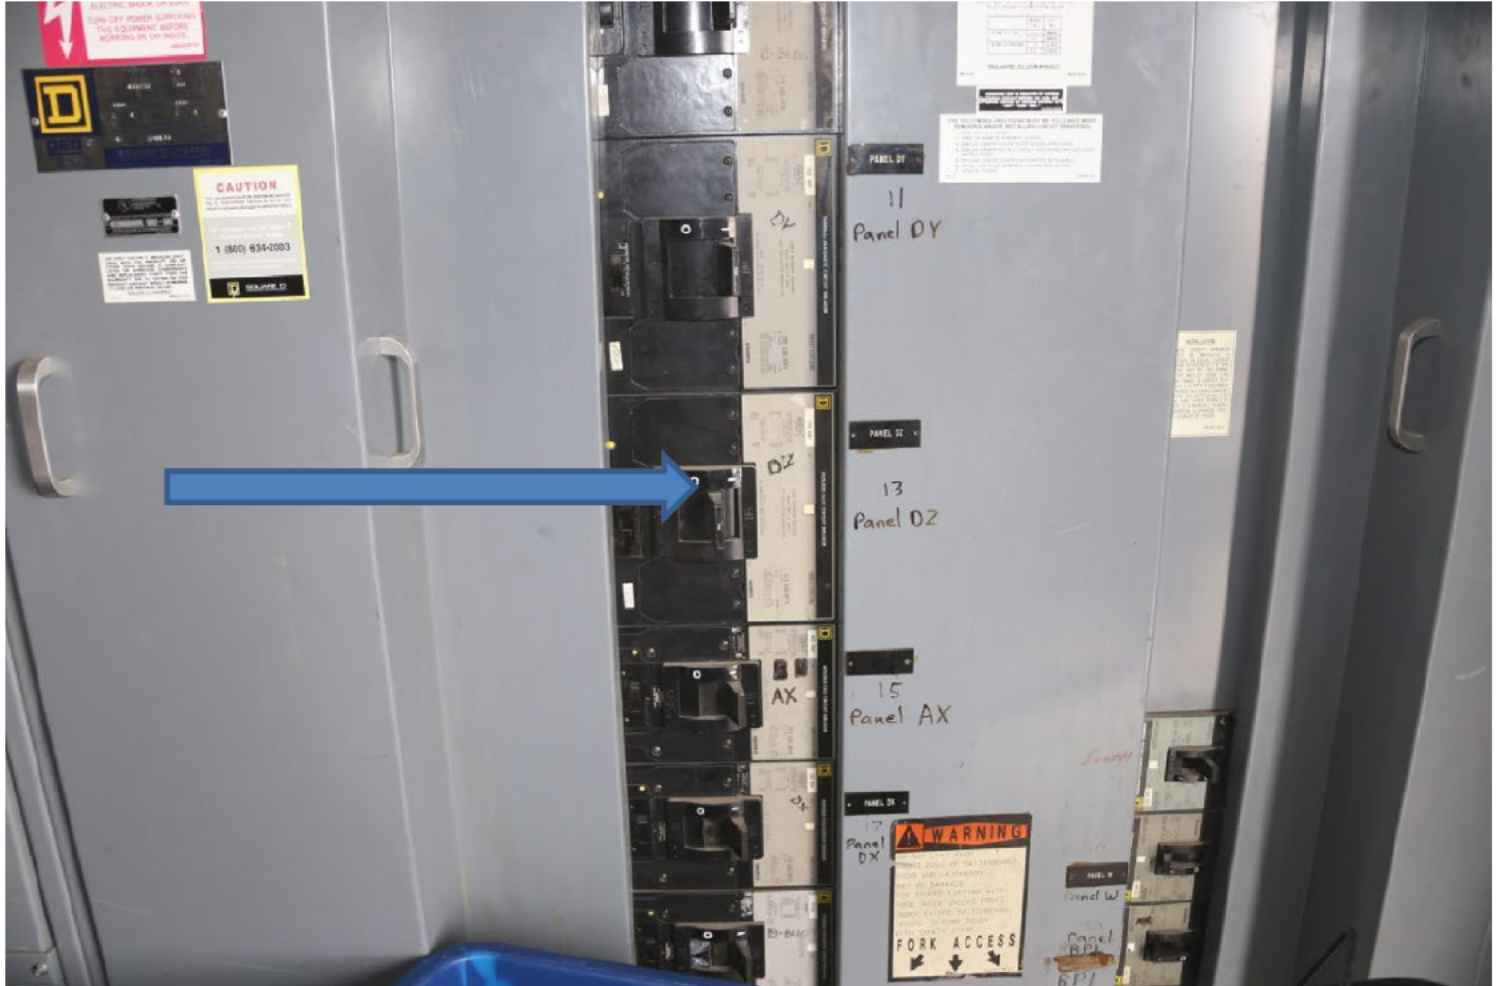
Examinations of the main service panel's interior and exterior areas revealed no fire or heat-related damage. The main breaker within the service panel was in the “on” position. Examinations of the main service panel's remaining breakers revealed that some were in the “tripped” position.

Blue arrow showing a trip on the main service panel. Picture is from file IMG_0313.CR2. A copy of this image is included in the addenda/held in the case file.

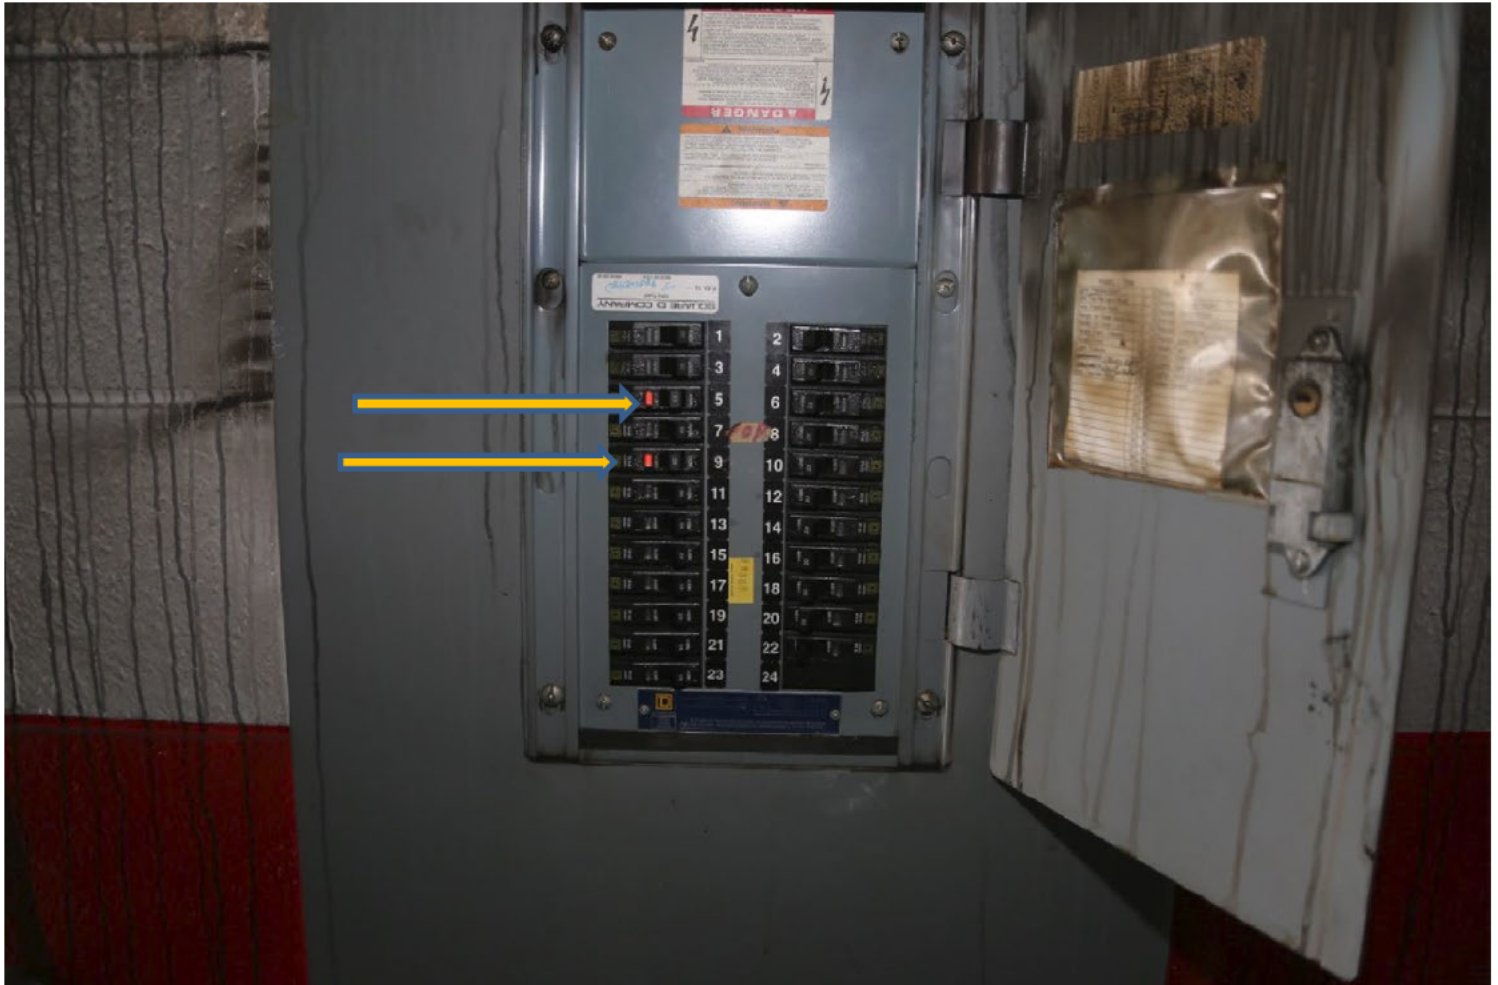
Panel D-2 located in the hallway of the D wing between the cafeteria and old gym. Orange arrows show breakers 5 and 9 tripped. Breaker 5 is connected to the fans in the practice room. Breaker 9 is connected to the receptacle on the stage lights. Picture is from file IMG_0316.CR2. A copy of this image is included in the addenda/held in the case file.

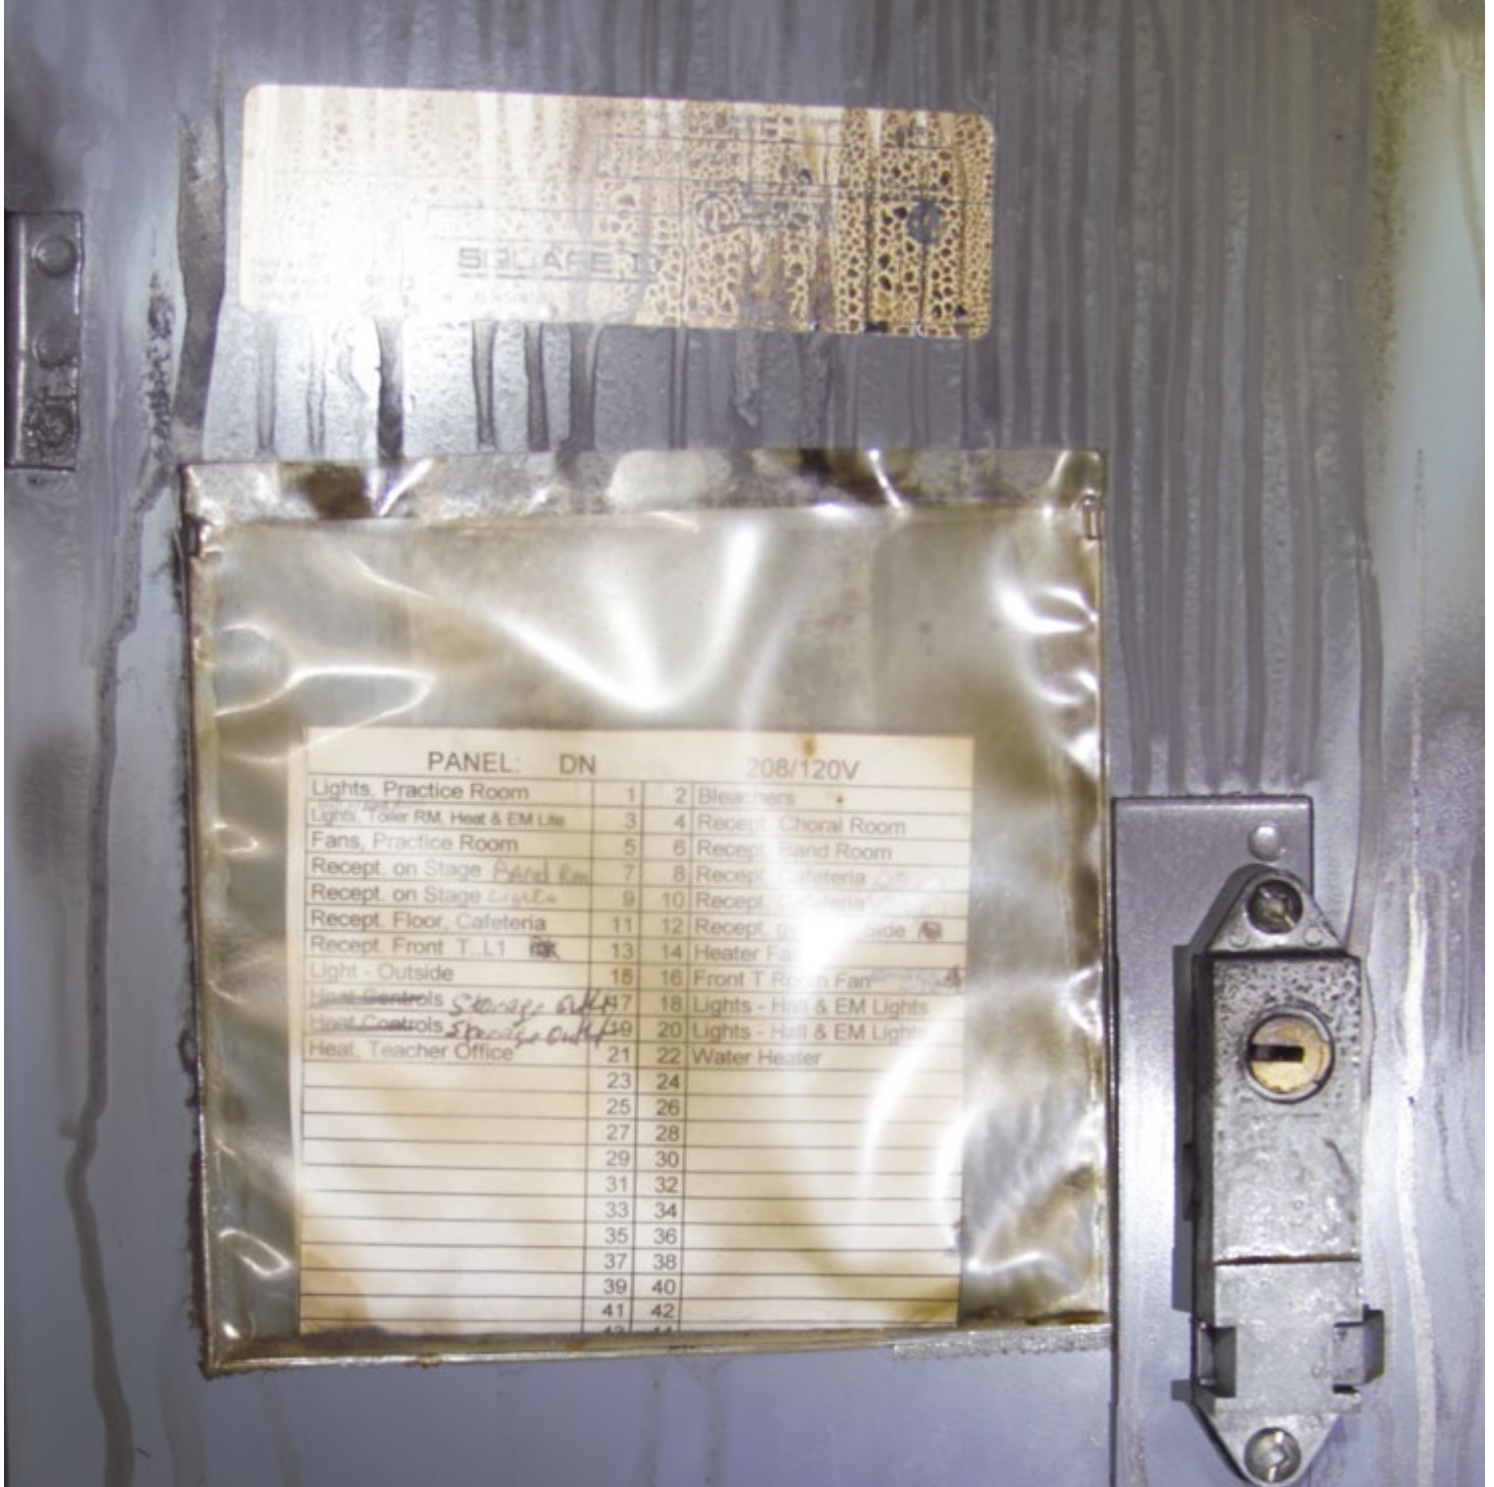
Labeling of Panel D2. Picture is from file IMG_0317.CR2. A copy of this image is included in the addenda/held in the case file.

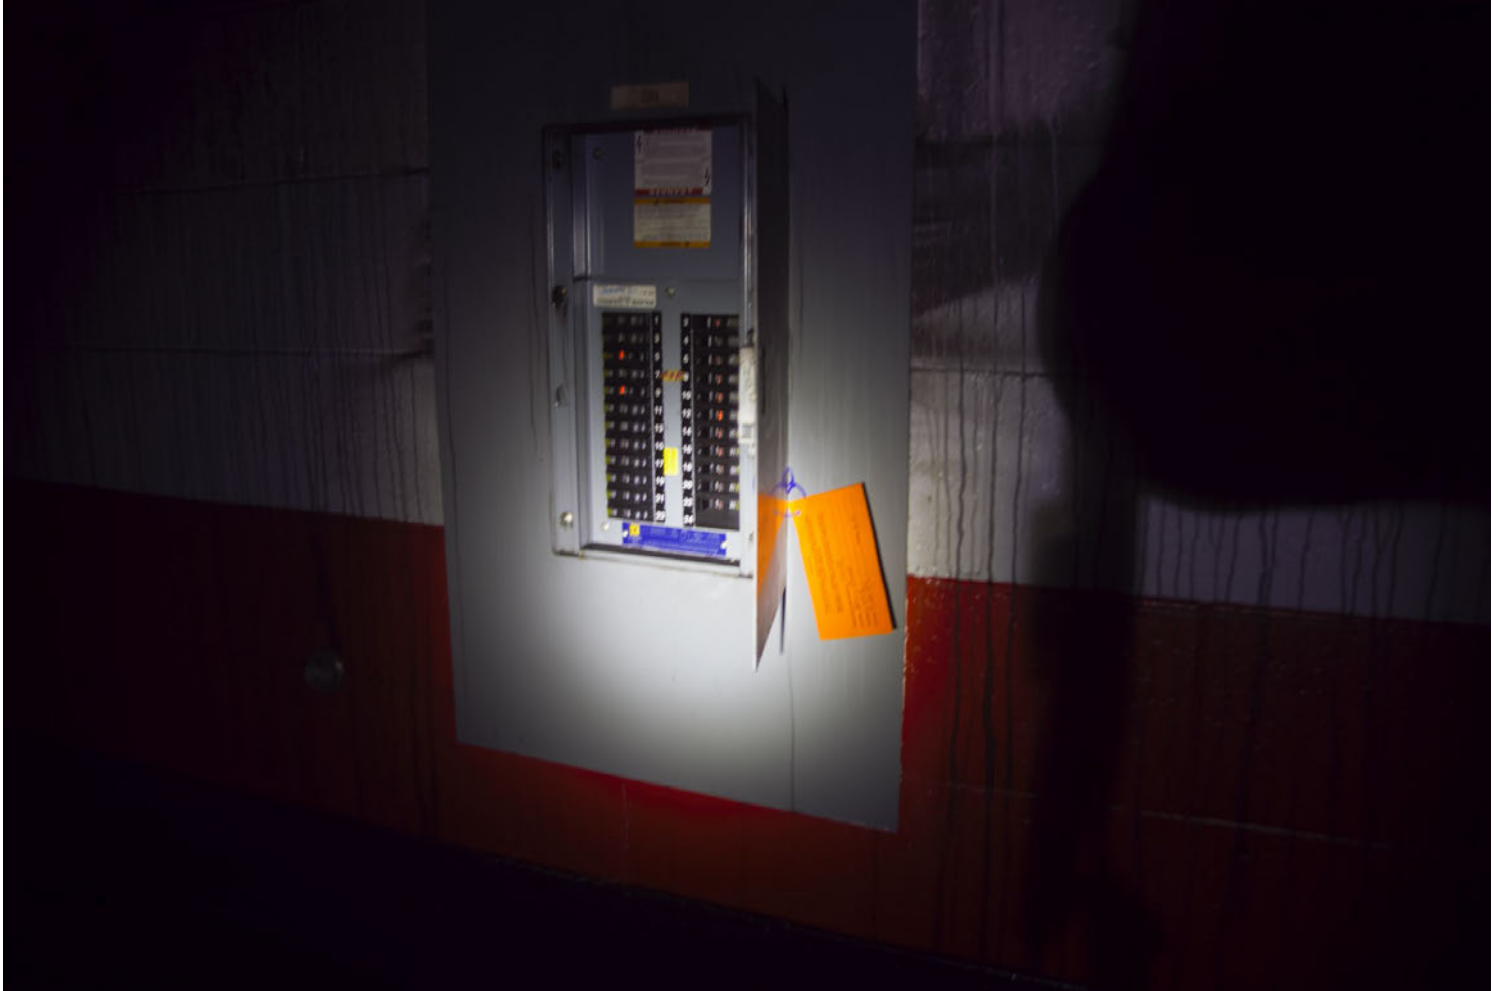
Panel D-2 located in the hallway of the D wing between the cafeteria and old gym marked as evidence. Picture is from file IMG_0364.CR2. A copy of this image is included in the addenda/held in the case file.

Analysis of the fire and heat-related patterns by their movement and intensity concludes the fire propagated to the panel.

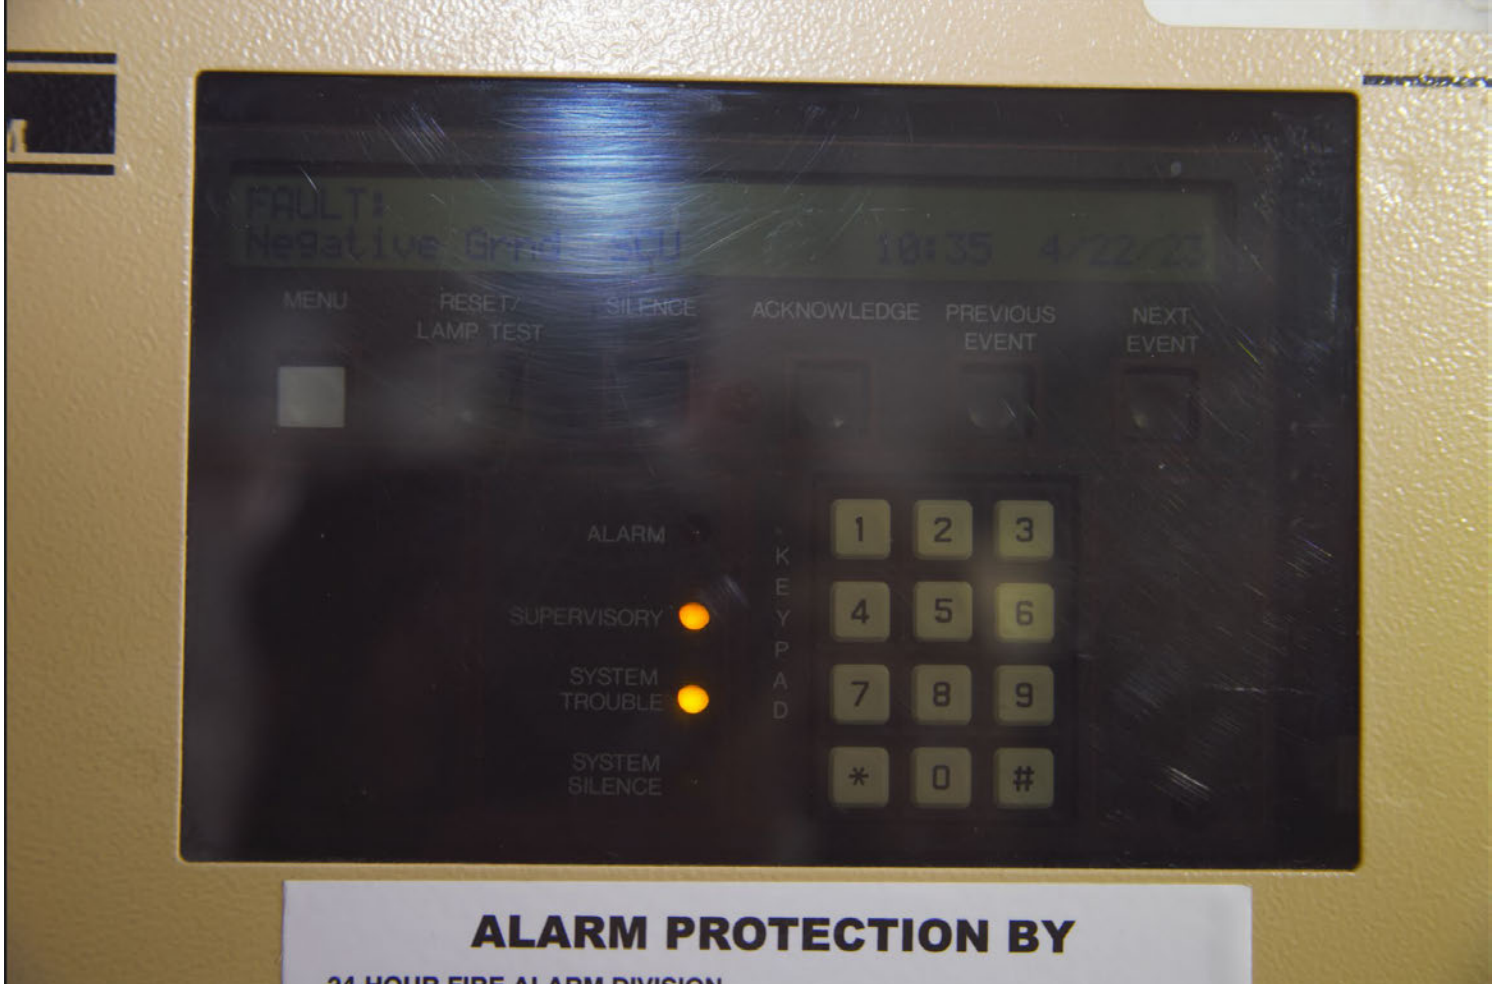
Examinations were conducted in an effort to locate any identifiable fire or building code issues. These efforts focused on the types of defects which would have caused, or contributed to, the “sequence of ignition” for the fire, as well as those which may have affected the “propagation and spread” of smoke, fire and/or heat. During this process, fire or building code issues were identified. The main fire alarm panel indicated it was in “trouble mode.” The fire alarm did not activate or send a single to the monitoring company. Once the sprinkler system was activated, it did not send an alarm or water flow to the monitoring company. The water bell did not sound, and the water strobe was not activated.

Alarm Panel reading Fault, Supervisory, and System Trouble on the day of the fire. Picture is from file IMG_0194.CR2. A copy of this image is included in the addenda/held in the case file. Pocatello Fire Department Inspection Report notes from November 28, 2022: Fire Alarm Panel in trouble mode (fail). The Inspection Report is included in the addenda/held in the case file.

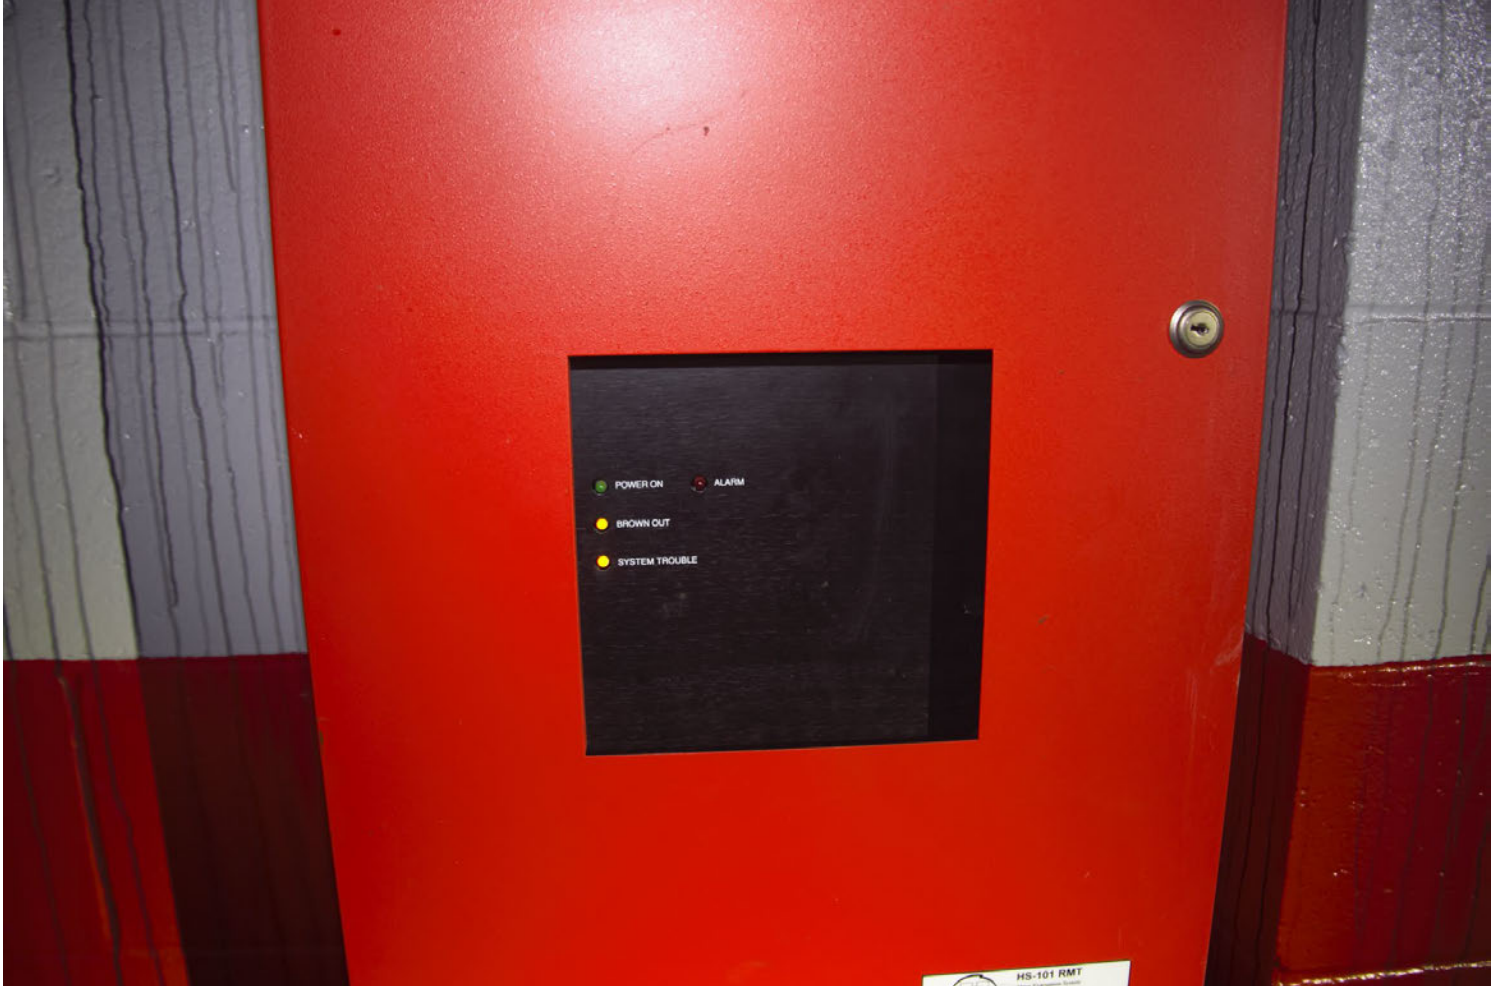
Main Alarm Panel showing Brown Out system trouble. Picture is from file IMG_0197.CR2. A copy of this image is included in the addenda/held in the case file.

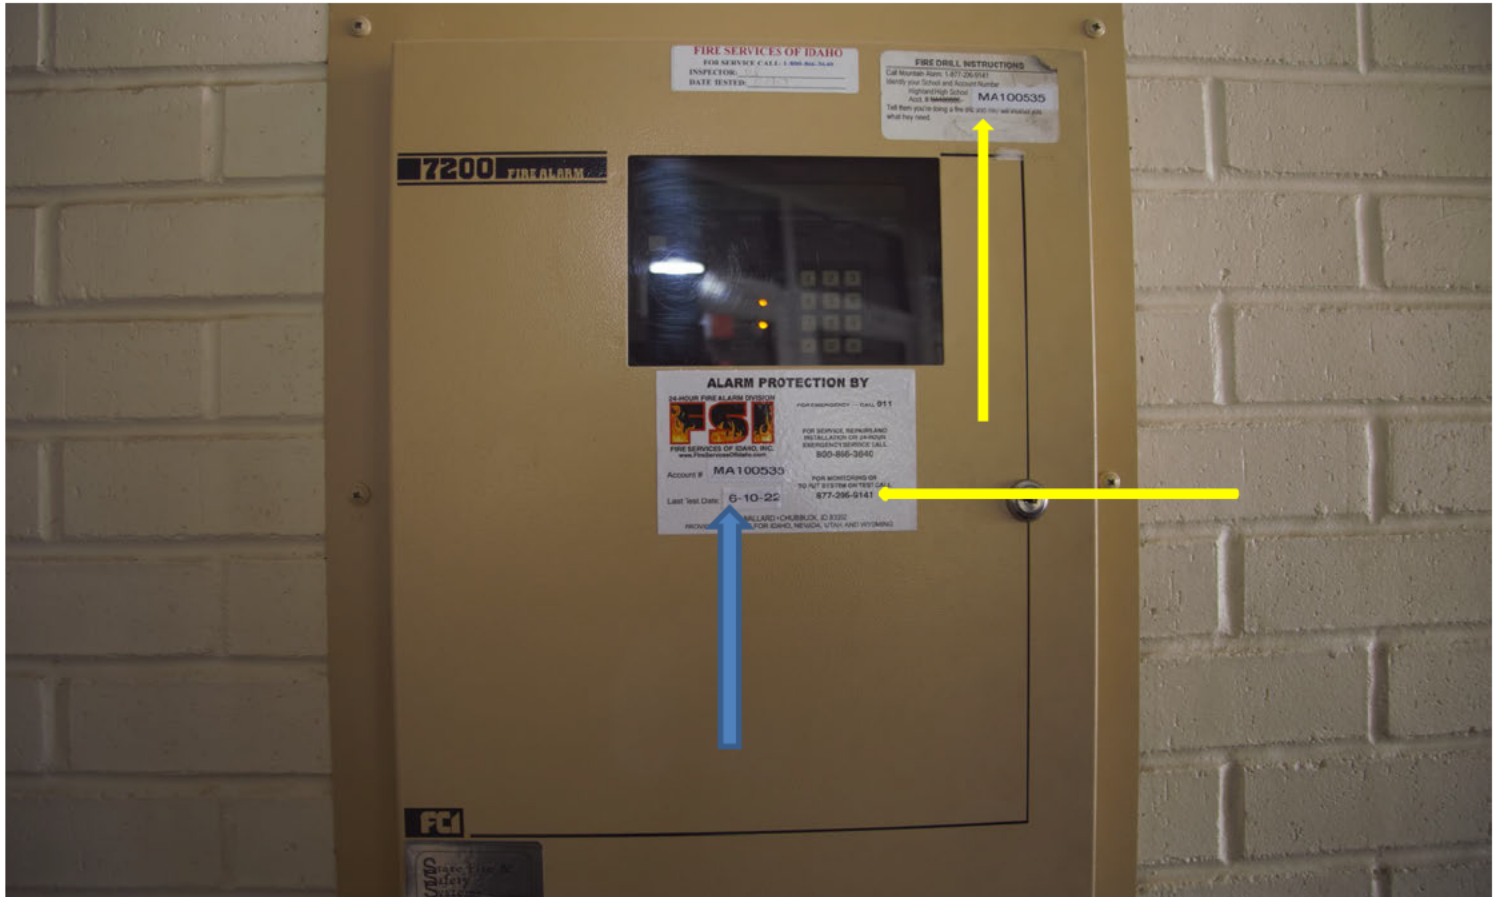
Blue arrow shows last inspection and test date by FSI. Yellow arrows show monitoring contacts. Picture is from file IMG_0193.CR2. A copy of this image is included in the addenda/held in the case file.

Specific Violation Identified, fire alarm panel in trouble:

901.6 Inspection, testing and maintenance. Fire detection and alarm systems, emergency alarm systems, gas detection systems, fire-extinguishing systems, mechanical smoke exhaust systems and smoke and heat vents shall be maintained in an operative condition at all times and shall be replaced or repaired where defective. Nonrequired *fire protection systems* and equipment shall be inspected, tested, and maintained or removed. IFC-2018 Chapter 9

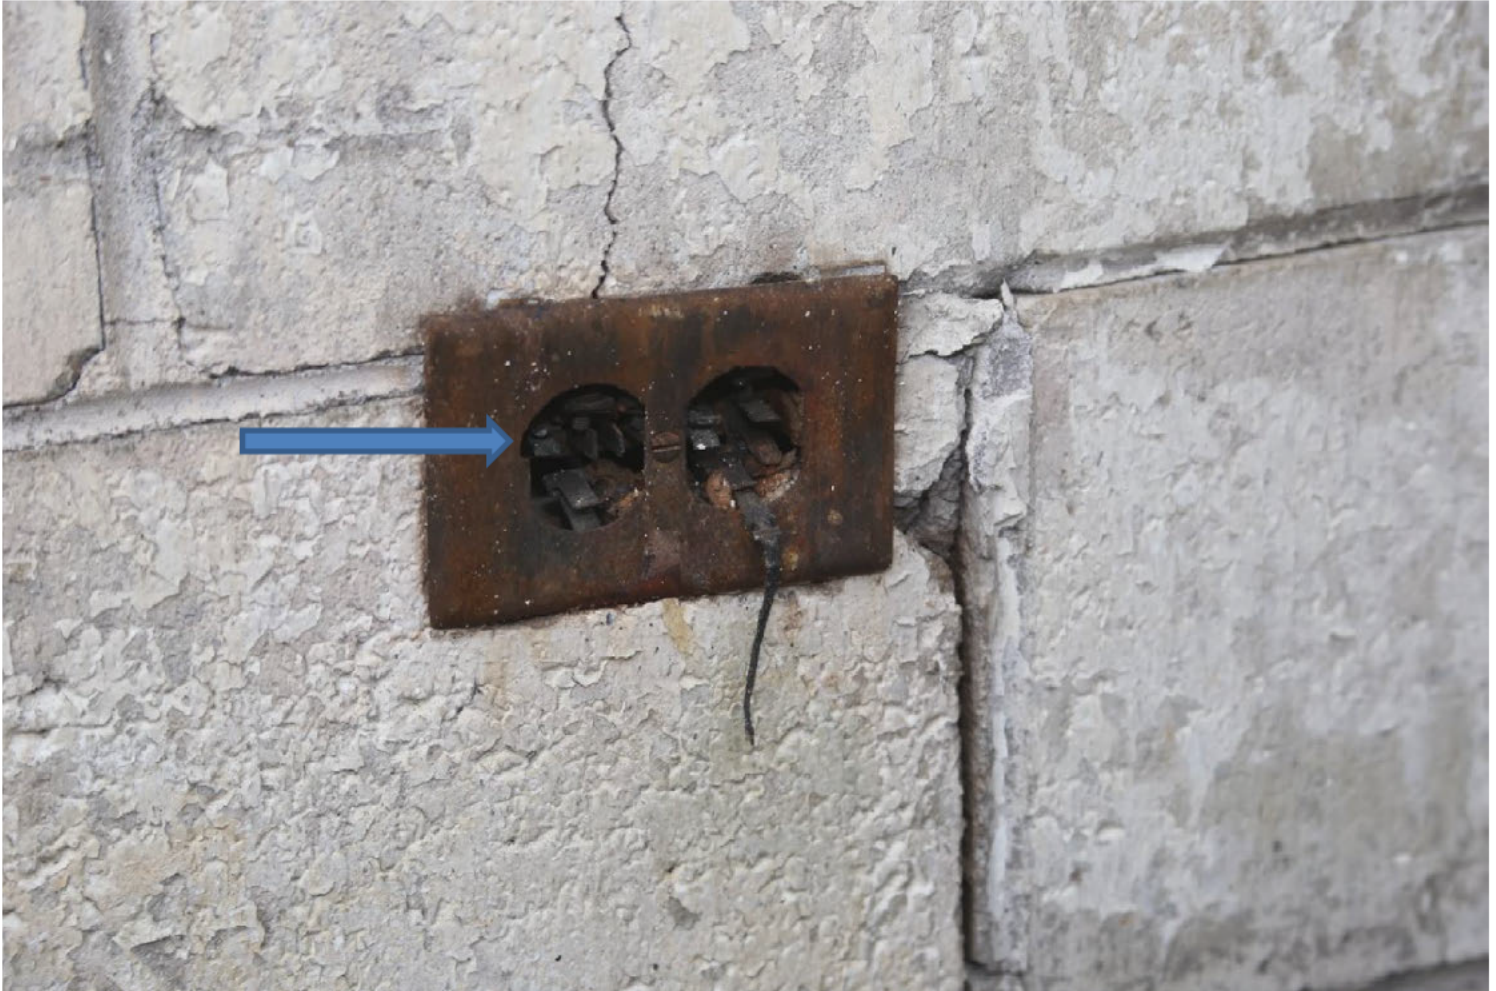
In-field investigation and examination provided evidence or information indicating the cause of the fire is most probably a component used in the construction of the audio power amplifier or the Tomcat floor scrubber.

Blue arrow showing arcing on outlet cover that the audio power amplifier was plugged into. Picture is from file IMG_0345.CR2. A copy of this image is included in the addenda/held in the case file.

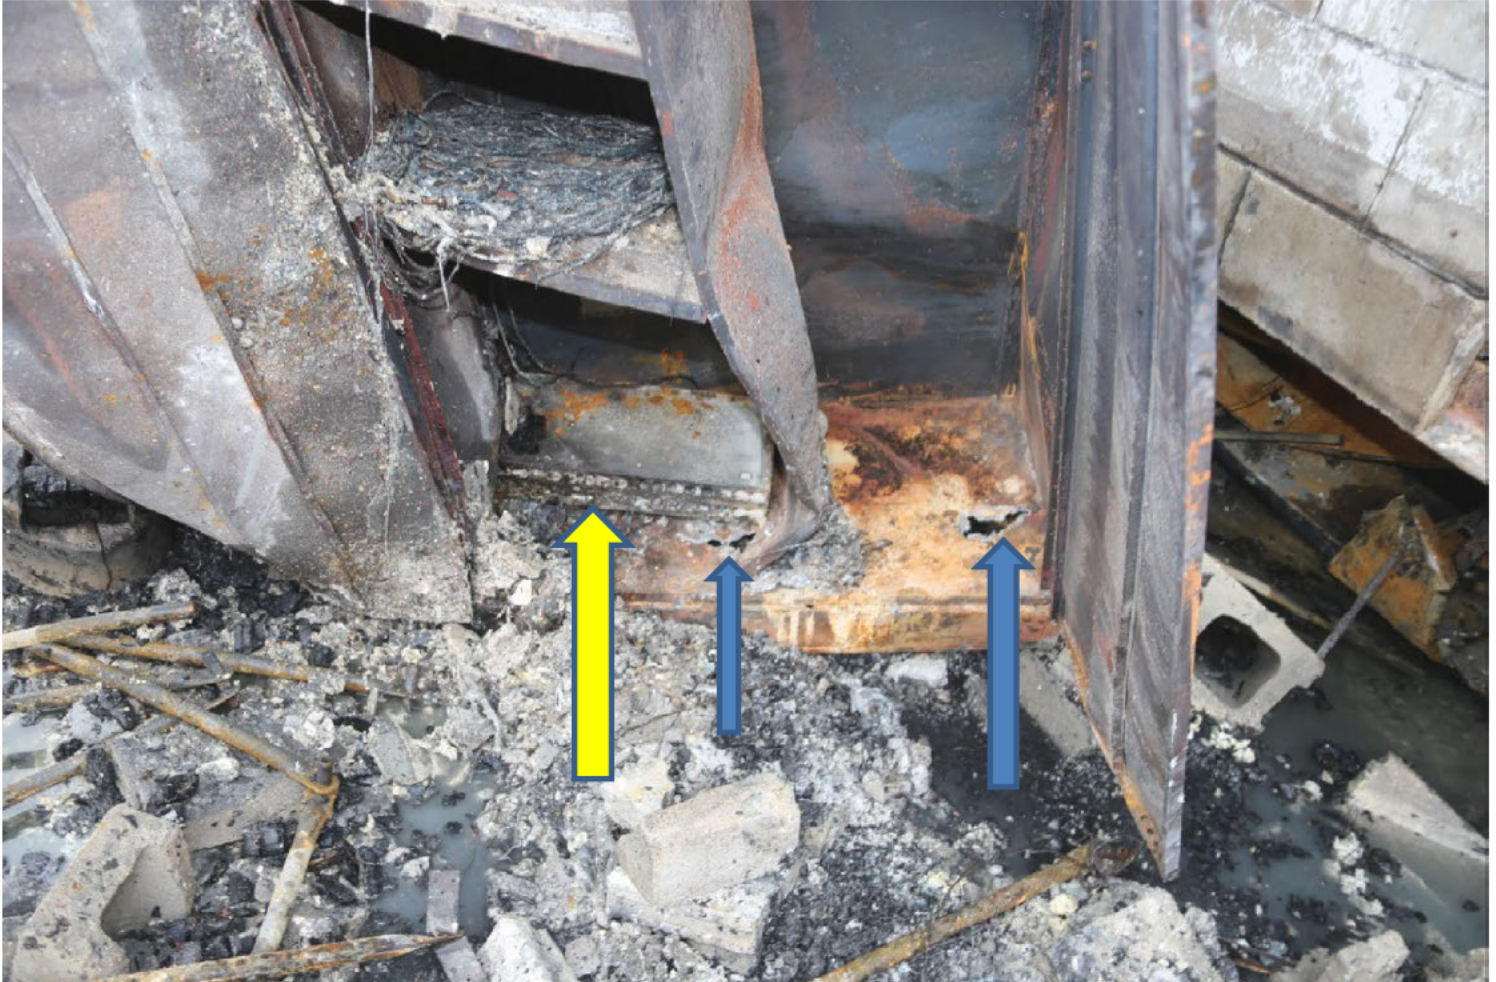
Yellow arrow showing equipment located in the cabinet on the northside of the stage area. Blue arrows show arcing inside the cabinet. Picture is from file IMG_0360.CR2. A copy of this image is included in the addenda/held in the case file.

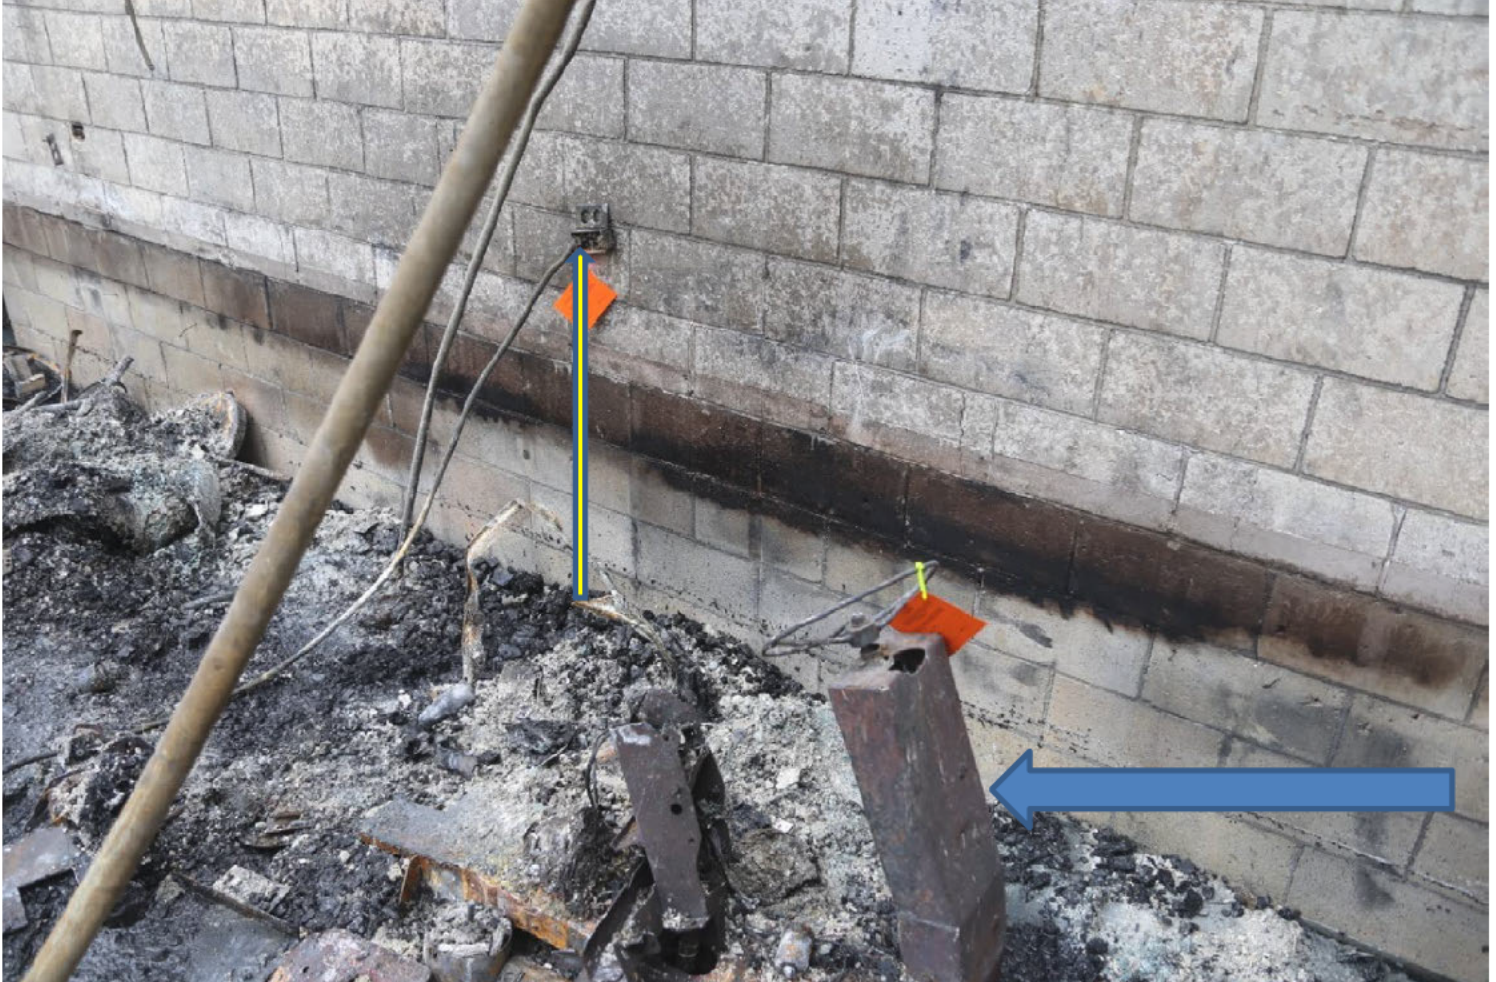
Blue arrow shows Tomcat floor scrubber located on the northside of the stage. Yellow arrow showing power cord for the Tomcat floor scrubber. Picture is from file IMG_0365.CR2. A copy of this image is included in the addenda/held in the case file.
