# **Emmett High School – Facility Condition Assessment**

## *Observations & Assessments*

Compiled Document of Observations & Assessments

**July 10, 2026**

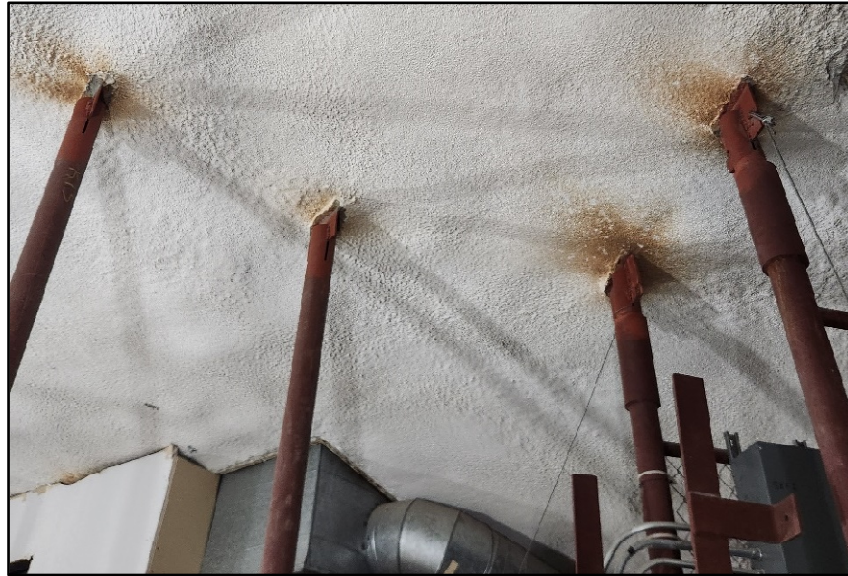
Observation: The connections for the catwalk to the primary dome structure was observed and an item that was noted as a concern by Emmett Maintenance. The connections appeared to be installed as noted within the existing building drawings. No concerns were noted.

Scanning of the concrete dome was performed at the top of the dome and the concrete was found to be of sound nature.

**FIGURE 1: CATWALK SUPPORT ATTACHMENT TO PRIMARY DOME STRUCTURE**

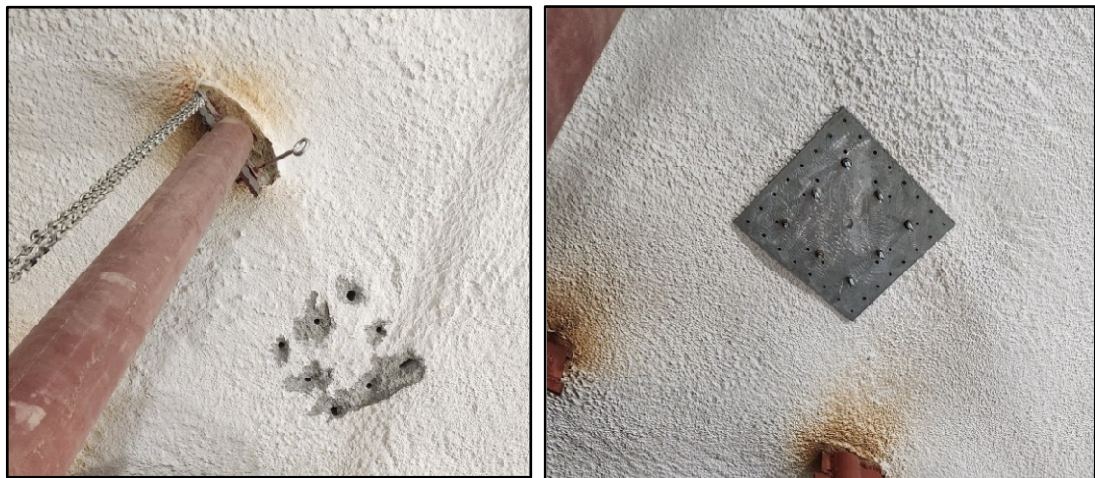
It was noted by Emmett Maintenance that the contractor who installed the roof tie-off anchors experienced wet and spalling concrete during the anchor installation. No wet or spalling concrete was observed during the site observation.

Possible Source: Damage to the concrete per the previous installment of roof tie-off anchors.

**FIGURE 2: PREVIOUS ATTACHMENTS FOR ROOF TIE-OFF ANCHORS**

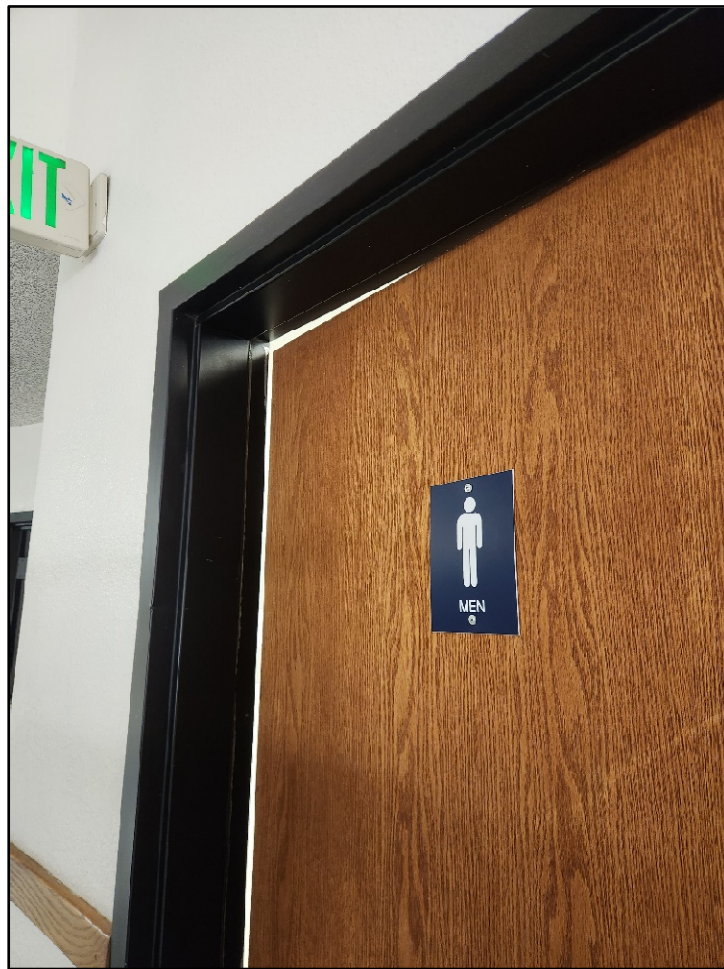
Observation: It was noted by Emmett Maintenance that the door frames on level 3 were experiencing issues with doors becoming “skewed” and needing regular maintenance to re-align the door. KPFF observed the door frames and the surrounding finishes and above ceiling. It was observed that the wall finishes surrounding the doors and the floors below the door were not showing signs of cracking which would indicate settlement (Figures 3 & 5). It was noted by Emmett Maintenance than one door (Room 305) was fixed and two (2) weeks later required adjustments. This location did not show signs of finishing damages (Figure 4).

Possible Source: Potentially experiencing issues with the door frames themselves, as these door frames are per the original building (circa 1986).

**FIGURE 3: LEVEL 3 MEN'S RESTROOM**

- 3) **Door Frame Skewing (Dome A):** We recommend that one of the skewing doors be replaced with a new door frame, door, and jambs. We recommend during this replacement to observe the existing conditions of the door jamb framing. Following replacement of one of the doors and its framing, we recommend monitoring the door to identify if it still experiences skewing problems. It is recommended that all doors and their jambs be completely replaced if it is observed that door replacement resolves door skewing problems.

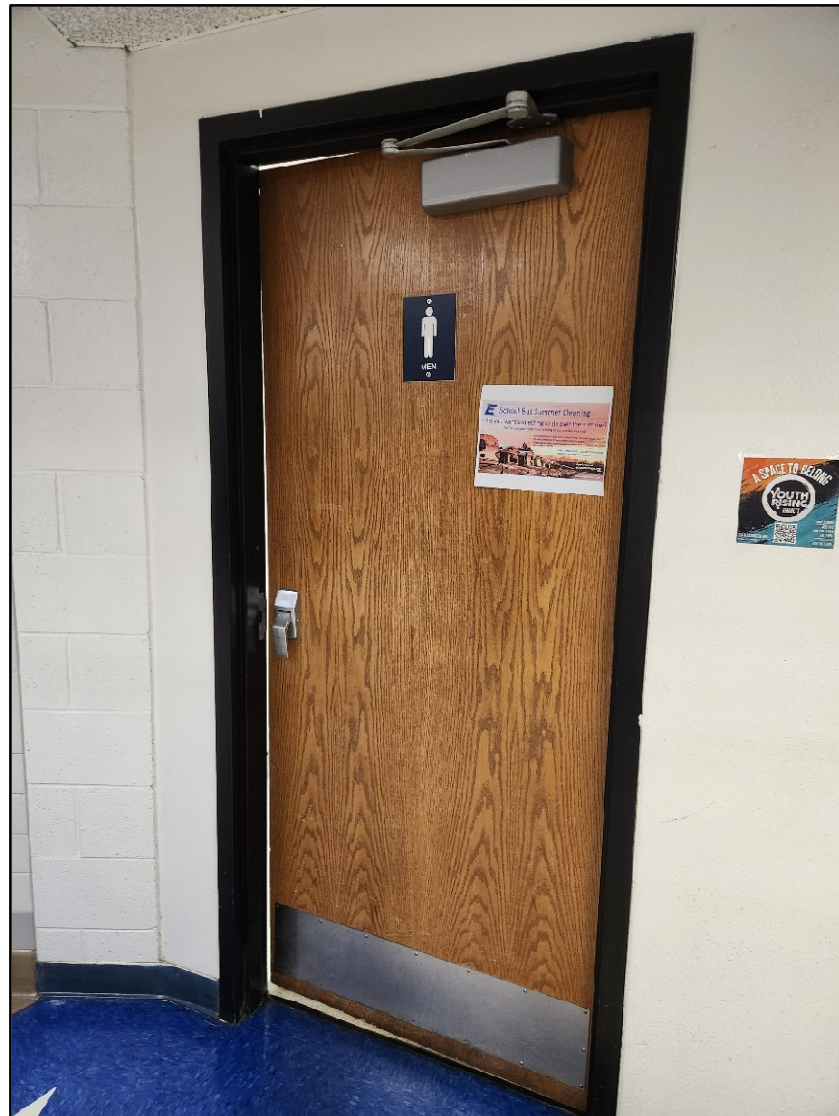
Observation: It was noted by Emmett Maintenance that Level 2 also experiences situations where the doors were skewing and required fixes to fit back into the frames properly, similar to the Observation #3 listed above. Figure 6 shows the mens restroom on Level 2 which is below the Level 3 Men's Room from Figure 3.

Possible Source: Potentially experiencing issues with the door frames themselves, as these door frames are per the original building (circa 1986).

**FIGURE 6: MEN'S RESTROOM DOOR AT LEVEL 2**

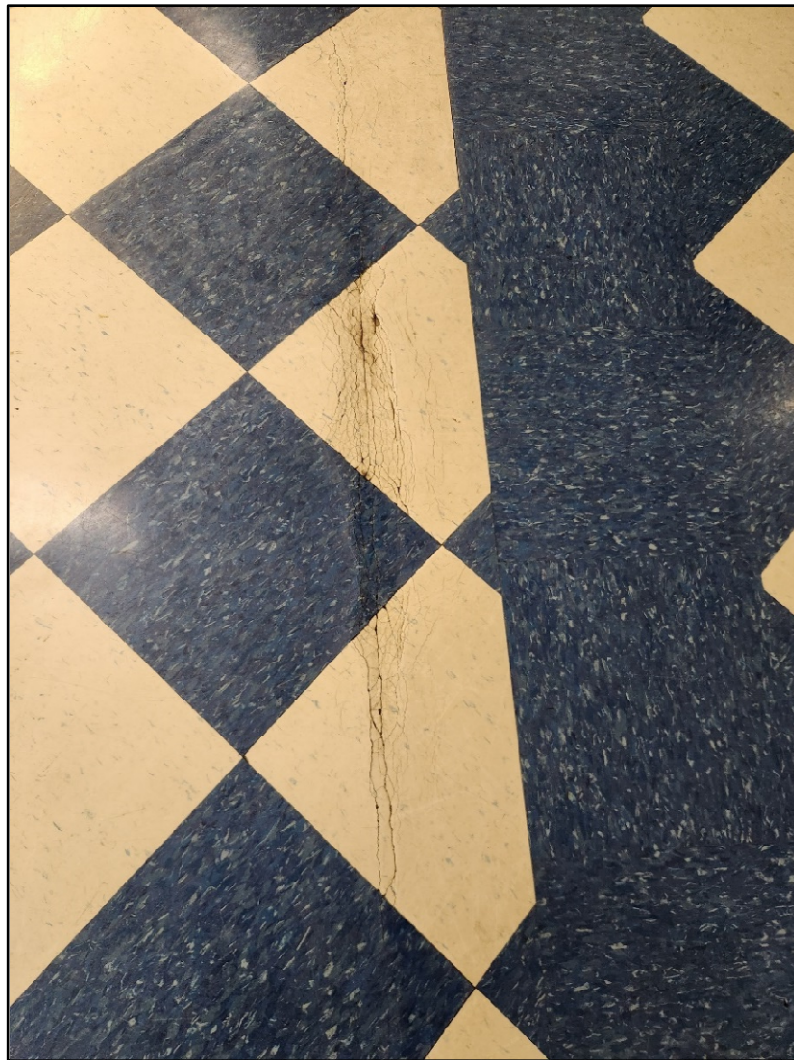
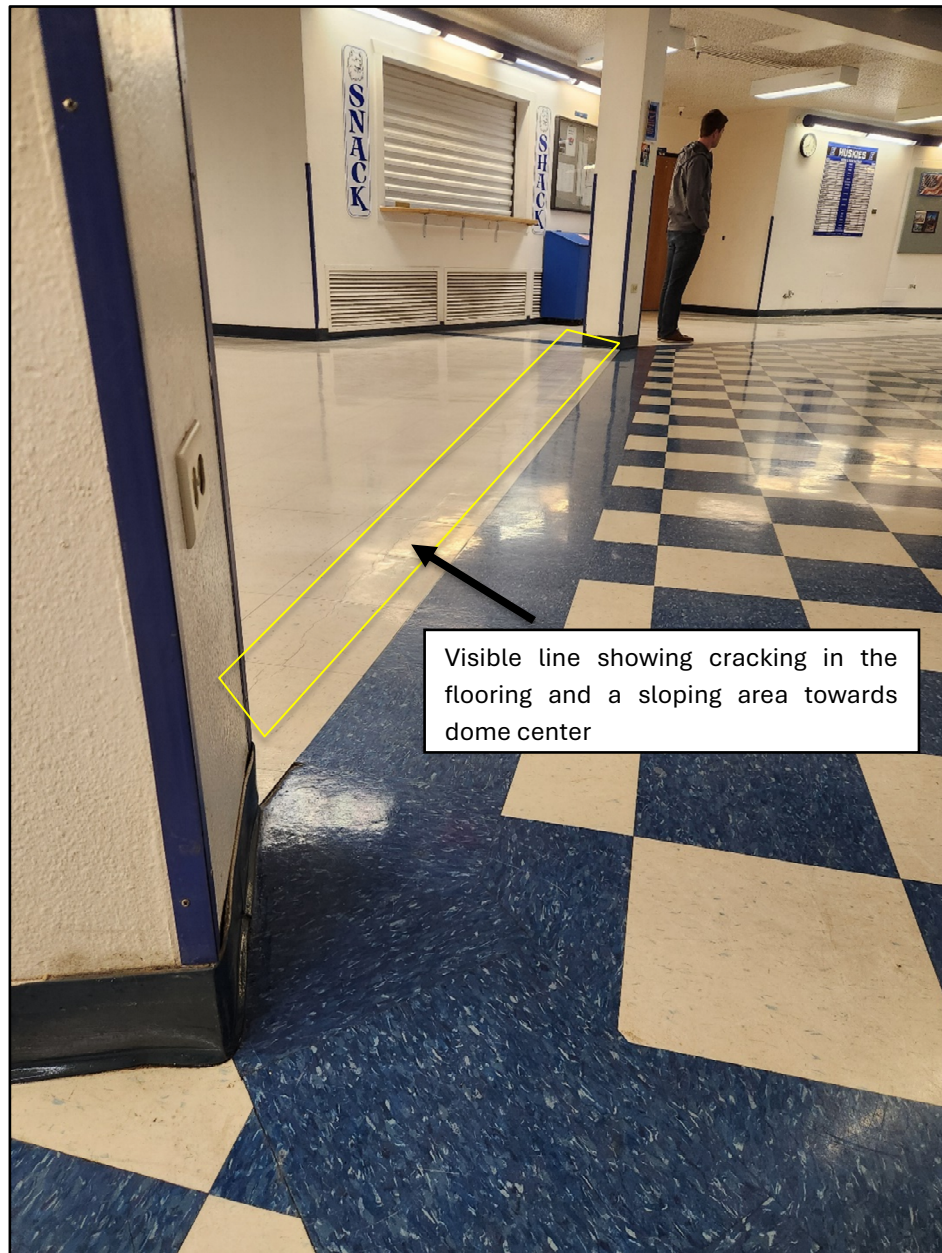
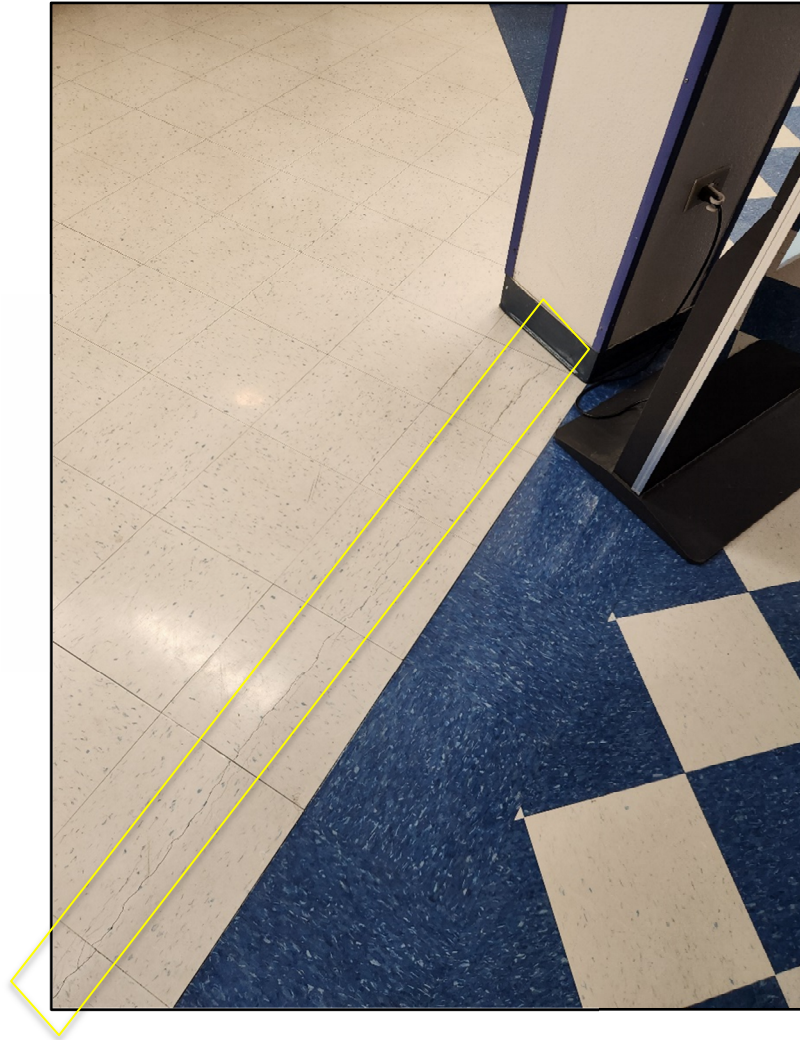
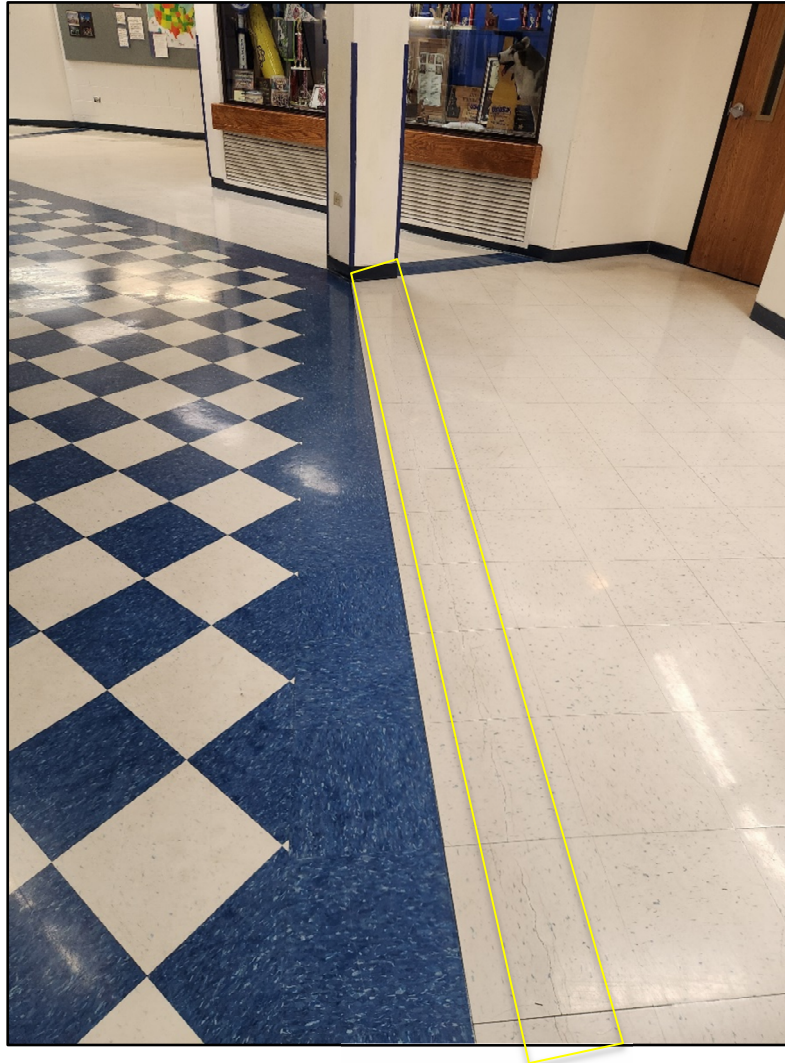
Observation: It was observed that the perimeter of the atrium between the column lines was cracking. Many locations had areas of already cracking flooring or areas where the flooring appears to be progressing towards a crack (Figures 7-10). Figure 11 shows that the cracking observed on site appears to follow the location of the original tongue and groove slab-on-grade floor joint.

Possible Source: The central slab-on-grade may be experiencing settlement which is causing differential settlement between the primary framing foundations and other portions of the slab-on-grade.

**FIGURE 7: ATRIUM PERIMETER FLOORING CRACKING**

- 2) **Cracking in Flooring at SOG within Atrium Perimeter (Dome A):** Monitor the existing floor cracking at the atrium perimeter to identify if increased settlement is occurring in the slab-on-grade.

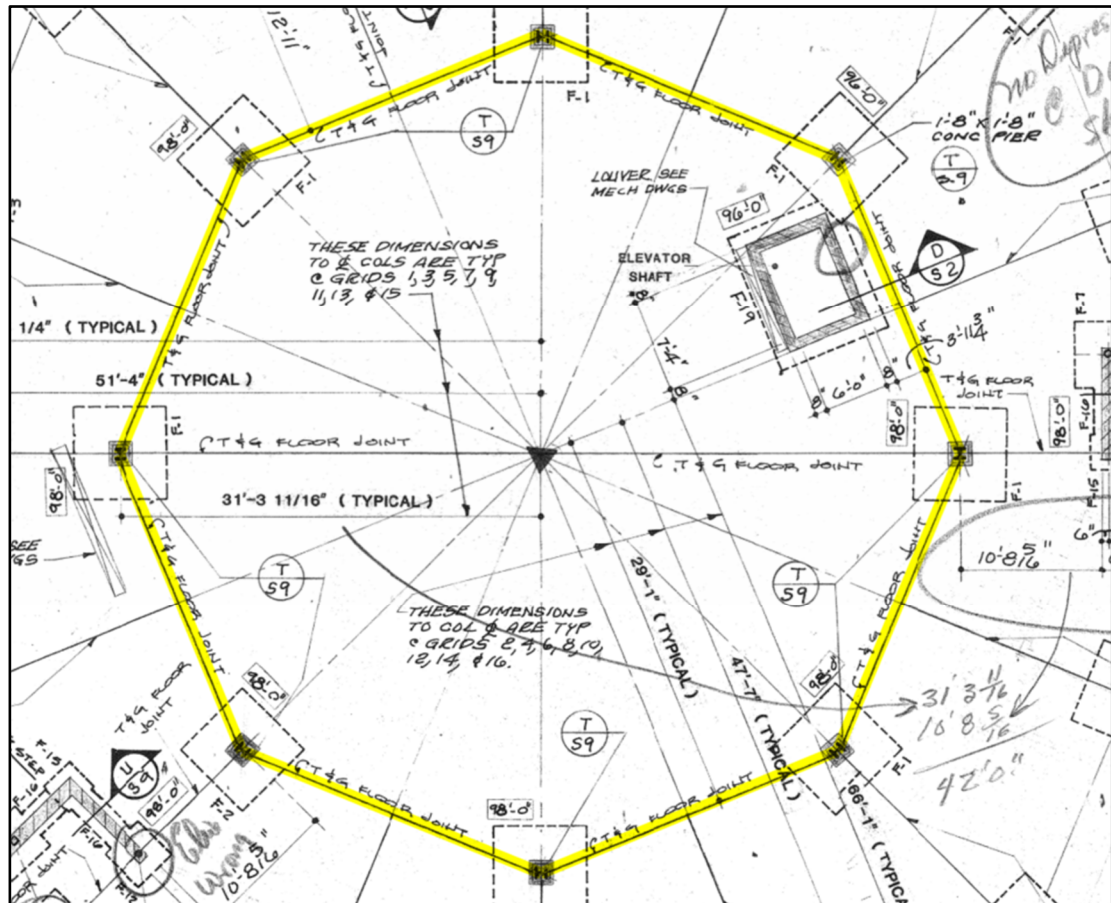
**FIGURE 11: PARTIAL PLAN OF EXISTING DRAWINGS WITH APPROXIMATE CRACKING LOCATIONS  
HIGHLIGHTED IN YELLOW**

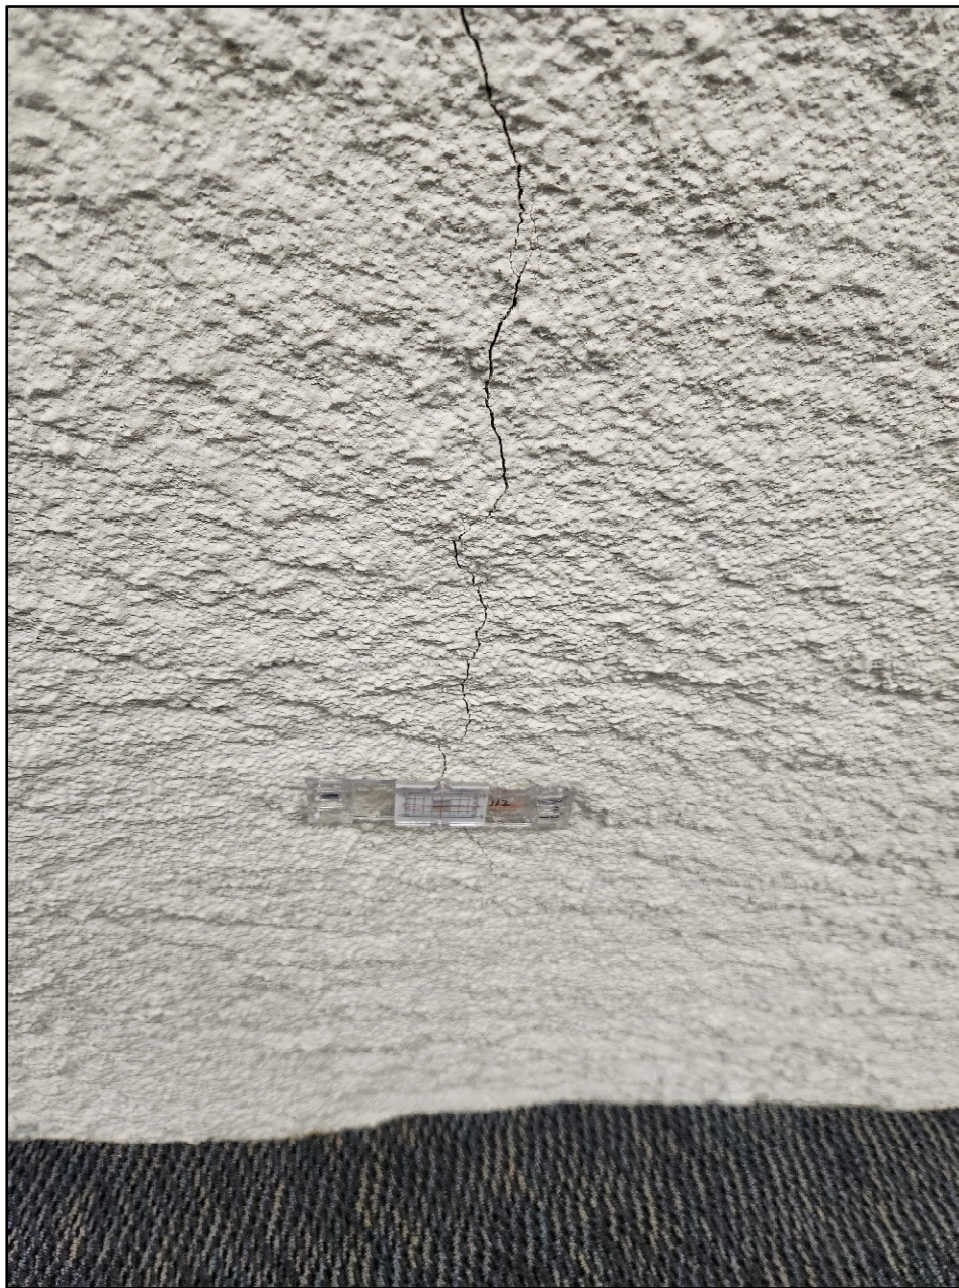
Observation: Various cracks in the reinforced concrete dome wall were observed. These cracks were previously observed by KPFF and the findings reported in the report dated November 20, 2024. The cracking within the reinforced concrete dome wall appeared to match the conditions found in the above mentioned report. Following KPFF observation, strain gauges were installed by Atlas as noted in the Atlas report dated October 10, 2025. On site, the strain gauges were showing potentially minute displacement (Figures 12 & 13). The cracks in the Music Room storage (Figure 14) had also been painted over at some time before the original KPFF observation. The paint over the cracks in these areas appears to remain.

Possible Source: The possible source is still as noted in the previous KPFF observation with the possible source of cracking being related to temperature and shrinkage cracking.

**FIGURE 12: DOME A CRACK WITH STRAIN GAUGE PER ATLAS (CLASSROOM)**

- 1) **Reinforced Concrete Dome Wall Cracks (Dome A & B):** Atlas to continue to monitor the cracks via previously installed crack gages to identify if cracks are continuously increasing in severity or if the structure is experiencing differential settlement.

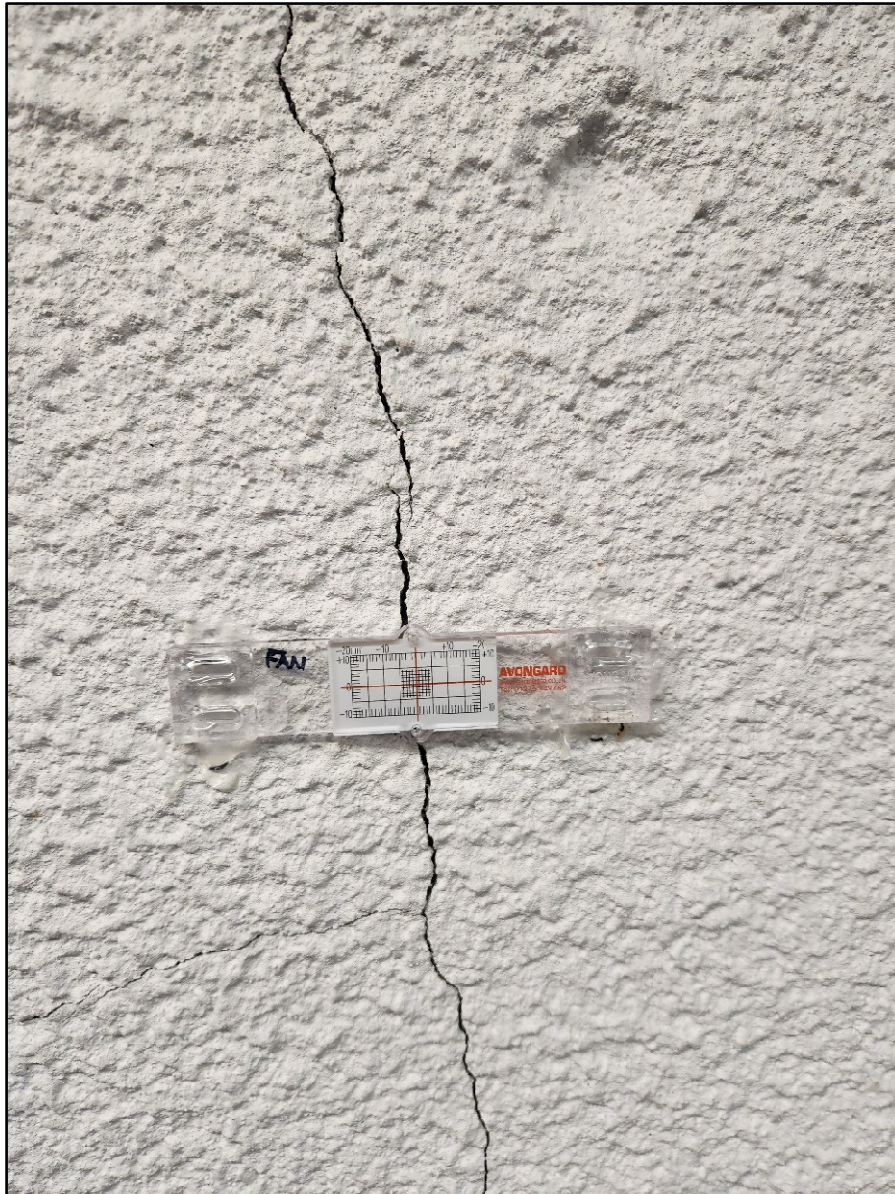
**FIGURE 13: DOME B CRACK WITH STRAIN GAUGE PER ATLAS (FAN ROOM)**

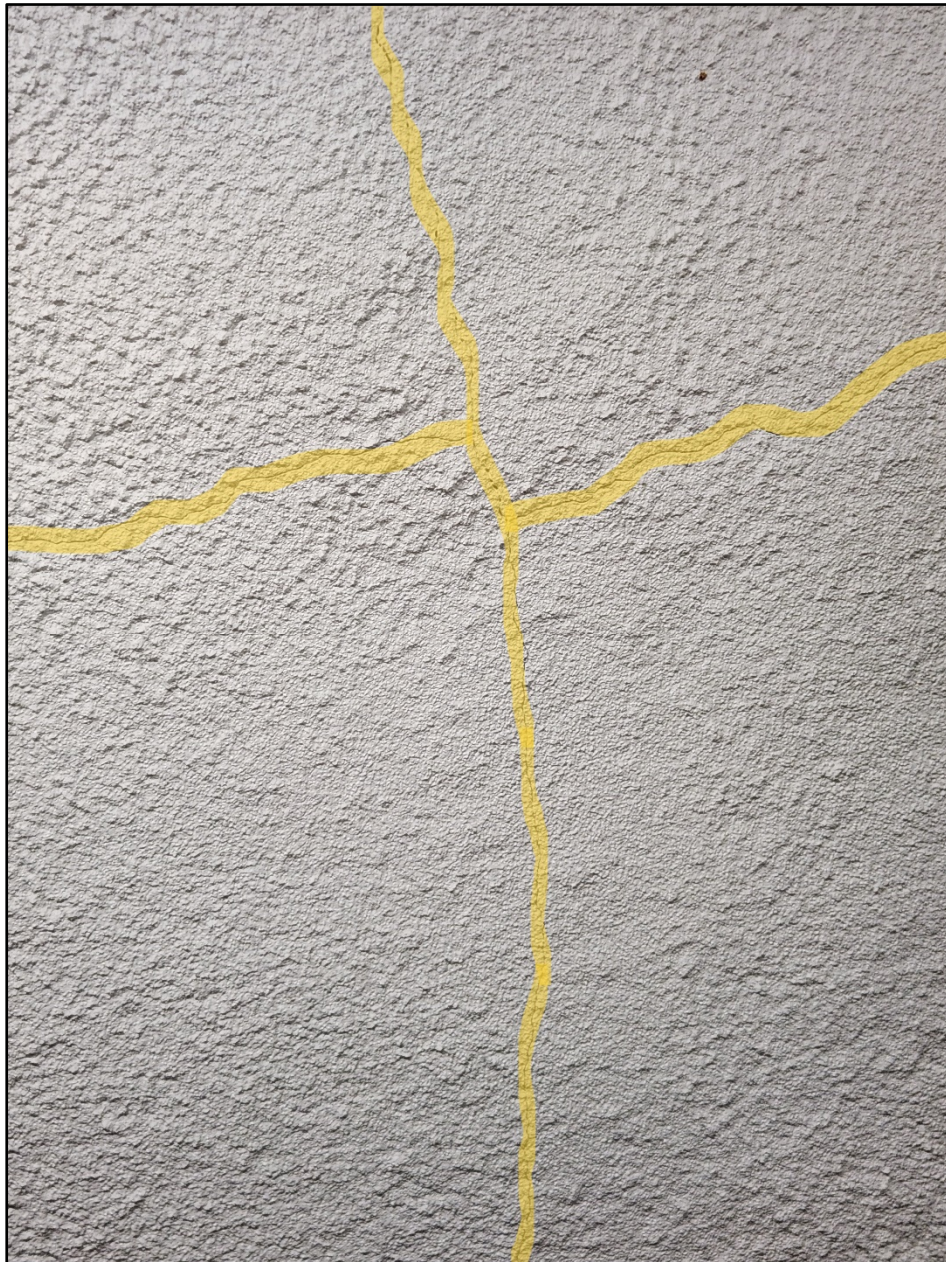
**FIGURE 14: DOME B CRACKS IN THE MUSIC ROOM STORAGE AREA WITH CRACK LOCATIONS HIGHLIGHTED IN YELLOW**

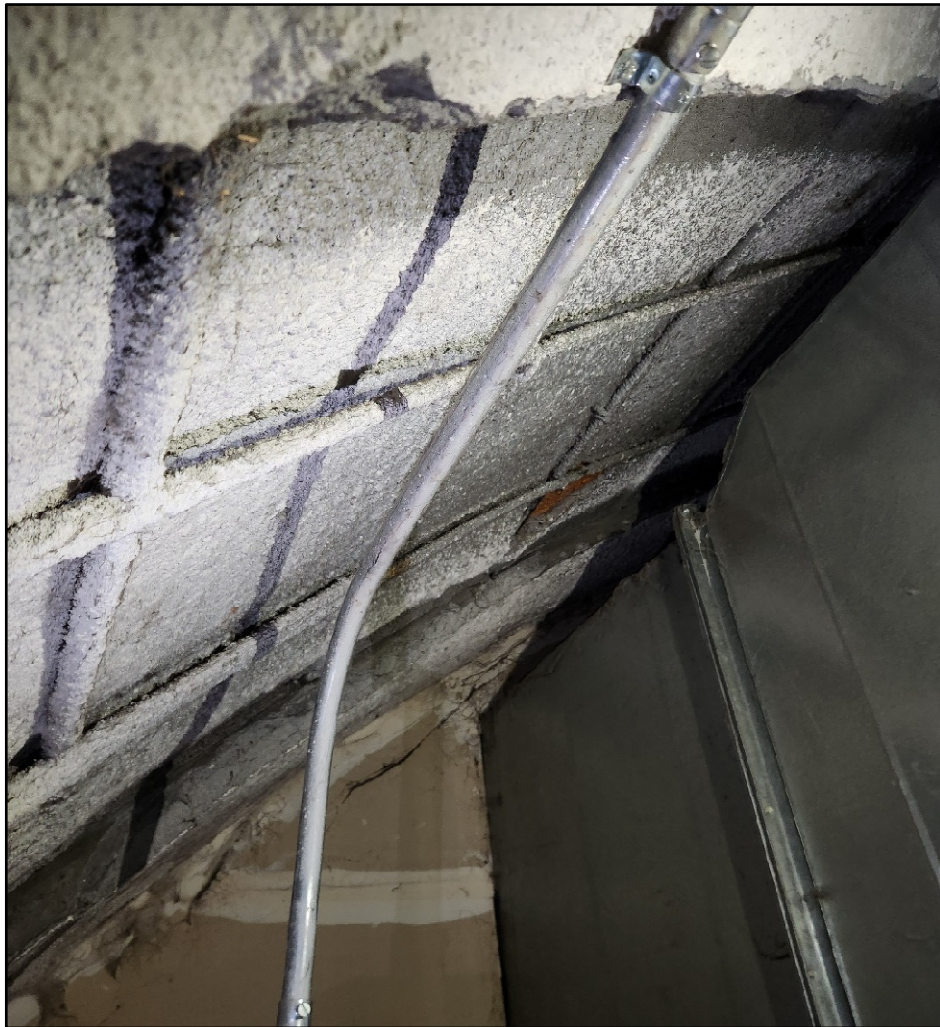
- 7) Location: Dome B – Southeast Entrance Mechanical Space  
Observation: Two (2) locations in the mechanical space had areas of exposed reinforcement with the exterior waterproofing membrane and insulation visible. The reinforcement at these locations

Figure 15 shows the first location observed that had an area of exposed reinforcement of approximately 3'-0" wide by 10'-0" in length. The length is an estimation due to mechanical conflicts obstructing the full line of side.

**FIGURE 15: DOME B MECH SPACE EXPOSED REINFORCEMENT – LOCATION 1**

- 4) **Mechanical Space Exposed Reinforcement (Dome B):** Repair the locations with exposed reinforcement via concrete encasement. It is recommended that this item is prioritized to ensure that the reinforcement and dome structure is protected. This item will be required to be repaired prior to any building envelope repairs or resurfacing.

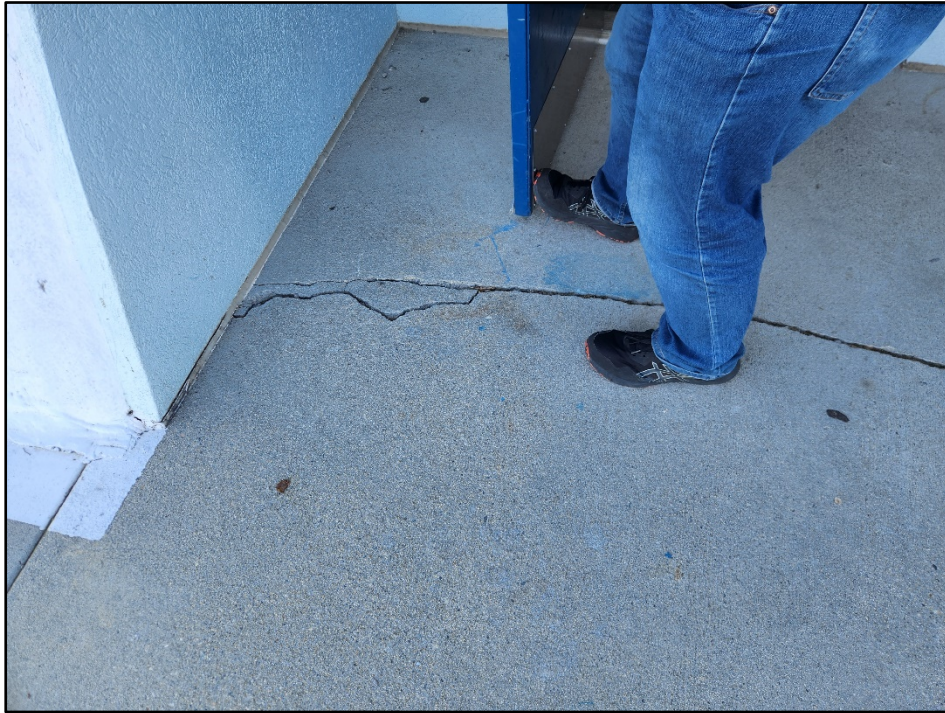
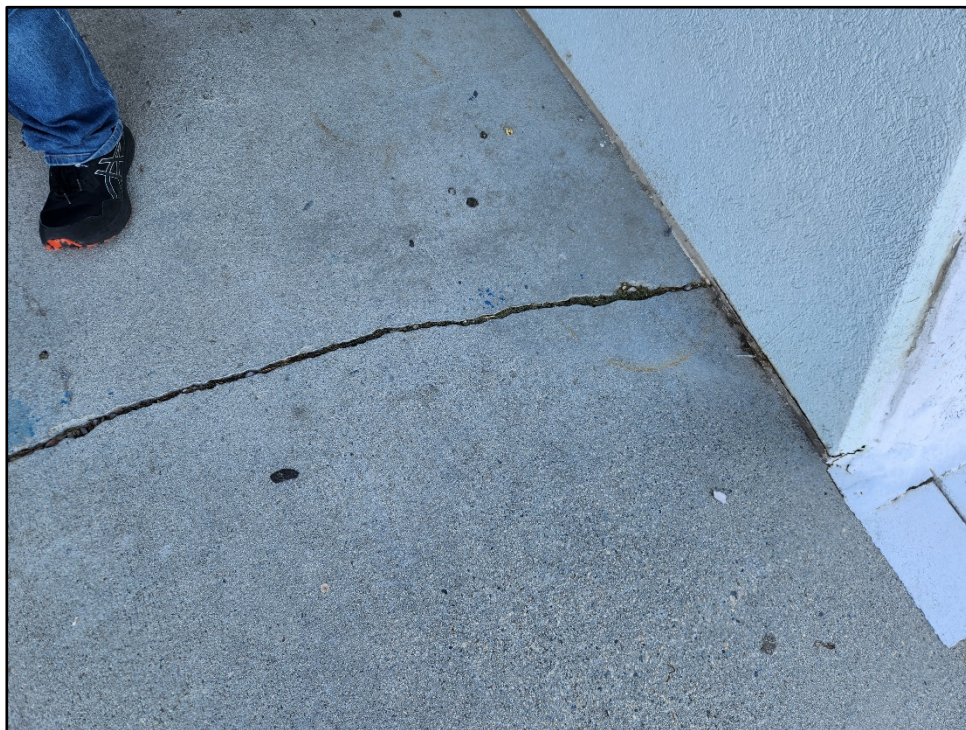
Observation: It was observed that large cracking of the slab-on-grade has occurred at the exit of the music room to the building exterior (Figures 18 & 19).

Possible Source: Per the existing structural drawings, the door inset has different shallow foundations than the primary reinforced concrete dome. The possible source of the cracking is differential settlement between the primary reinforced concrete dome foundations and the door inset foundations.

**FIGURE 18: SLAB-ON-GRADE CRACKING AT MUSIC ROOM EXTERIOR**

- 5) **Music Room Exterior Slab-on-Grade Cracking (Dome B):** Repair slab-on-grade at this location to prevent further moisture infiltration and remove existing trip hazard.

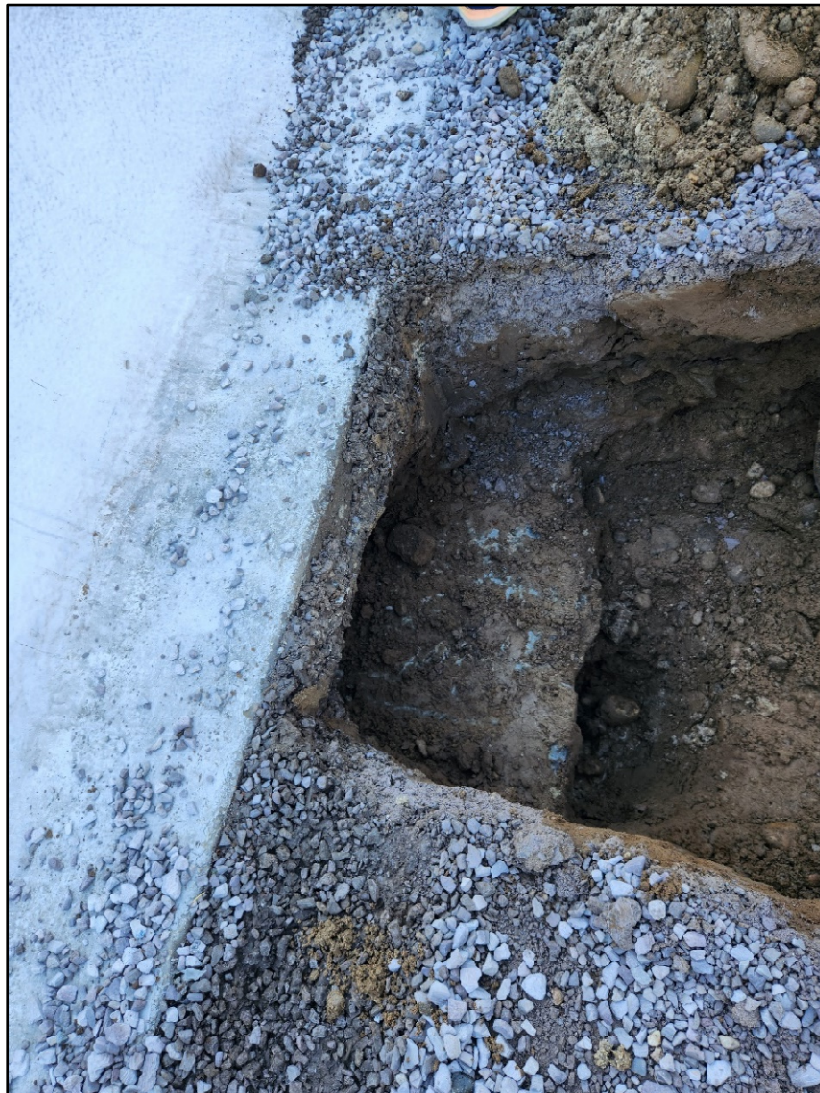
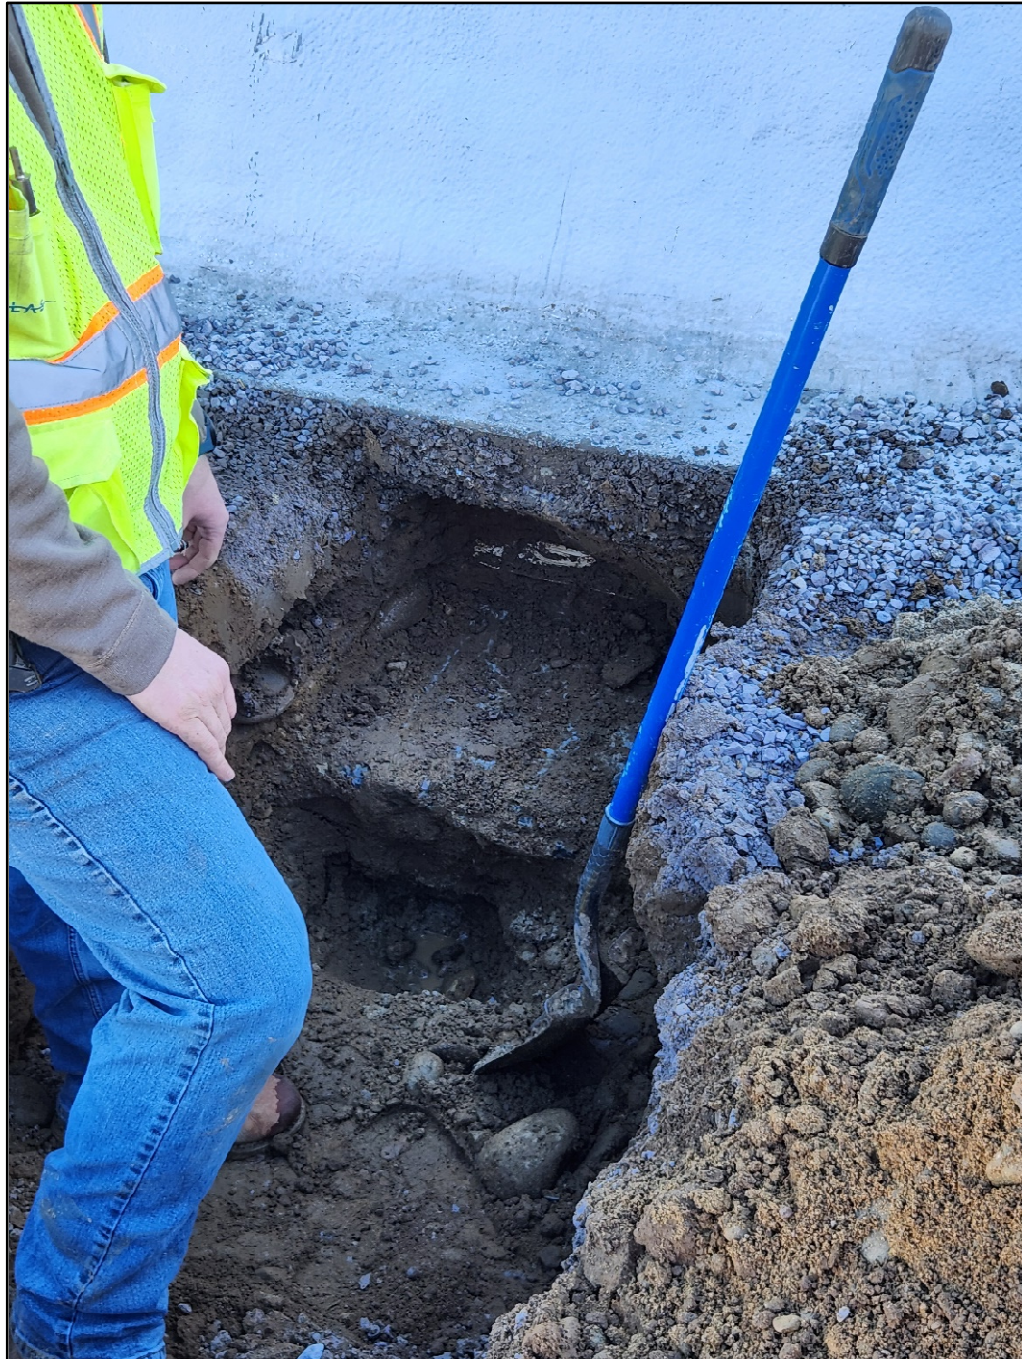
Observation: The existing foundations were exposed during the site observation by Atlas on the southwest side. The foundations appeared to be cast against earth. The foundations appeared to have a layer of waterproofing that extended below grade underneath a concrete curb. A single exposed rebar was observed at the location of excavation. The existing foundations measured approximately 17” wide from the stem to the edge of footing and approximately 12” thick. The depth from the top of the concrete curb/soil elevation to the bottom of the footing measured to 2’-7”.

**FIGURE 20: DOME “A” FOUNDATIONS AT SOUTHWEST SIDE OF THE DOME**

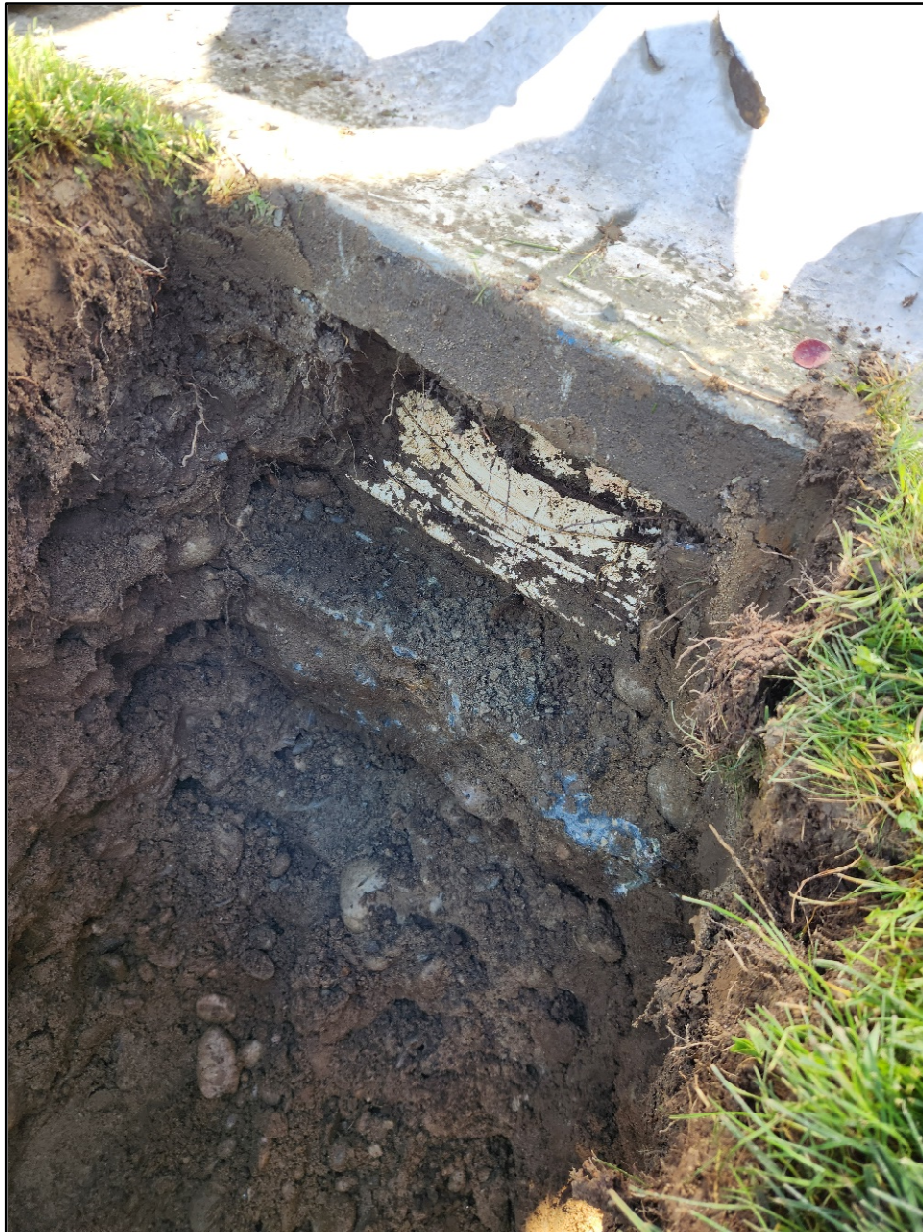
Observation: The existing foundations were exposed during the site observation by Atlas at Dome B on the east side. The foundations appeared to have a layer of waterproofing that extended below grade underneath a concrete curb. A single exposed rebar was observed at the location of excavation. The existing foundations measured approximately 6” wide from the stem to the edge of footing and approximately 12” thick.

**FIGURE 22: DOME “B” FOUNDATIONS AT EAST SIDE OF THE DOME**

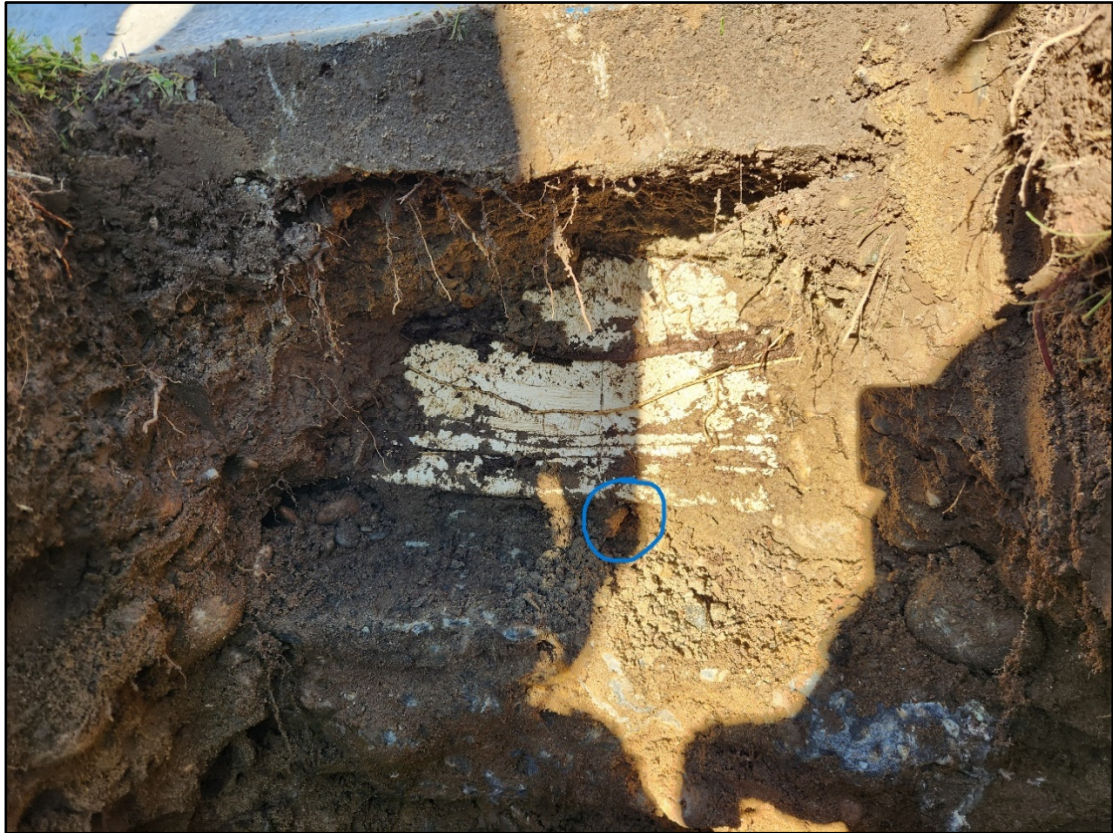
**FIGURE 23: DOME “B” FOUNDATIONS AT EAST SIDE OF THE DOME WITH EXPOSED BAR CIRCLED IN BLUE**

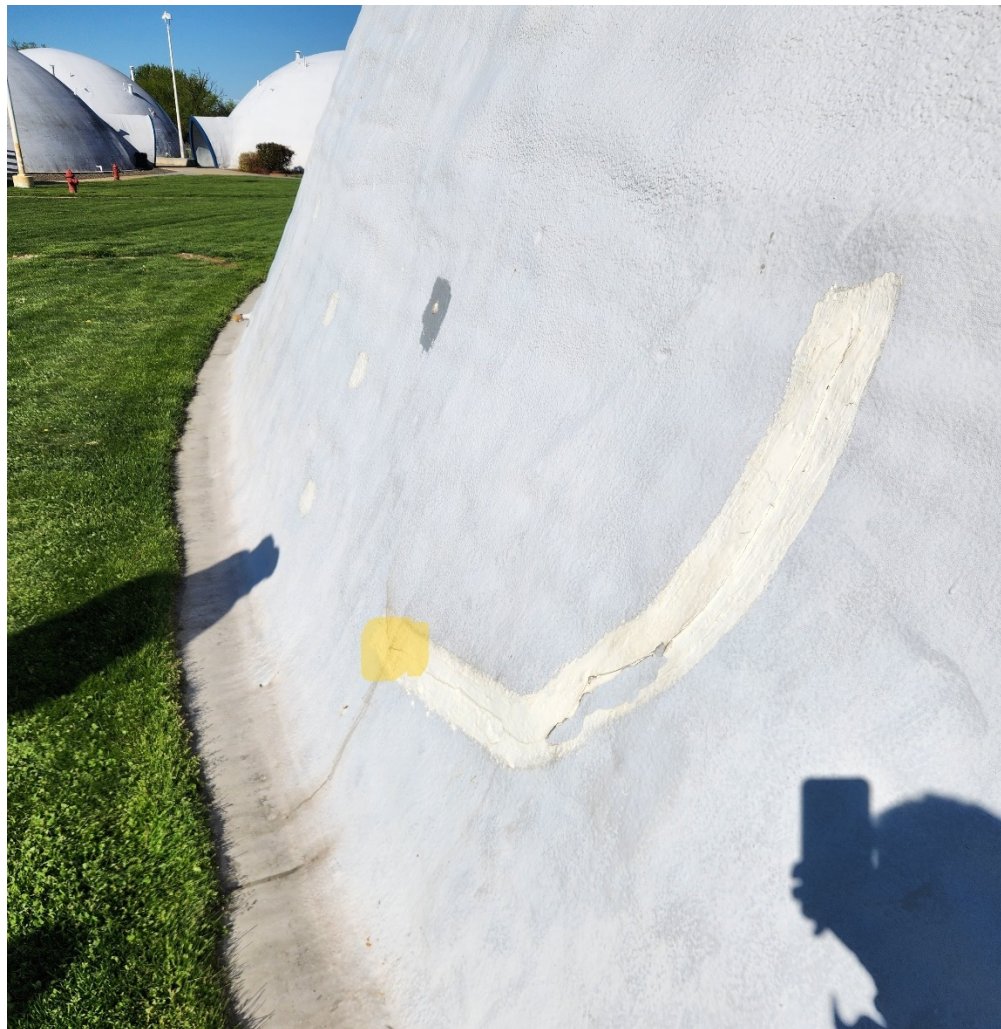
Observation: The exterior of the building was observed at a location that was previously repaired on the southeast side of Dome B. This location recently had splitting of the waterproofing and insulation and was noted in the report by Atlas on October 10, 2025.

At the time of the initial observation, the location was repaired but the bottom of the repair had water leaking from a small hole in the building envelope.

Possible Source: Water infiltration behind the building envelope causing hydrostatic pressure behind the envelope.

**FIGURE 24: DOME B PREVIOUS EXTERIOR REPAIR WITH LOCATION OF WATER LEAK OBSERVED  
HIGHLIGHTED IN YELLOW**

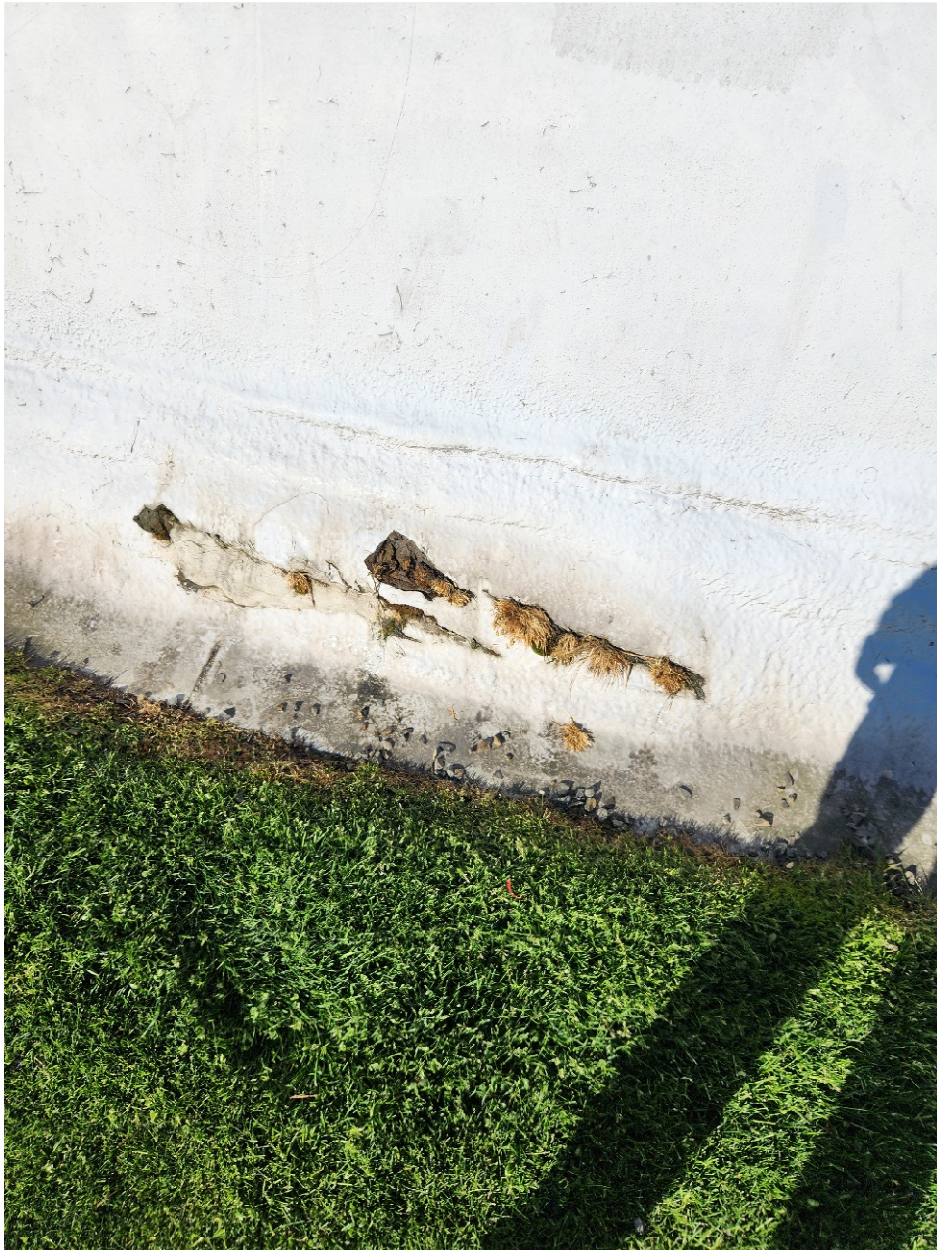
Observation: It was observed that there are areas of the building envelope that has been damaged with vegetation growth growing inside of the damaged portions (Figure 25).

Possible Source: Damage to the exterior finishes allowing for sediment to land and harbor vegetation.

**FIGURE 25: AREA OF DAMAGED EXTERIOR WITH VEGETATION GROWTH**
