# **Emmett High School – Facility Condition Assessment**

## *Observations & Assessments*

Compiled Document of Observations & Assessments

**July 10, 2026**

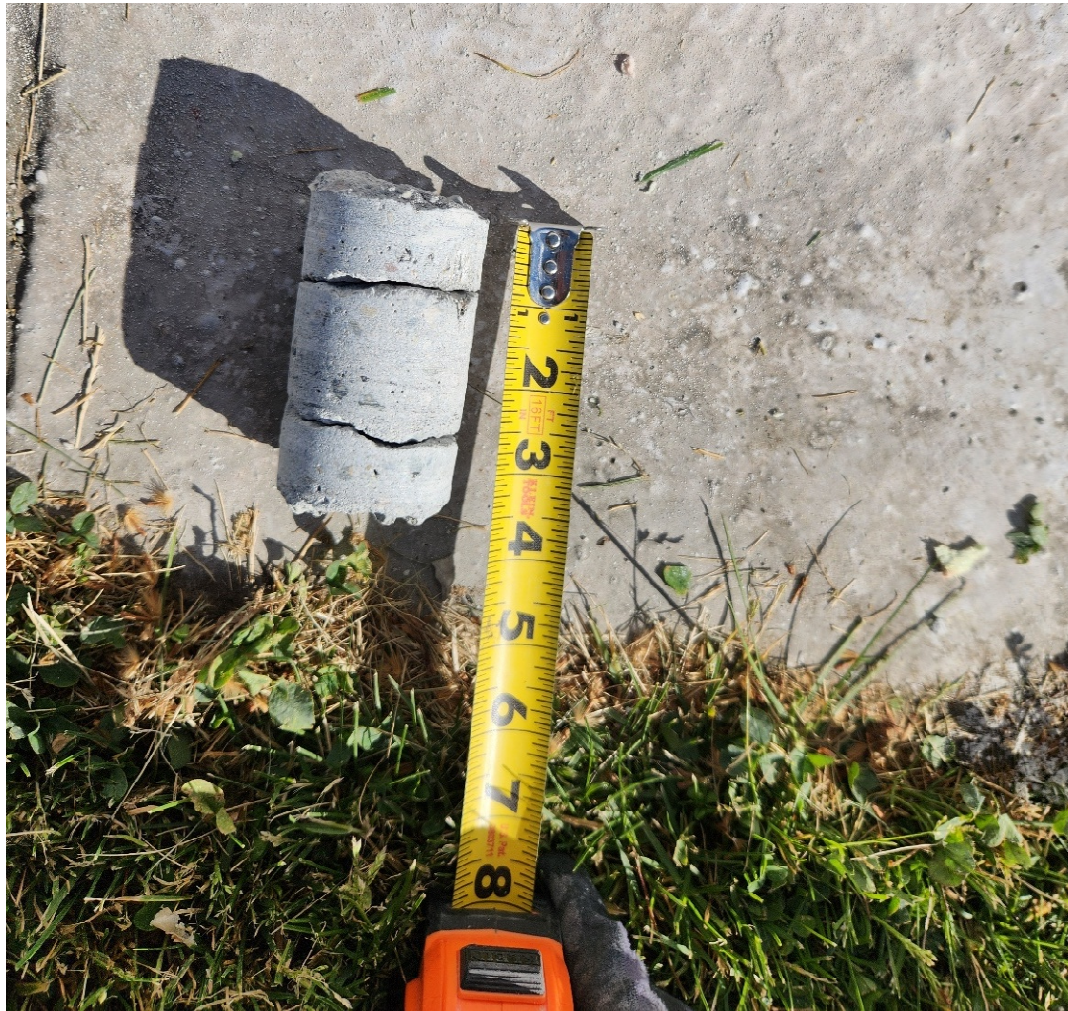
Observation: An additional site observation was performed and the building envelope was removed to observe the building envelope layers and the extent of previous repairs (Figure 27 & 28). A 2" diameter concrete core sample was taken at these locations with an approximate depth of 4" to observe the concrete health (Figure 26 & 28). The concrete at these locations was dry and appeared to be in good condition. Each location for the coring was at locations of previous building envelope repair (Figure 30).

**FIGURE 26: DOME A CONCRETE SAMPLE**

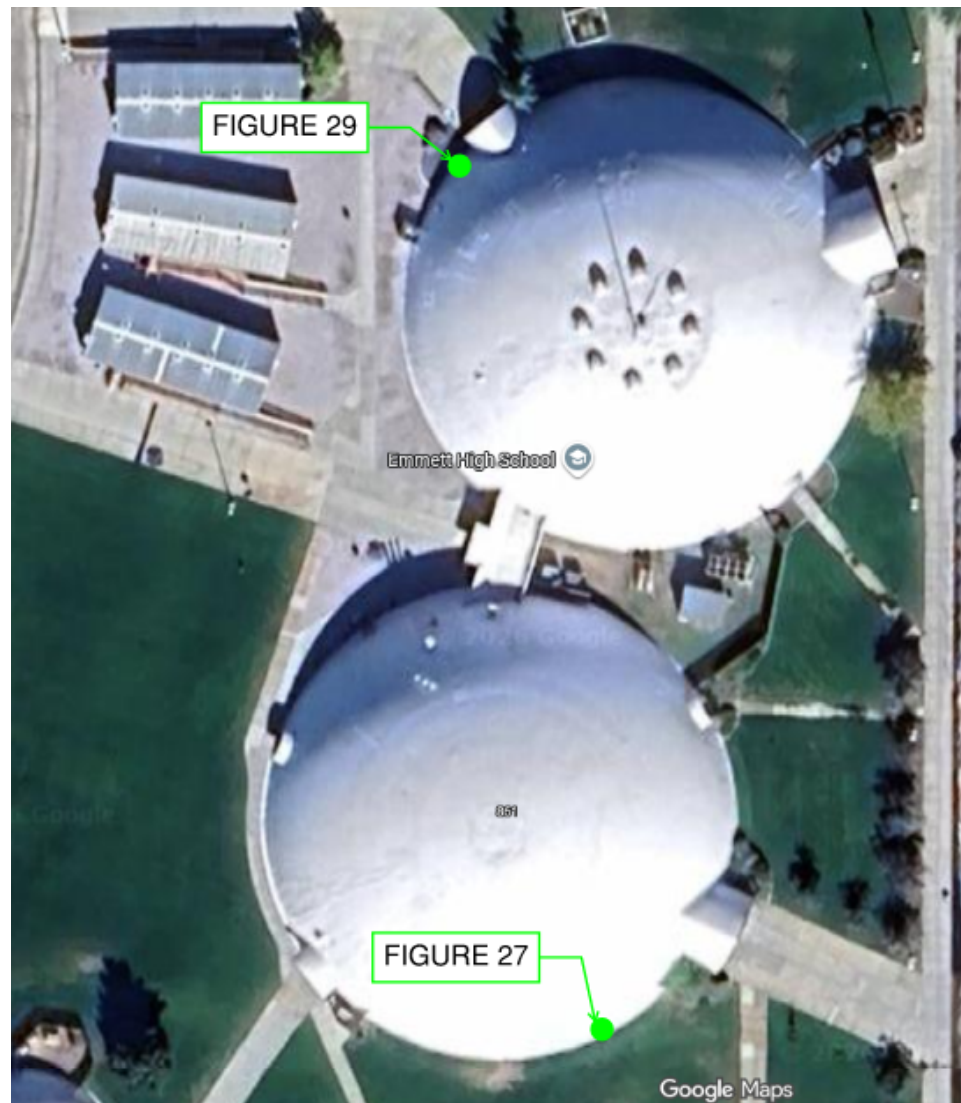
**FIGURE 30: LOCATIONS OF CORE SAMPLES**

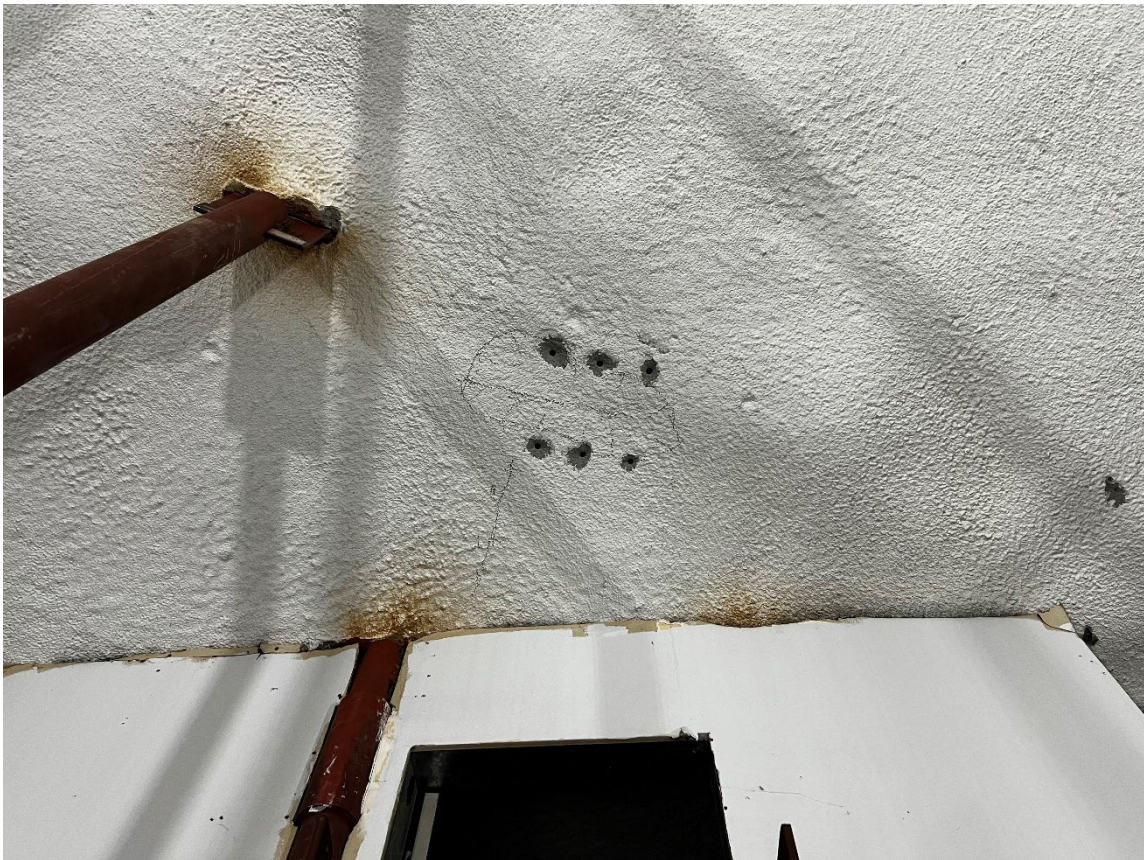
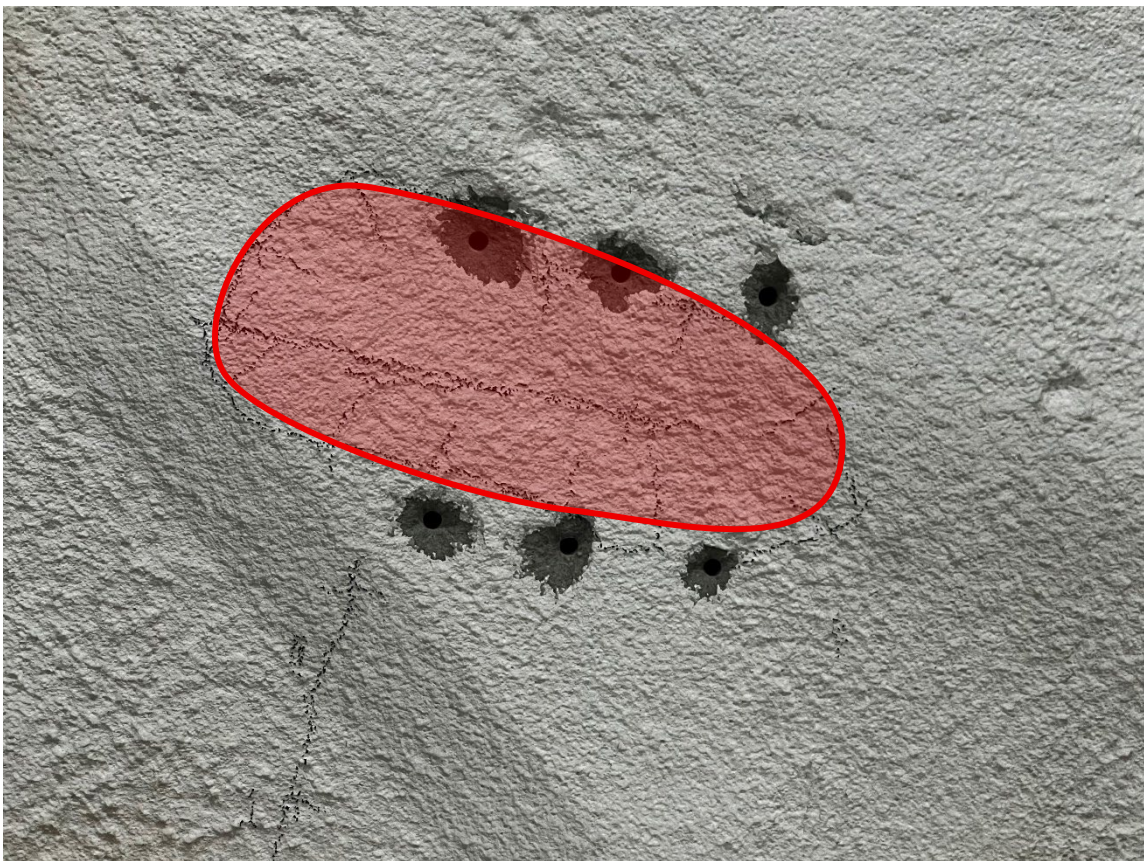
Location 1 at entry to dome apex. Six holes drilled to attach roof anchor. Delamination in middle caused by drilling. Remainder of concrete was sound.

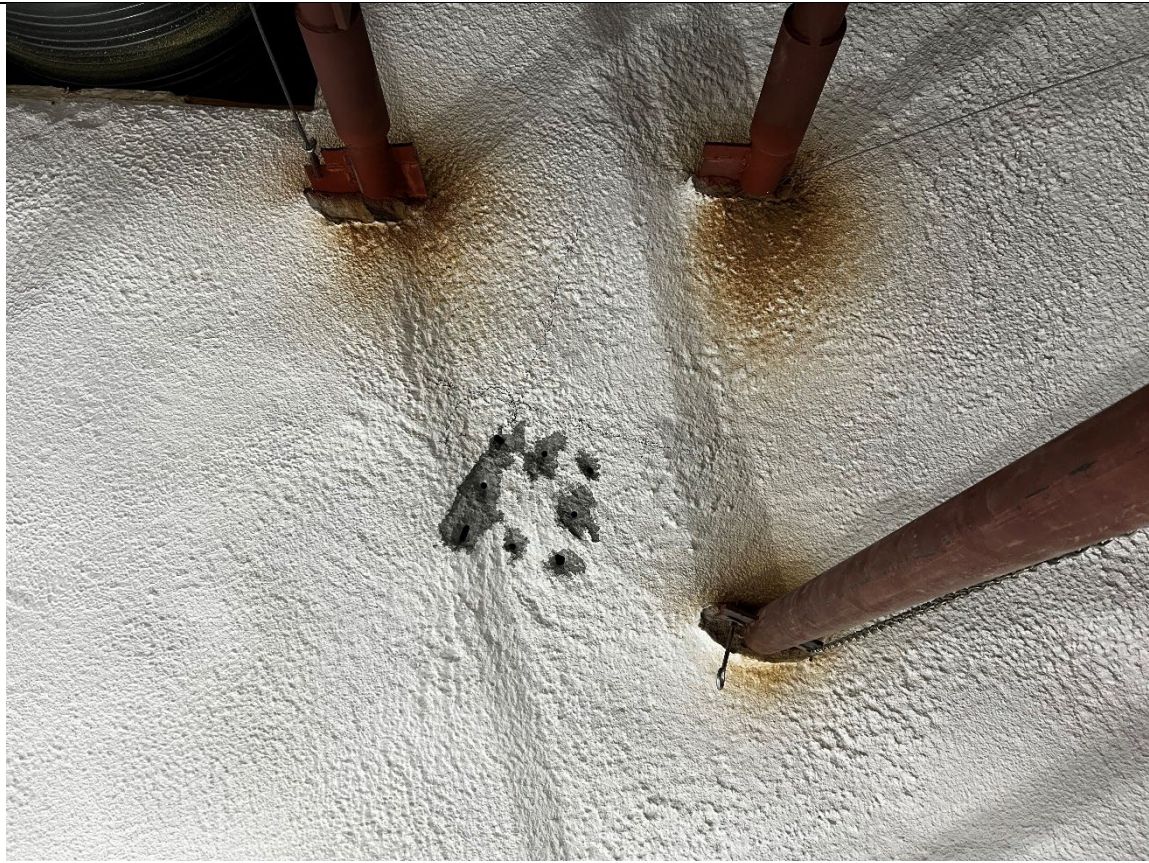
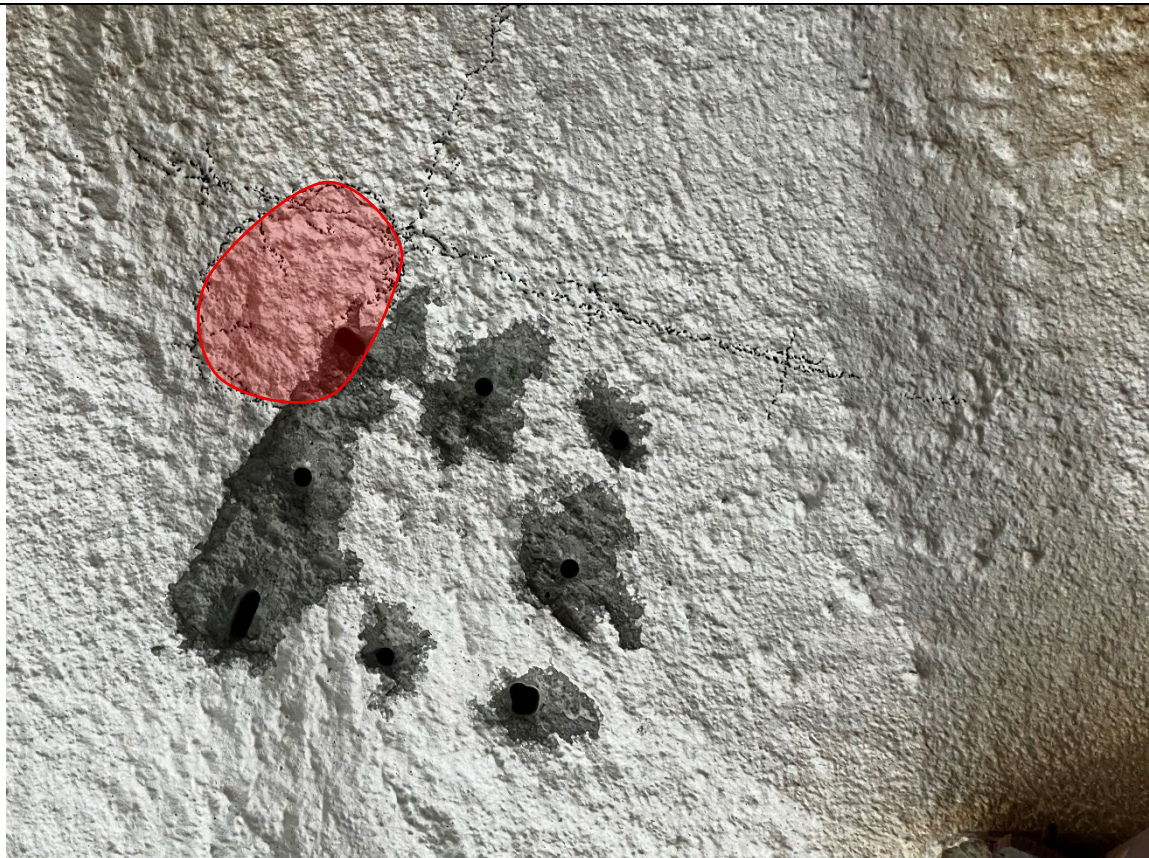
Location 6 clockwise from entry. Eight holes drilled for roof anchor. Small delamination at hole. Remainder of concrete was sound.

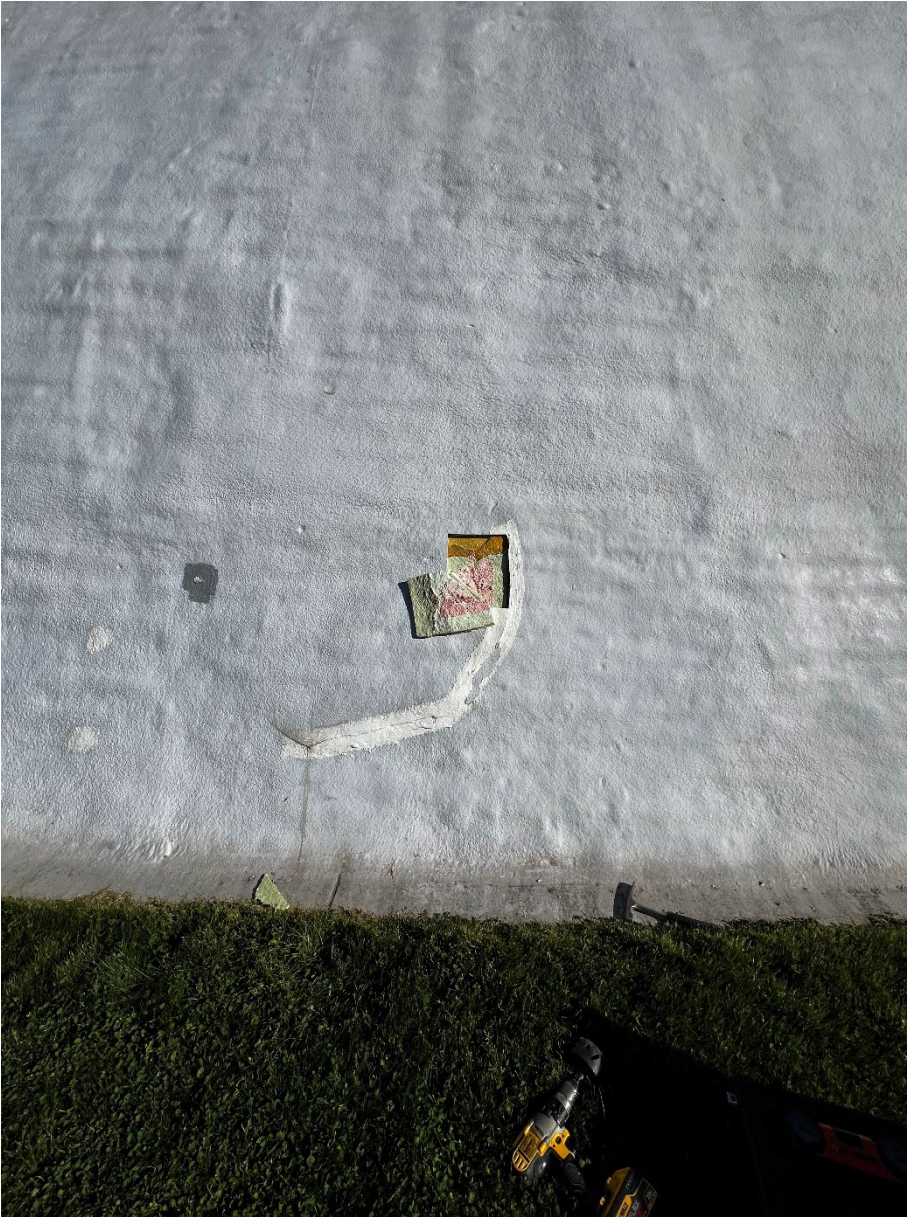
Leaking area of roofing membrane opened for coring at Dome B.

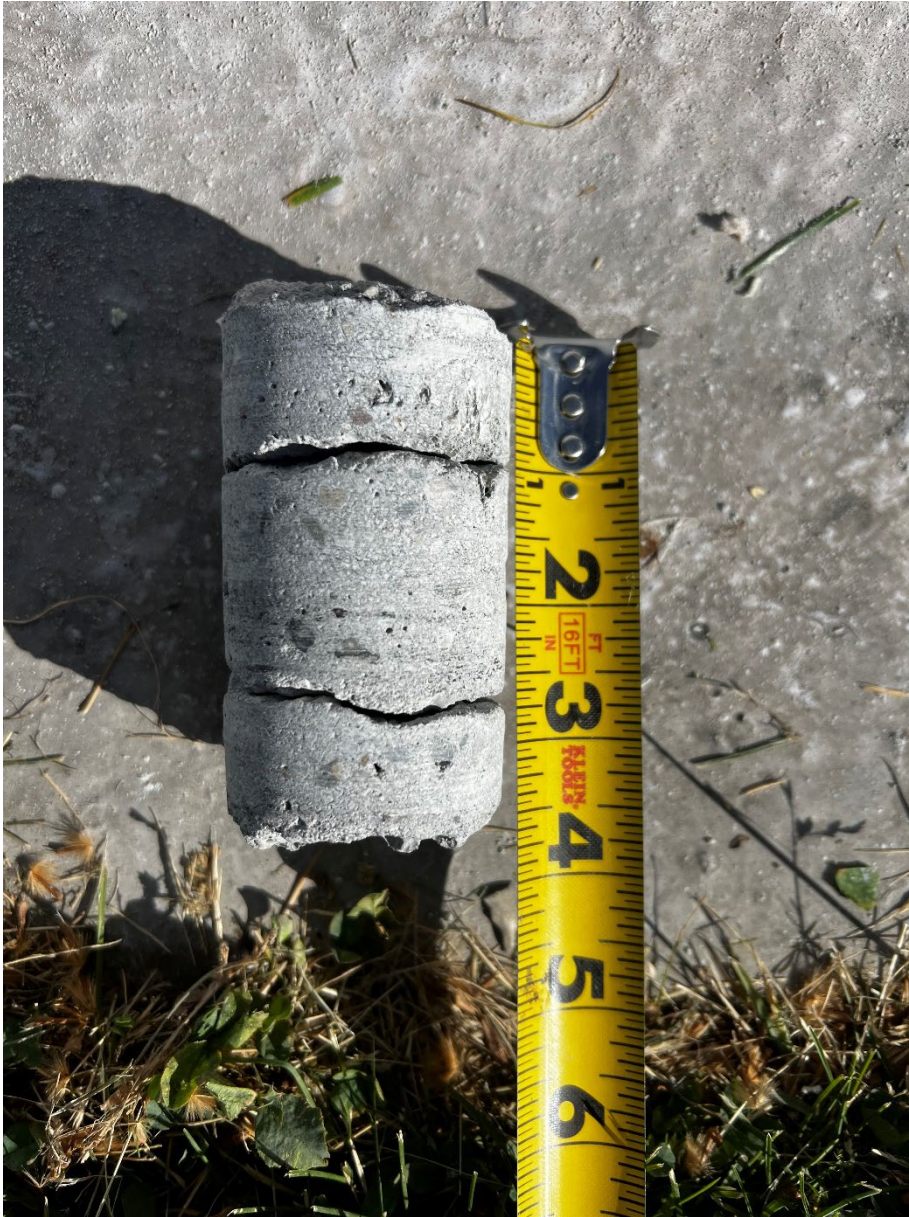
Recovered core was 3.5-inches long and appeared to be sound and competent. No damage to concrete observed.

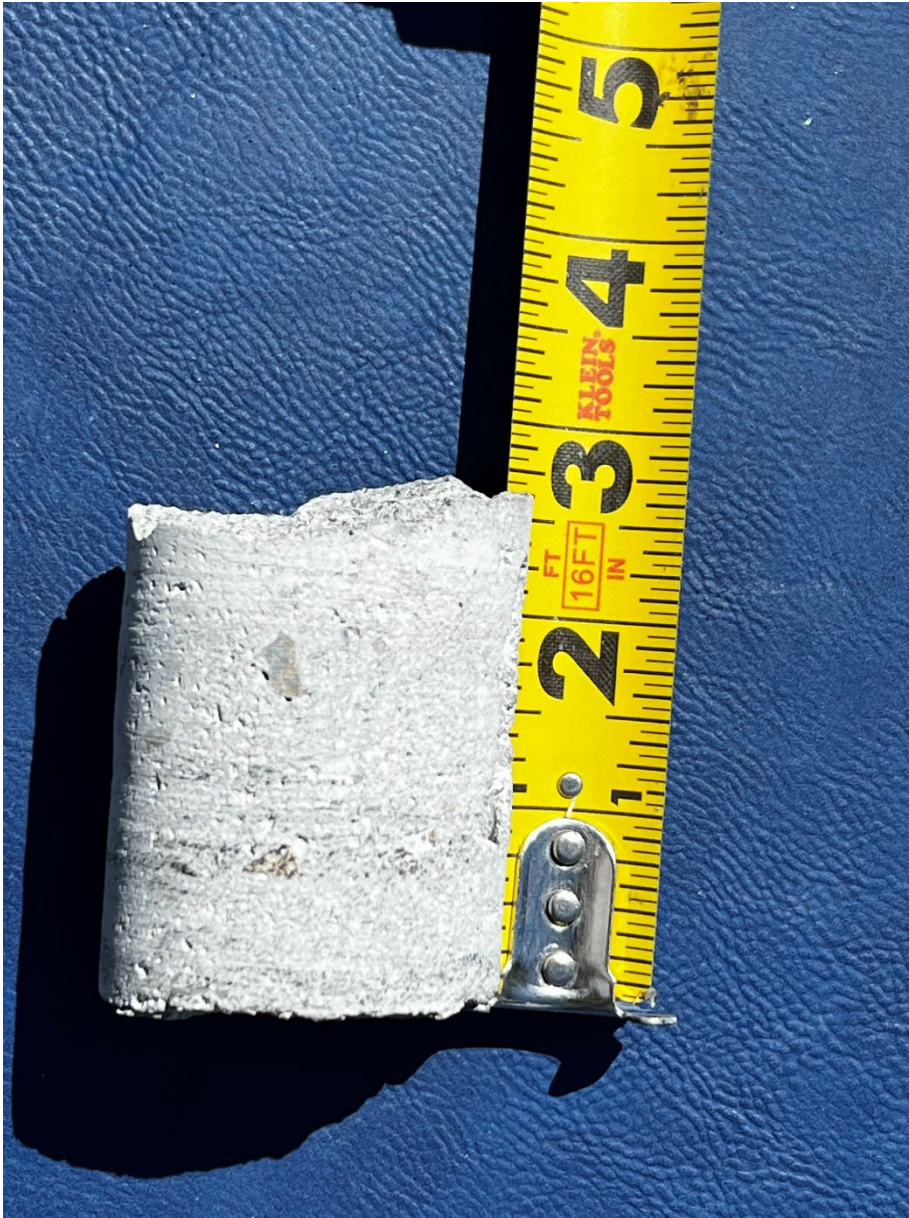
Recovered core was 2.75-inches long and appeared to be sound and competent. No damage to concrete observed.

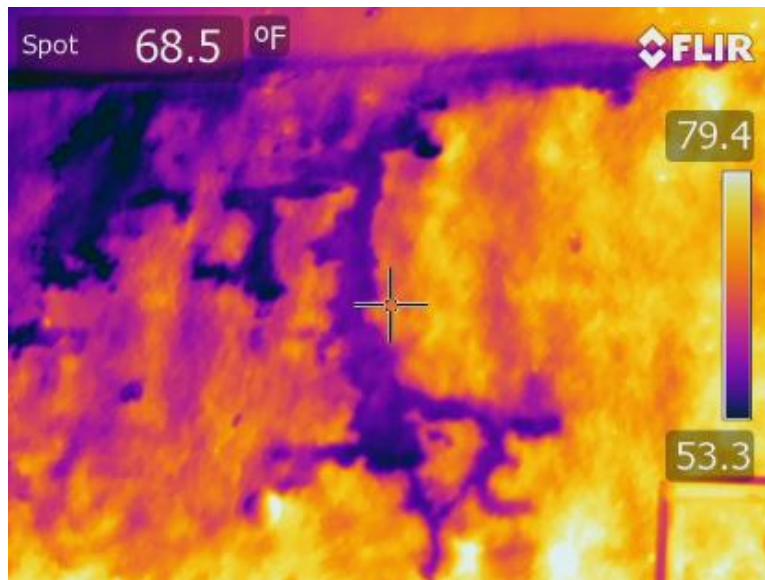
Temperature anomalies were also observed at areas of the original roof system, possibly indicating breaches in the roof membrane, allowing moisture to enter the roof system. See Figures 12 and 13. Note that the darker purple areas indicate colder temperatures.

**FIGURE 4: IR IMAGE OF REPAIRED ROOF AREA AT DOME #4.**

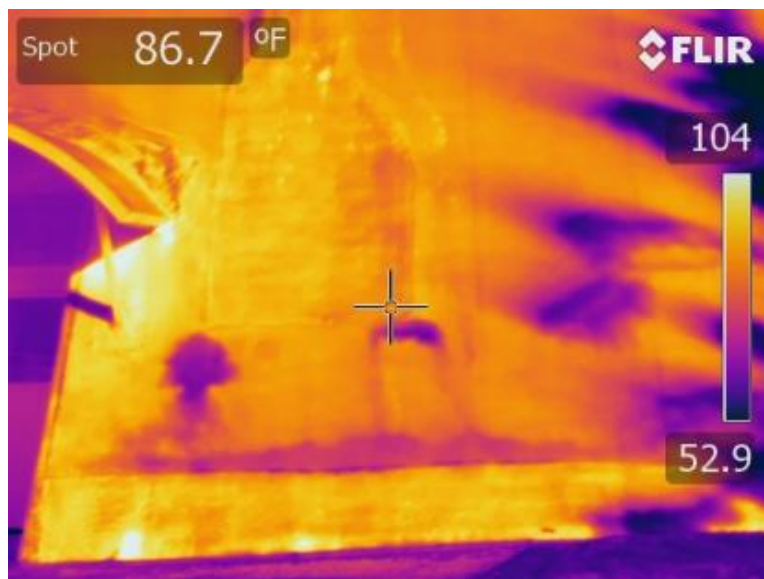
**FIGURE 7: IR IMAGE OF SAME AREA AS FIGURE 6 SHOWING TEMPERATURE ANOMALIES AT LOWER CORNERS OF PATCHED AREA.**

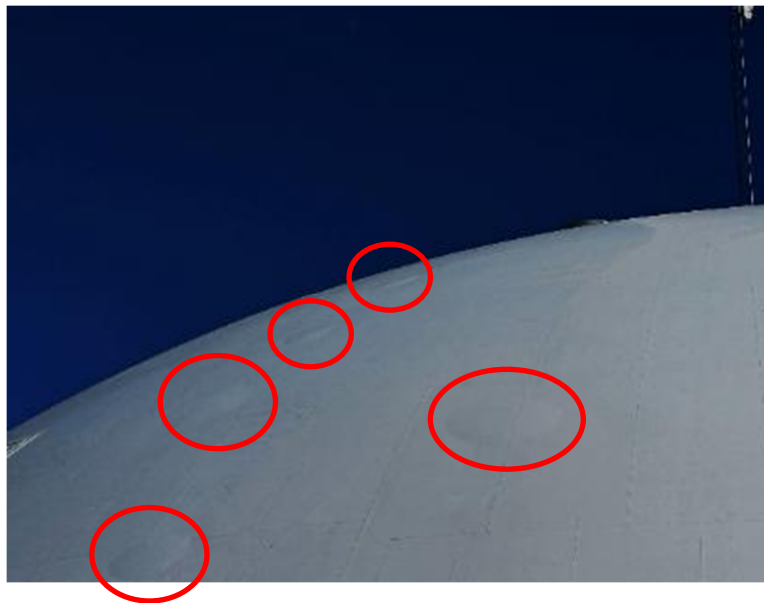
Minor holes and voids in both the repaired roof coating and the original roof membrane were present at all domes. These voids will allow moisture to enter the roof system and saturate the foam insulation in isolated areas. This will reduce the thermal effectiveness of the spray foam and increase the rate of degradation of the roof system. See Figures 22 through 27.

**FIGURE 146: BUBBLES IN ROOF MEMBRANE AT DOME #1.**

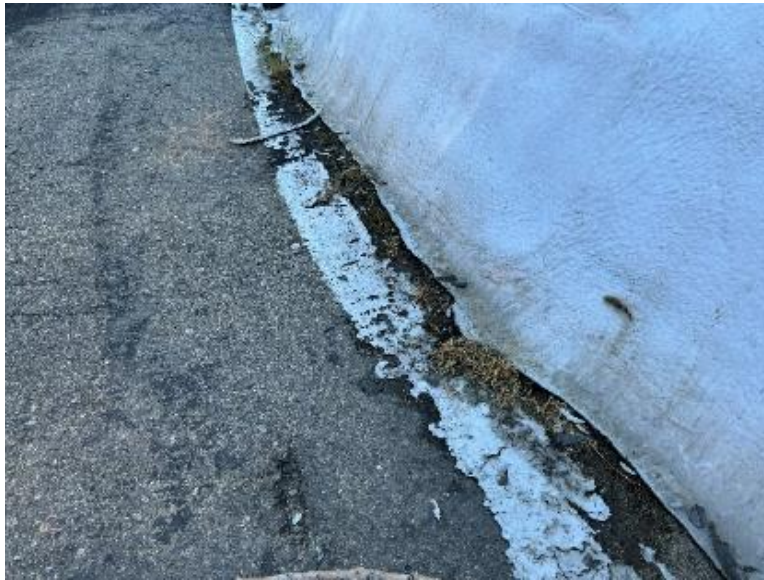
**FIGURE 179: ROOF COATING AT REPAIRED ROOF AREA ON DOME #4 DEBONDED FROM HORIZONTAL CONCRETE, ALLOWING ORGANIC GROWTH TO OCCUR.**

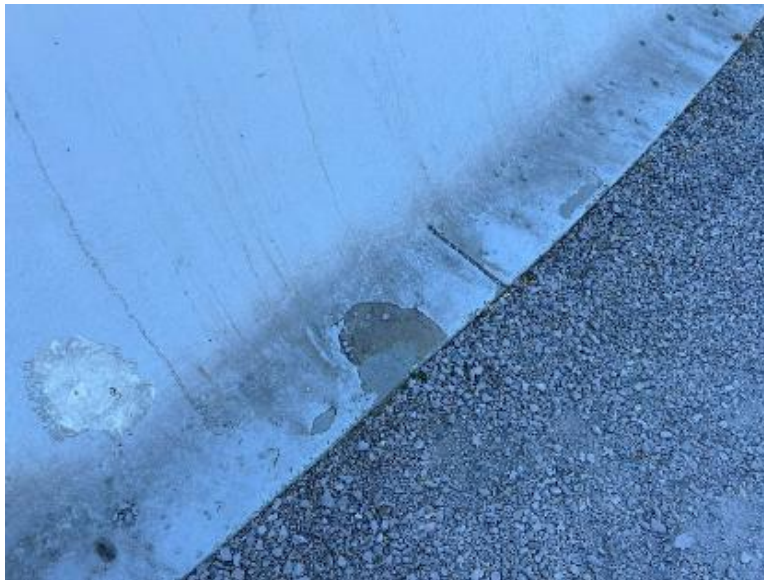
**FIGURE 20: ORIGINAL ROOF MEMBRANE AT DOME #1 DEBONDING FROM HORIZONTAL CONCRETE.**

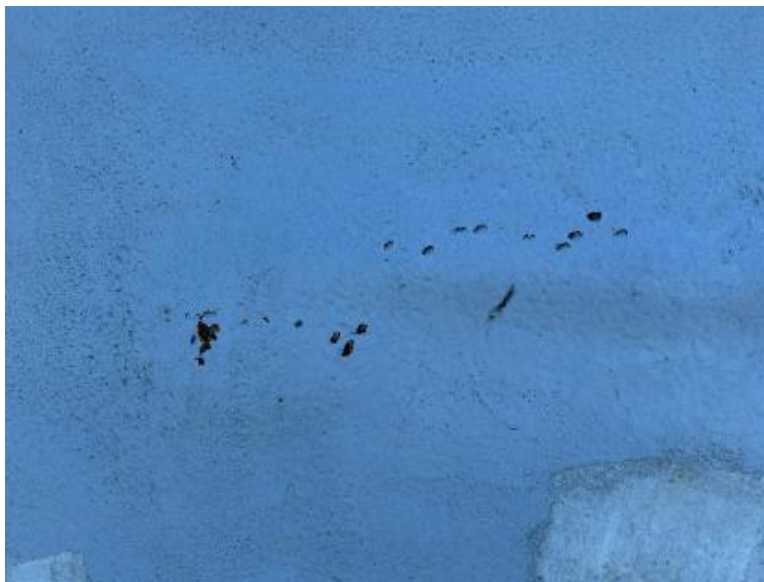
**FIGURE 24: SEVERAL HOLES THROUGH THE REPAIRED ROOF AREA AT DOME #2.**

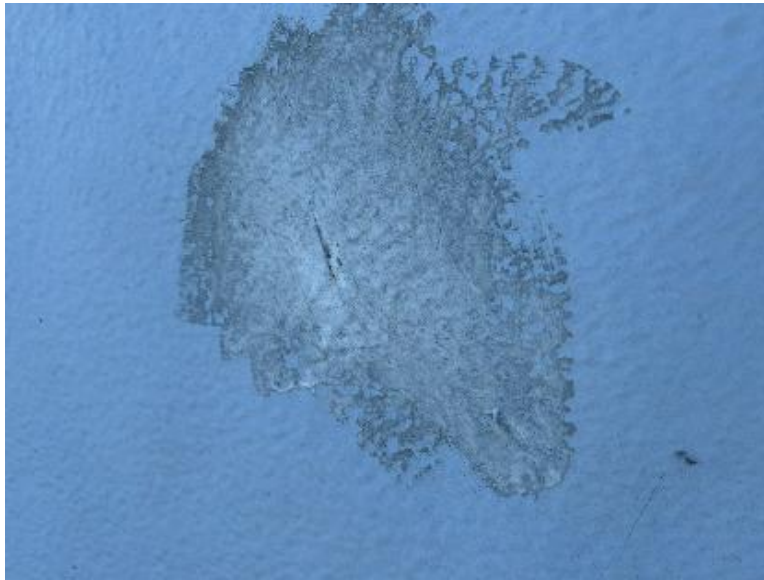
**FIGURE 25: SPLIT IN ROOF MEMBRANE AT DOME #1 WITH EVIDENCE OF PREVIOUS REPAIR THAT HAS SINCE FAILED.**

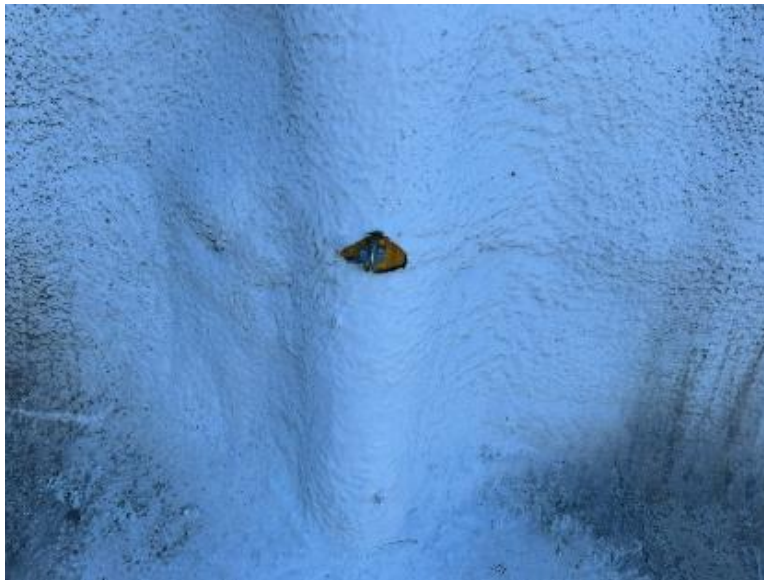
**FIGURE 26: HOLE THROUGH ROOF COATING AND SPRAY FOAM AT REPAIRED ROOF AREA ON DOME #1.**

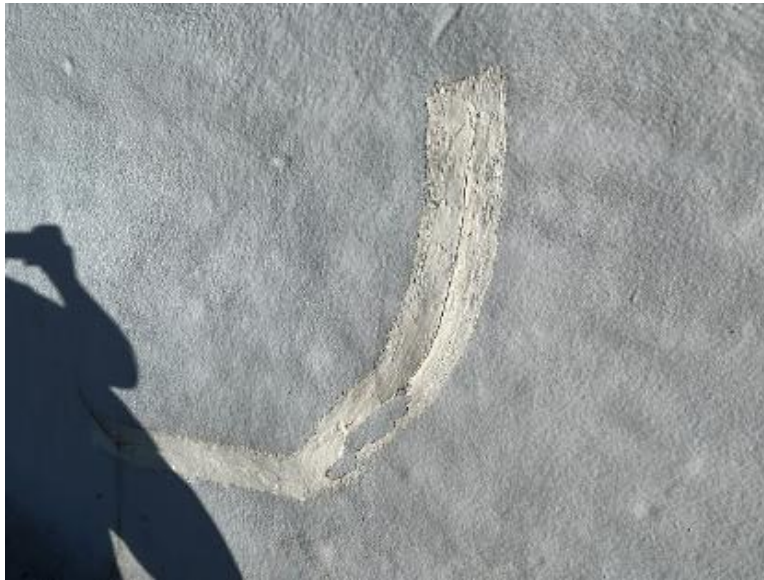
**FIGURE 28: SPLIT IN ROOF COATING AND FOAM BEFORE REMOVAL WITH EVIDENCE OF PREVIOUS REPAIR.**

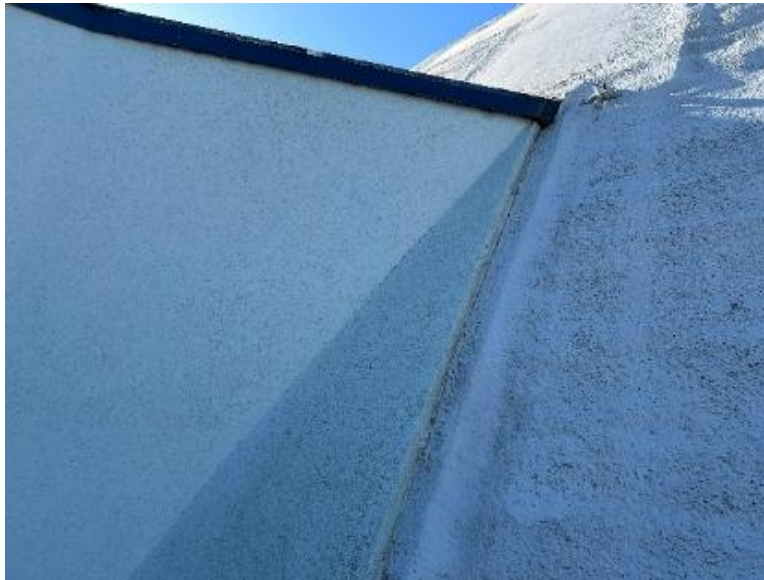
The EIFS cladding does not appear to be from the original construction, but appeared to be a face-sealed system, as there was no accommodation for draining the system observed. Whether a weather resistant membrane is provided on the exterior sheathing beneath the EIFS cladding was not known; the original architectural drawings do not show a sheathing membrane. See Figure 43. Face-sealed EIFS systems are problematic, as they do not account for moisture entering behind the face seal, and don't provide a method of draining incidental moisture. They also typically don't provide a weather resistant barrier on the exterior sheathing that would protect the wall assembly from moisture-related deterioration. There is also an area at the enclosed corridor between Domes #1 and #2 where the EIFS system interfaces directly with the roof system and is not vertical, with a portion of the EIFS clad wall being skyward facing. EIFS is not intended to be installed on walls that aren't vertical.

**FIGURE 48: SKYWARD FACING EIFS CLADDING INTERFACING DIRECTLY WITH REPAIRED ROOF AREA.**

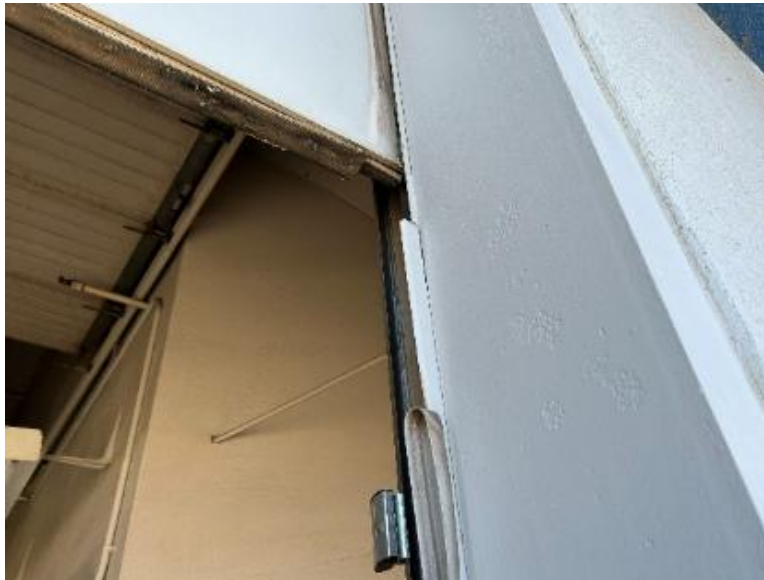
**FIGURE 50: DAMAGED/MISSING GASKETS AT OVERHEAD COILING DOORS.**
