# **Emmett High School – Facility Condition Assessment**

## *Observations & Assessments*

Compiled Document of Observations & Assessments

**July 10, 2026**

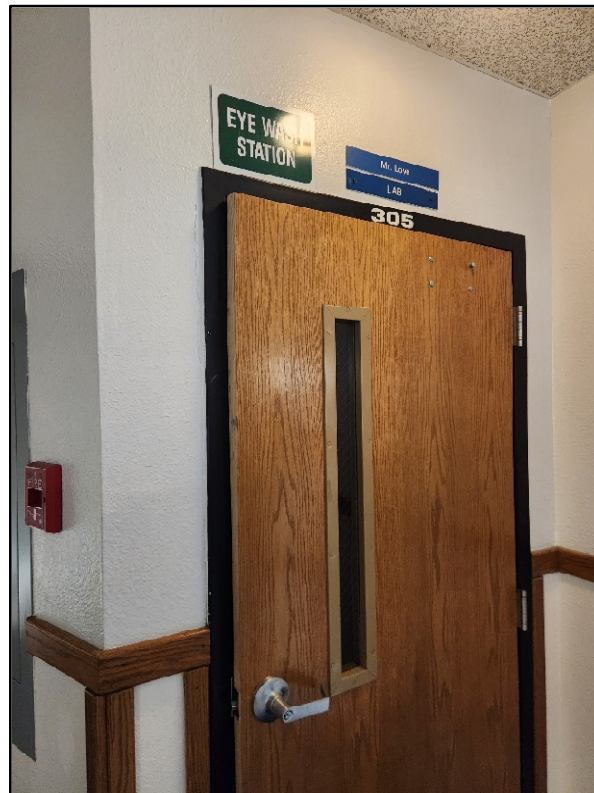
**FIGURE 4: LEVEL 3 ROOM #305**

Observation: It was noted by Emmett Maintenance that the door frames on level 3 were experiencing issues with doors becoming “skewed” and needing regular maintenance to re-align the door. KPFF observed the door frames and the surrounding finishes and above ceiling. It was observed that the wall finishes surrounding the doors and the floors below the door were not showing signs of cracking which would indicate settlement (Figures 3 & 5). It was noted by Emmett Maintenance than one door (Room 305) was fixed and two (2) weeks later required adjustments. This location did not show signs of finishing damages (Figure 4).

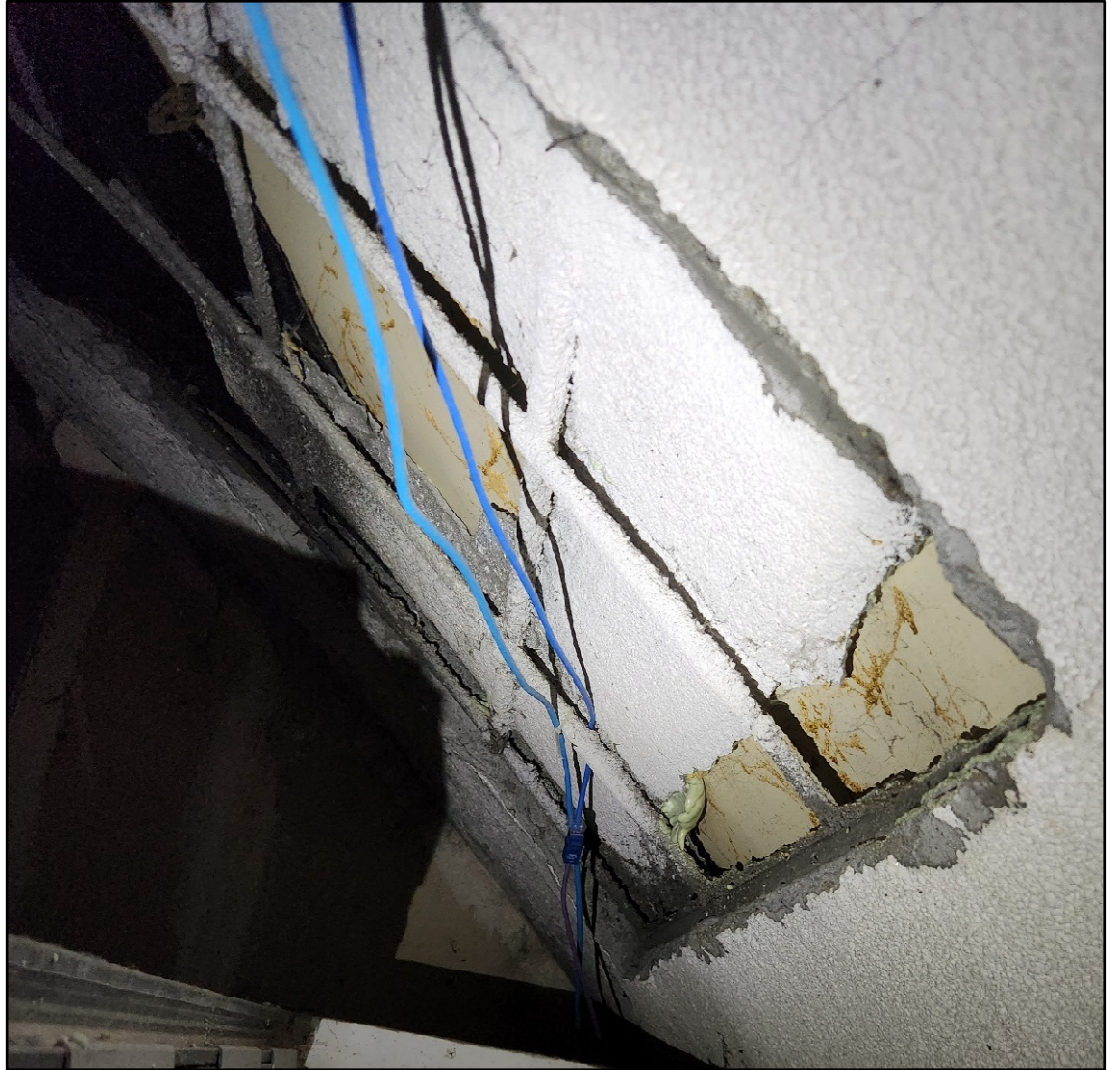
**FIGURE 15: DOME B MECH SPACE EXPOSED REINFORCEMENT – LOCATION 1**

Figures 16 & 17 show the second location observed that had an area of exposed reinforcement of approximately 3'-6" wide by 10'-0" in length. The length is an estimation due to mechanical conflicts obstructing the full line of side.

- Patch dome at area of exposed concrete
- Repair concrete at exit of the Music Room in Dome B
- Replace and upgrade doors and door frames impacted by skewing

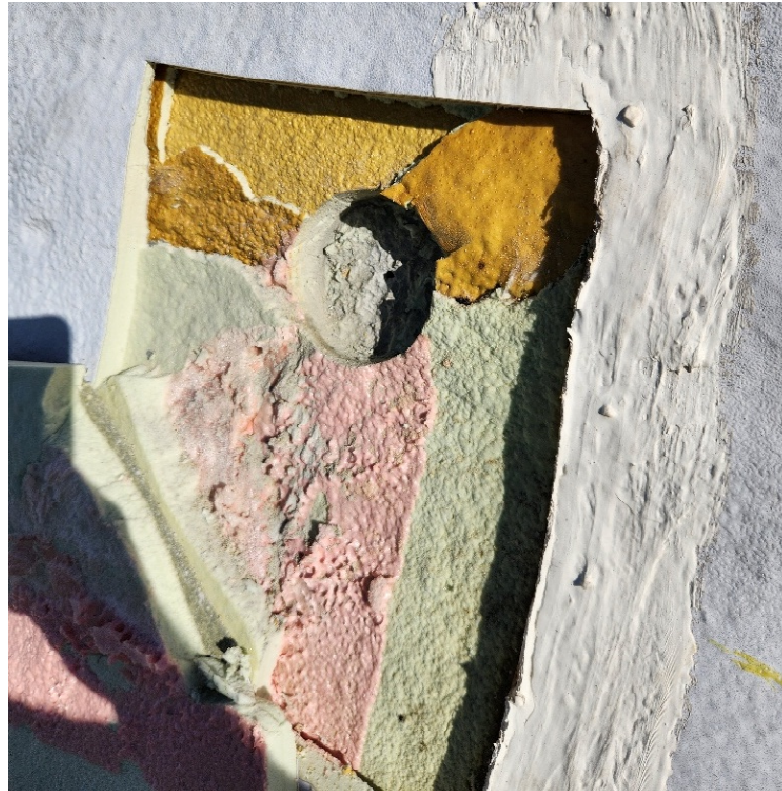
**FIGURE 27: DOME A EXPOSED ENVELOPE**

Observation: An additional site observation was performed and the building envelope was removed to observe the building envelope layers and the extent of previous repairs (Figure 27 & 28). A 2" diameter concrete core sample was taken at these locations with an approximate depth of 4" to observe the concrete health (Figure 26 & 28). The concrete at these locations was dry and appeared to be in good condition. Each location for the coring was at locations of previous building envelope repair (Figure 30).

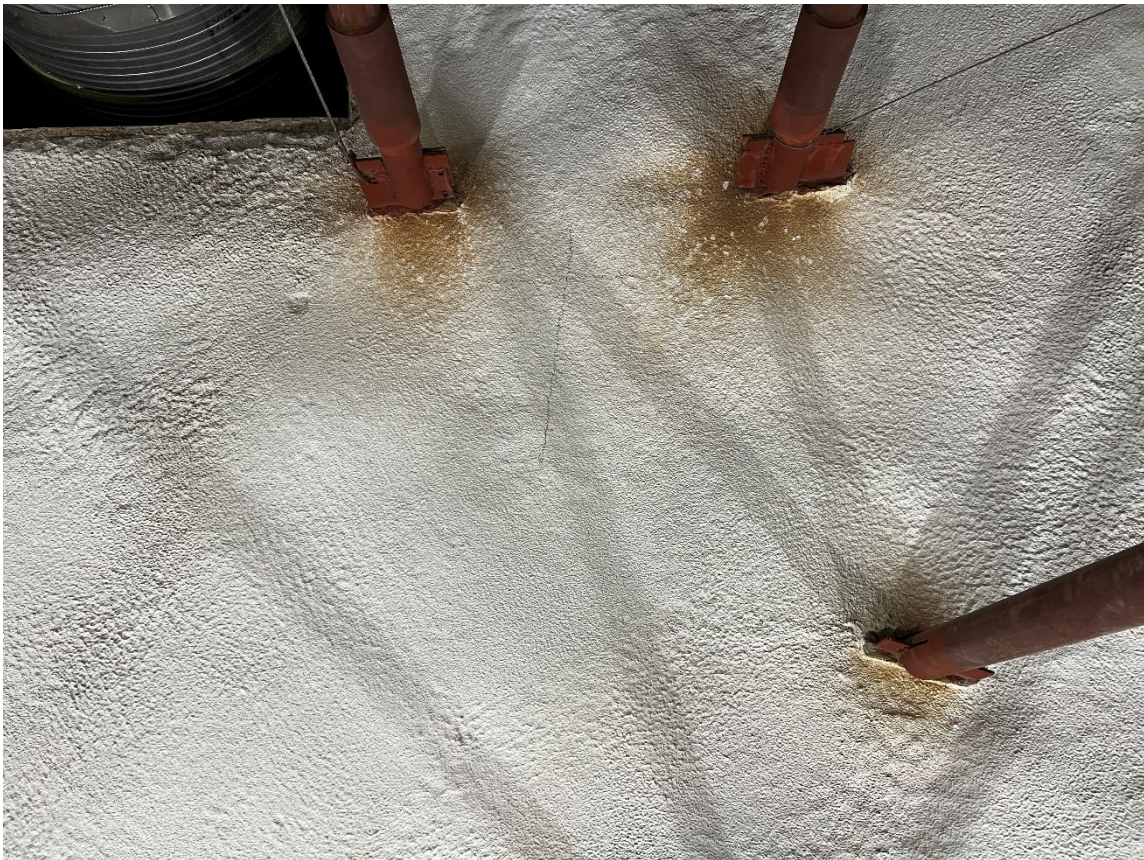
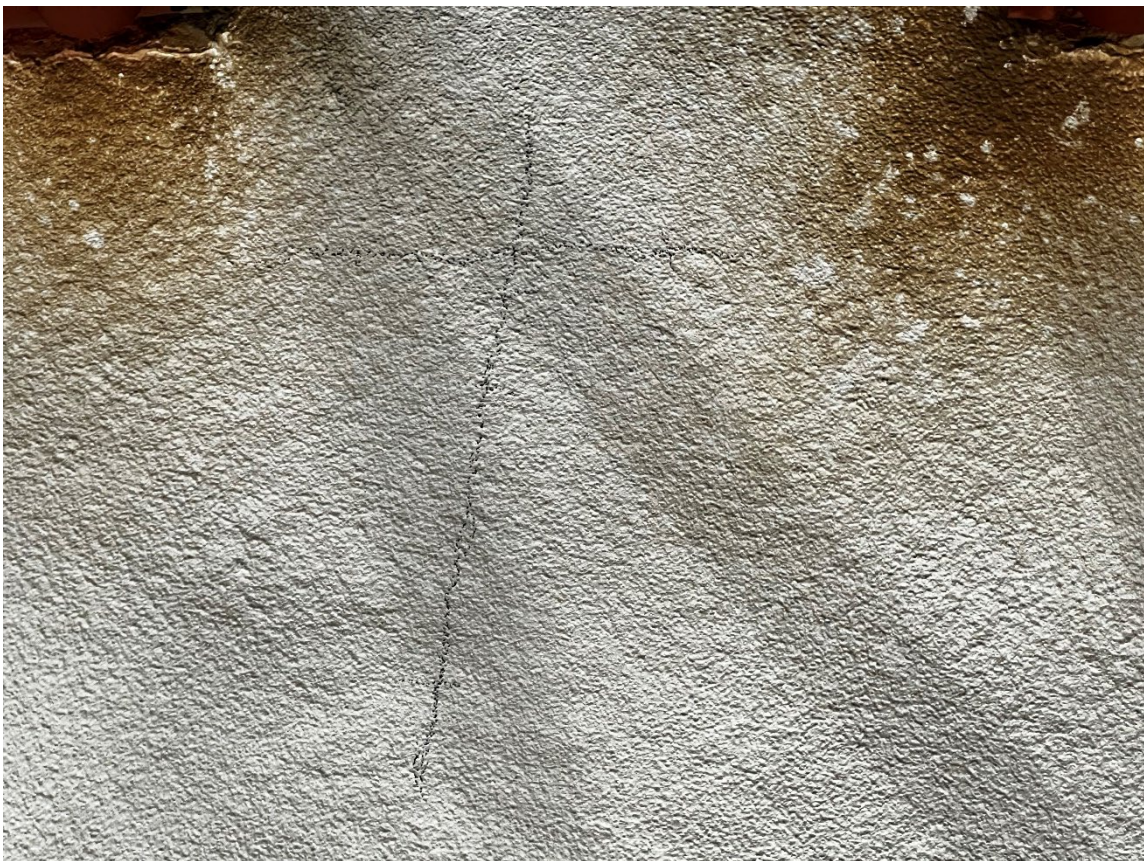
Location 2 clockwise from entry. All concrete sound. No damage.

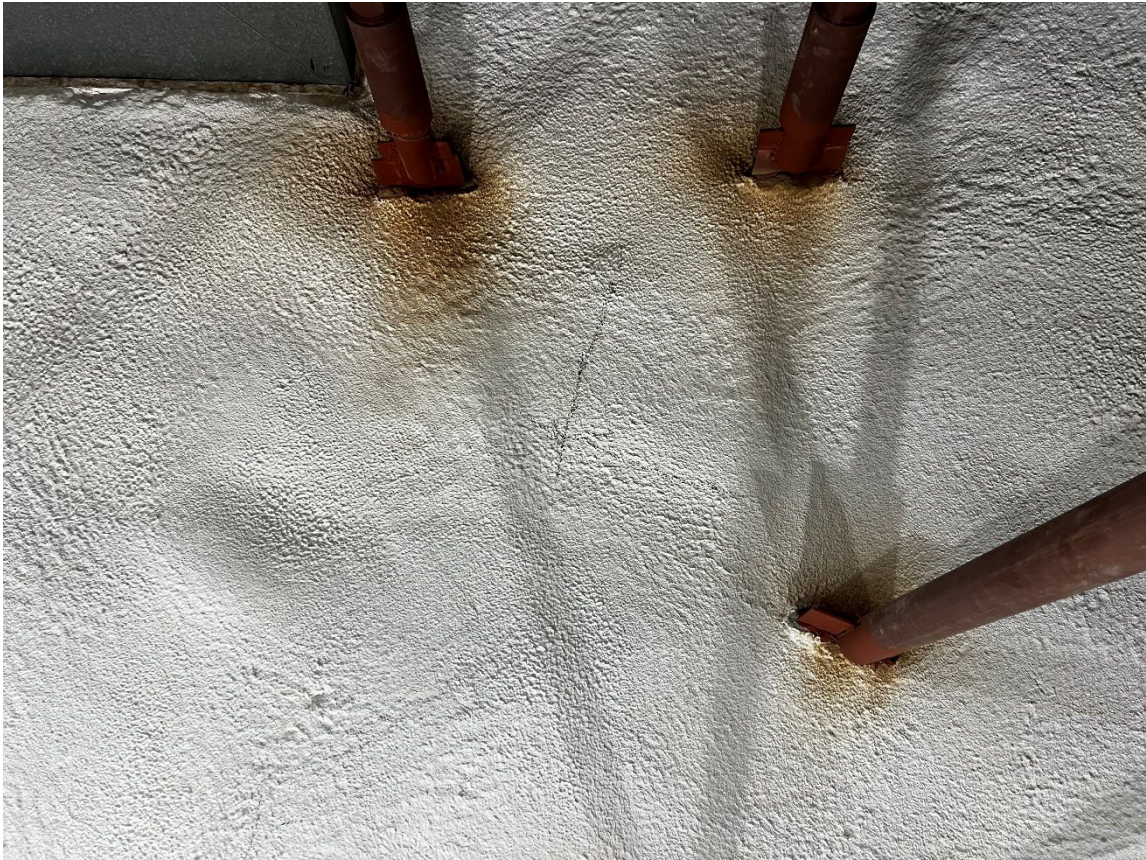
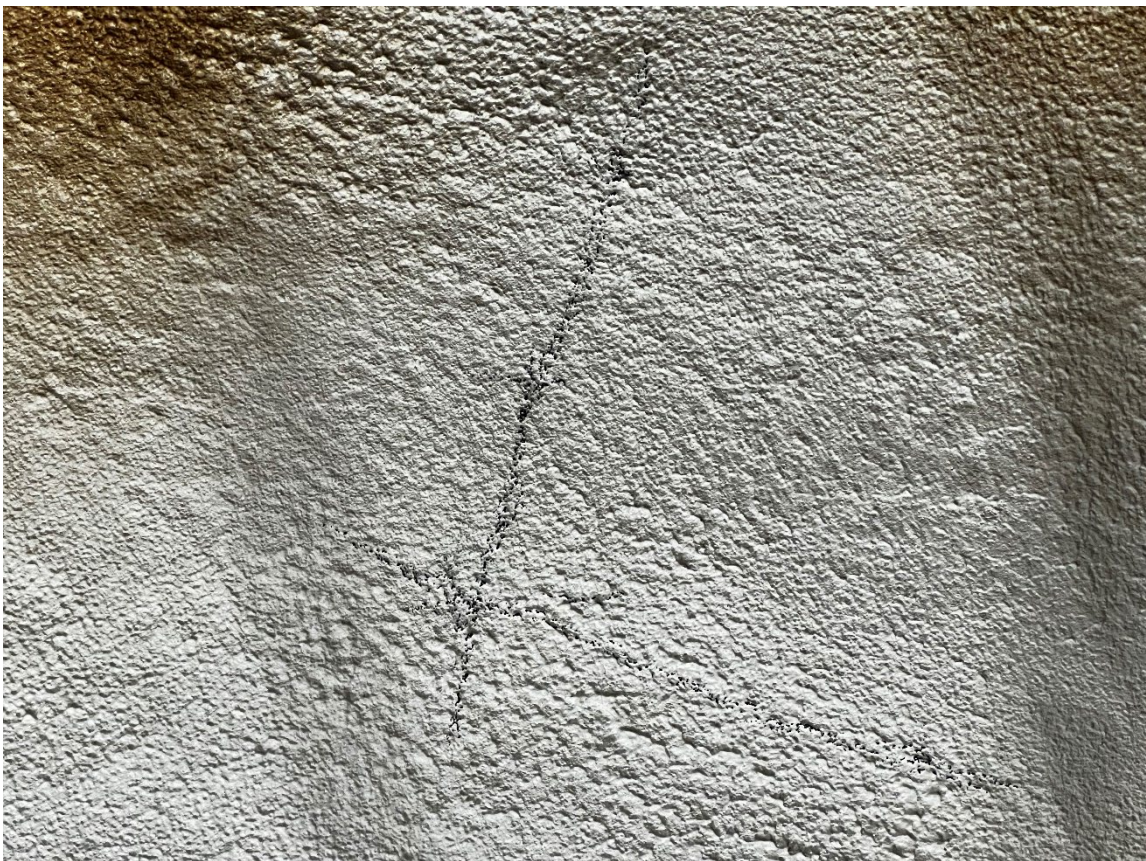
Location 3 clockwise from entry. All concrete sound. No damage.

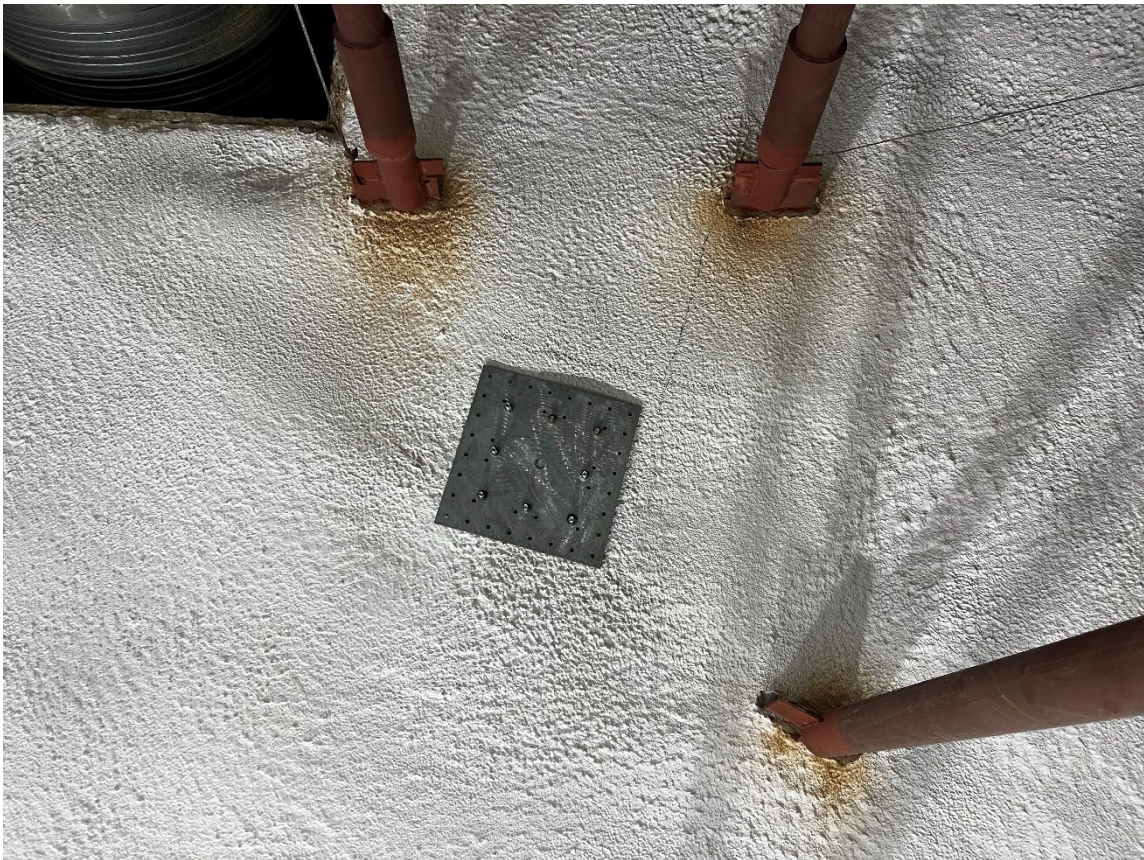
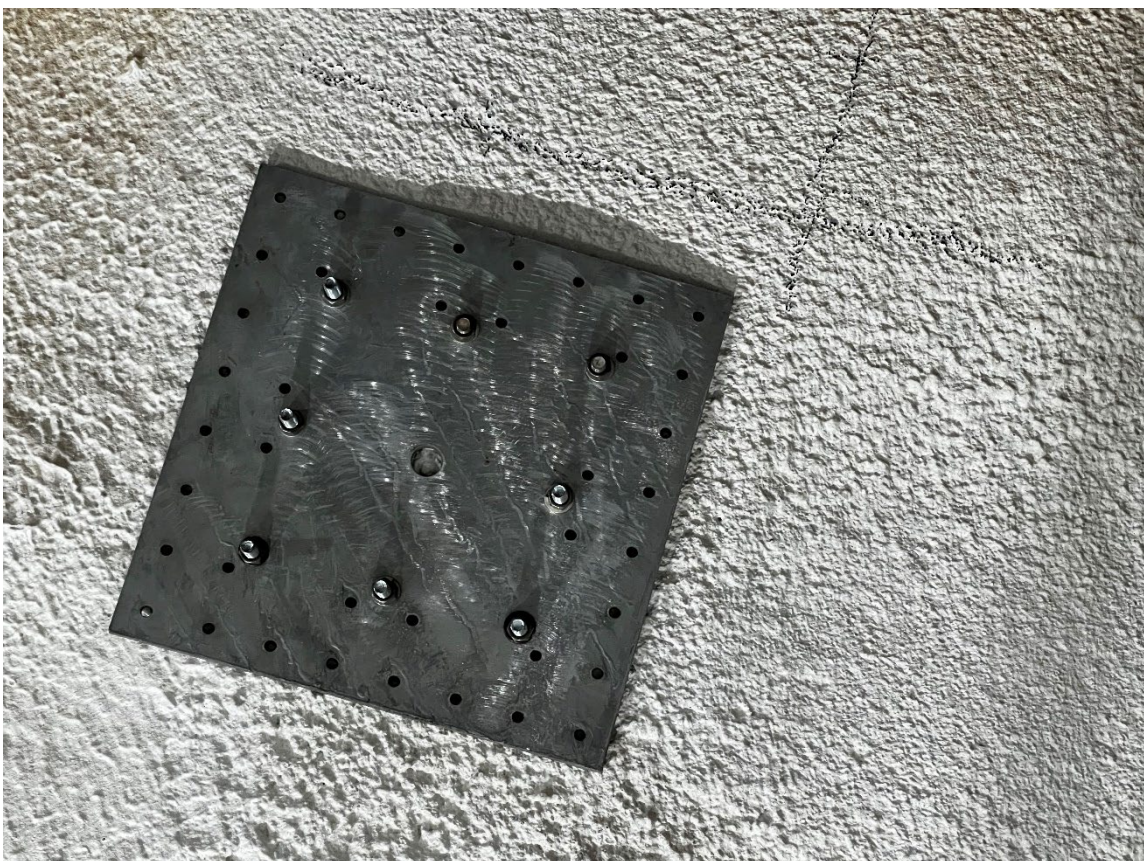
Location 4 clockwise from entry. All concrete sound. No damage. Plate installed for roof anchors.

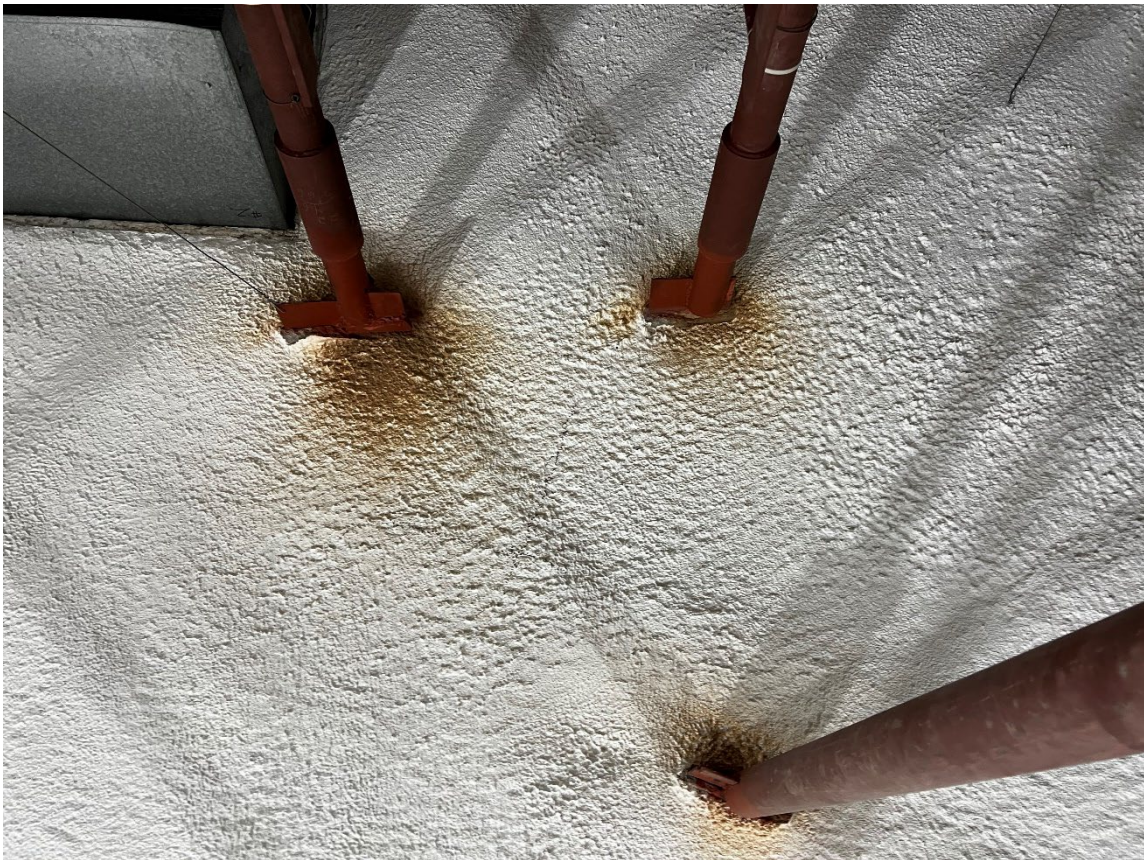
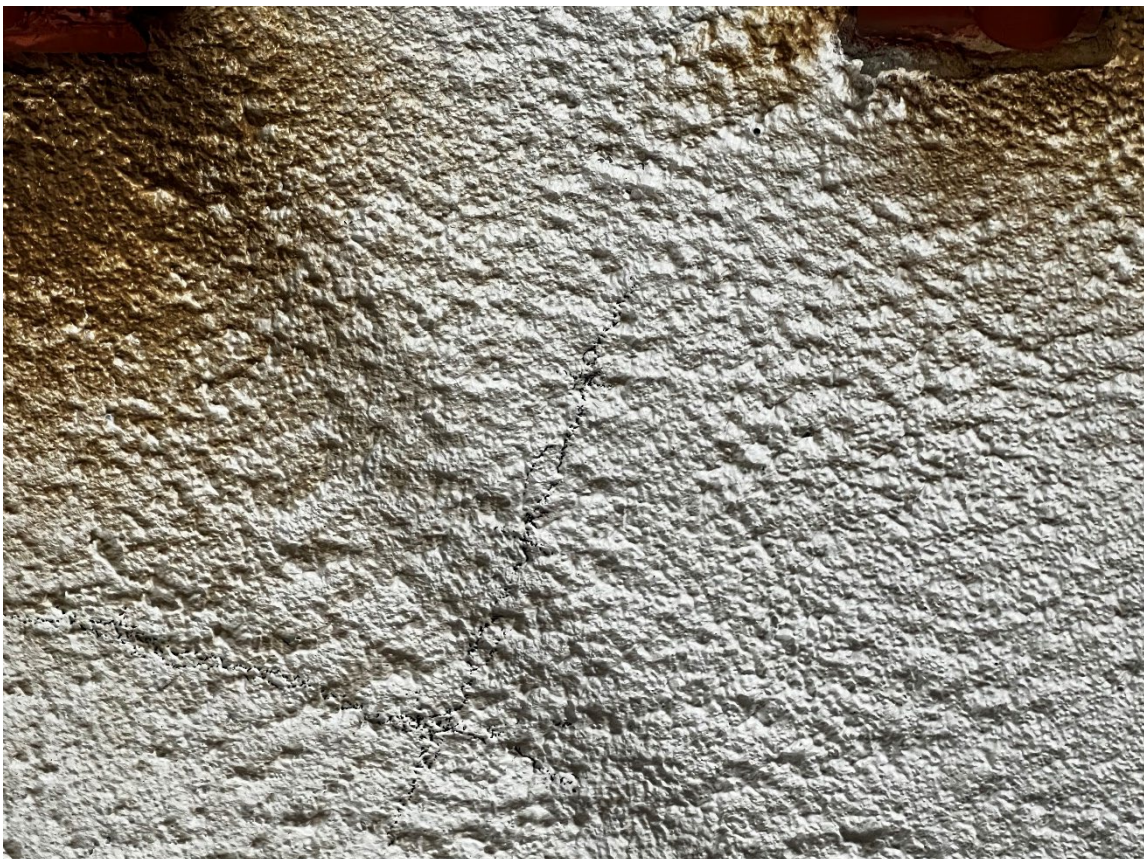
Location 5 clockwise from entry. All concrete sound. No damage.

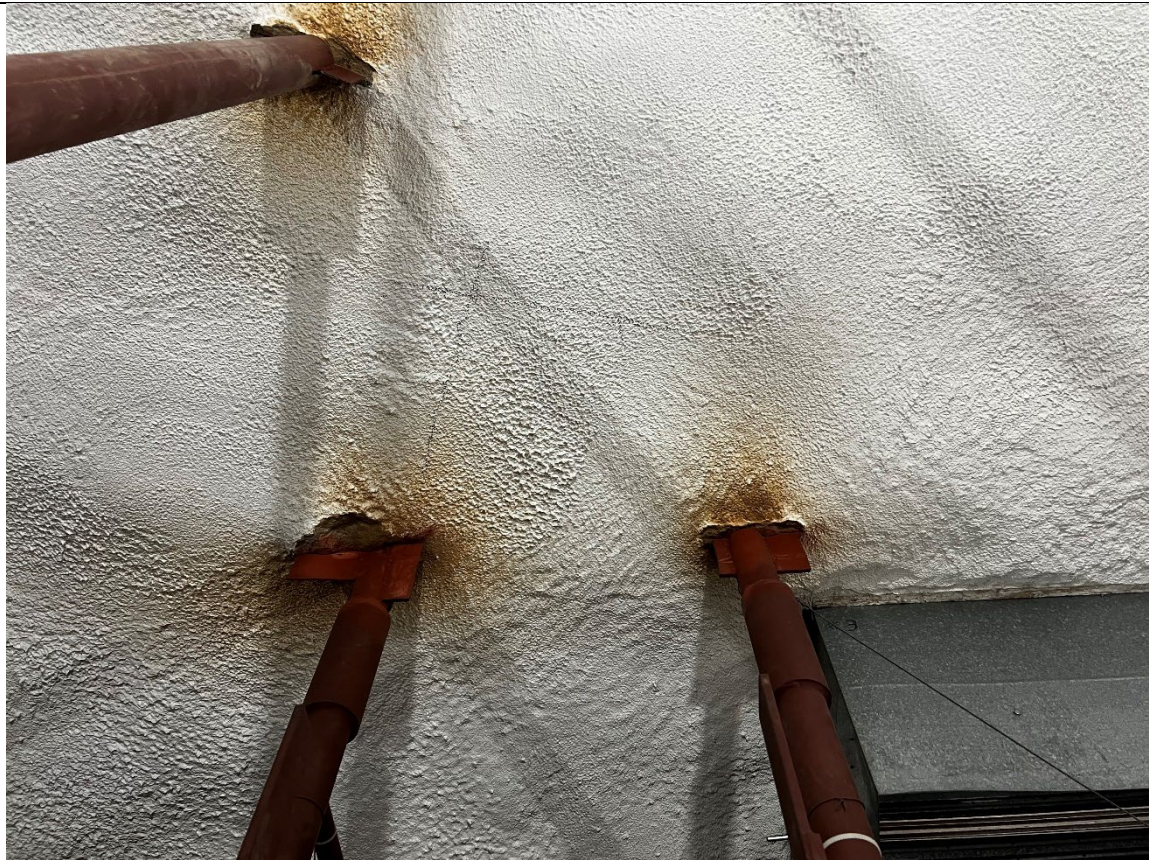
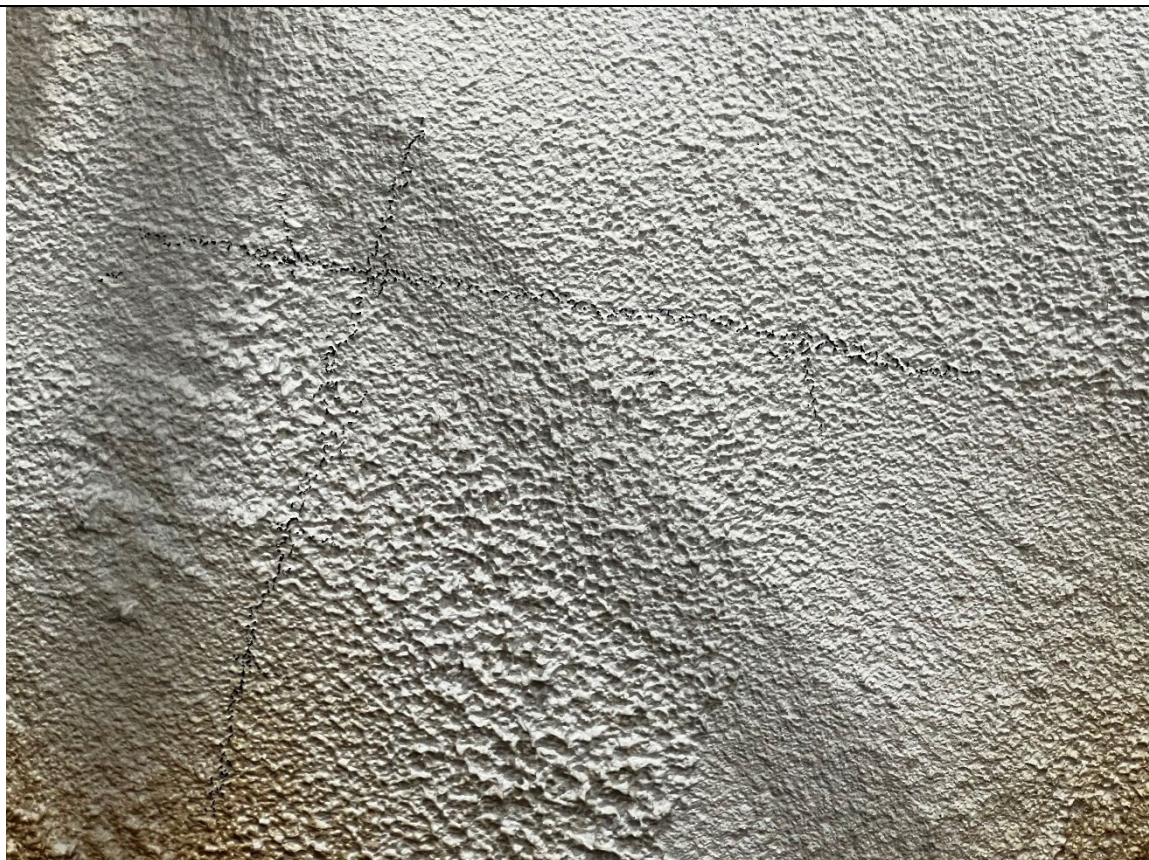
Location 7 clockwise from entry. All concrete sound. No damage.

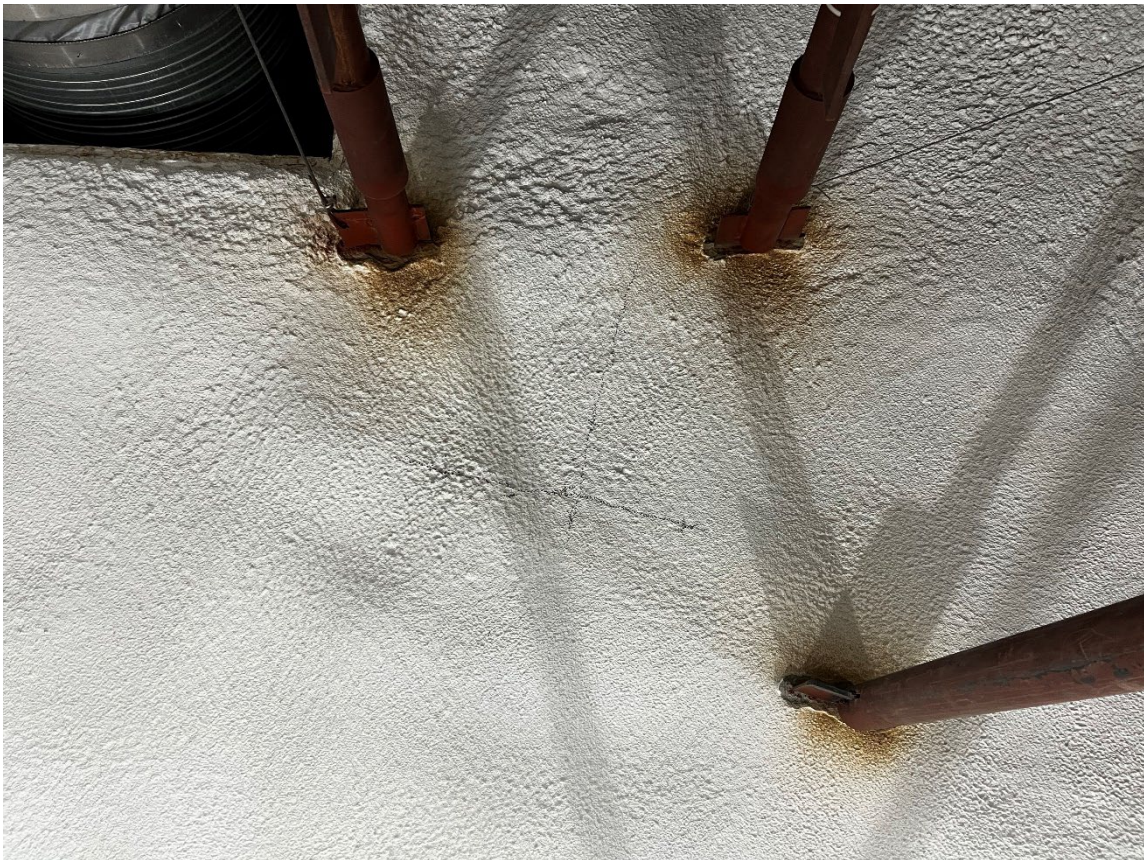
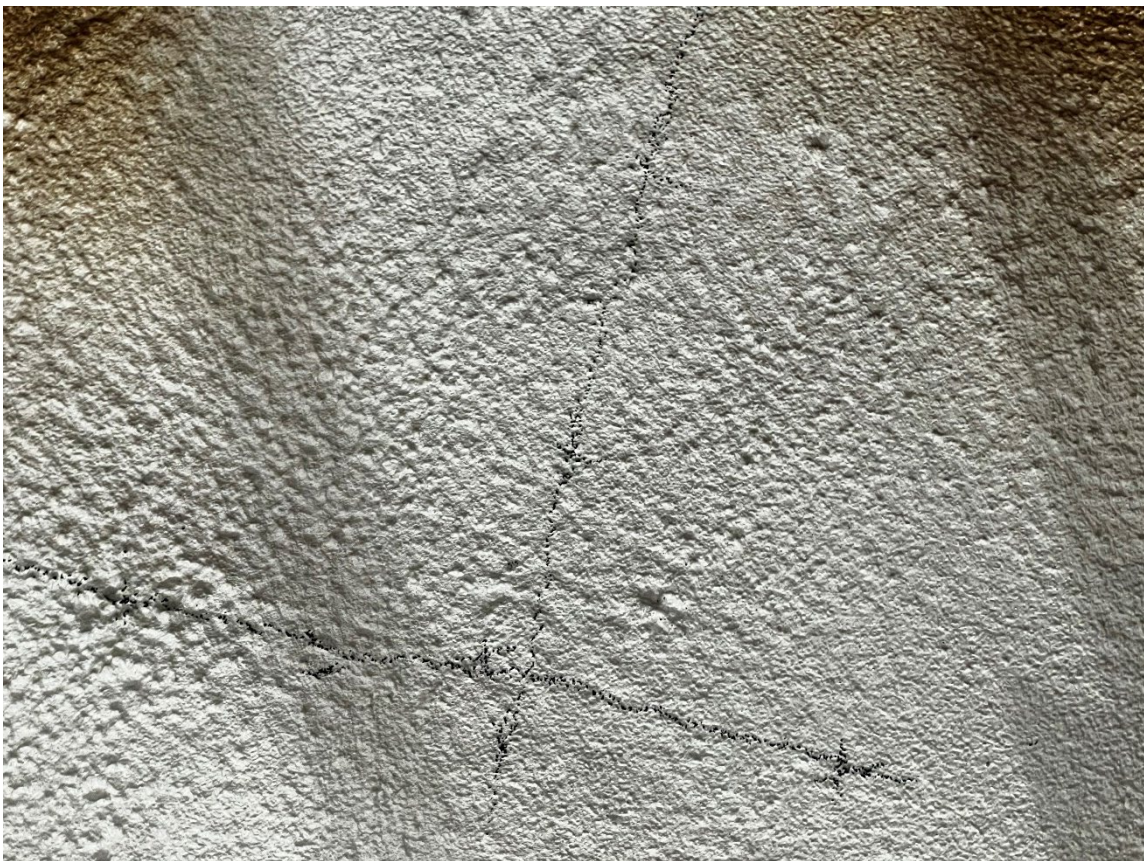
Location 8 clockwise from entry. All concrete sound. No damage.

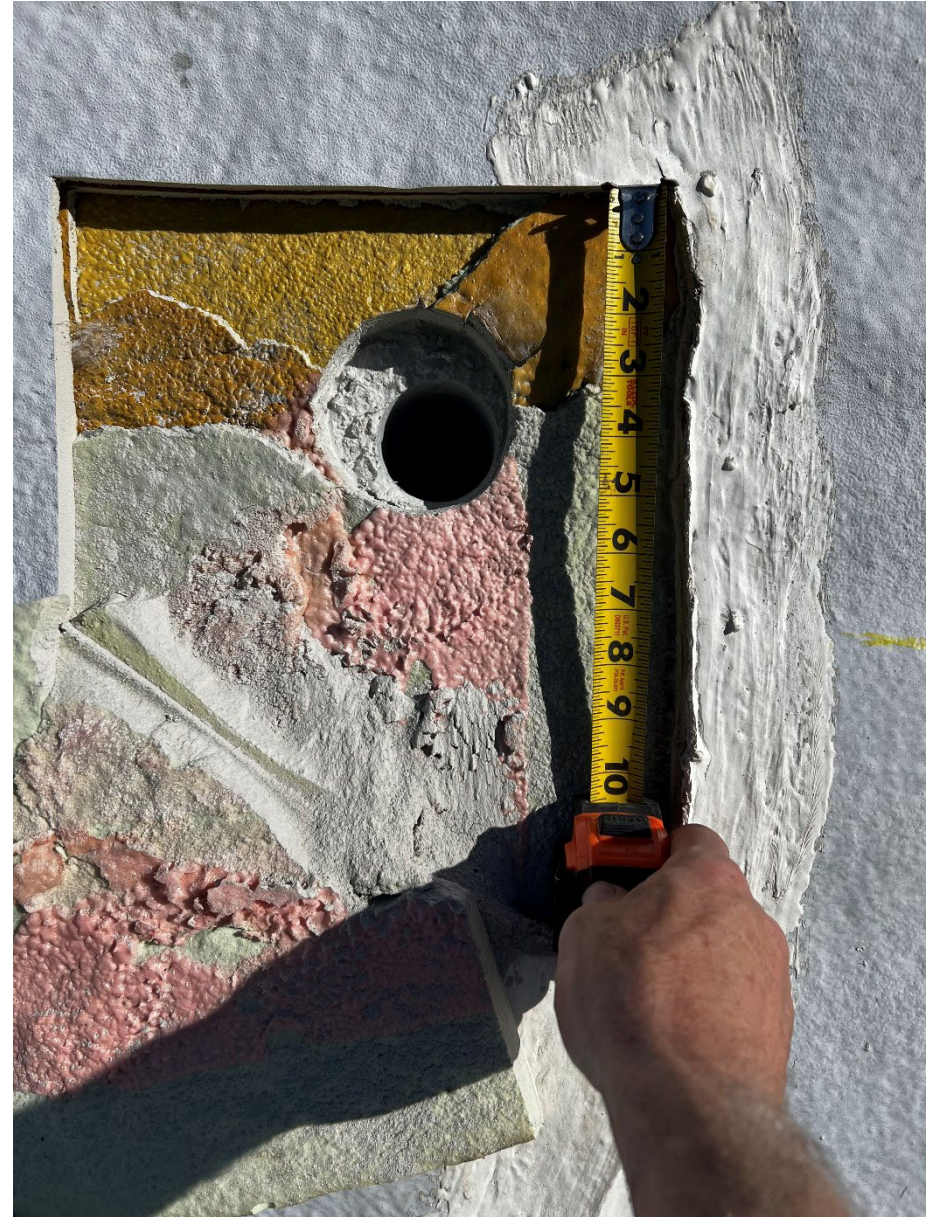
Core advanced through foam and then through concrete.

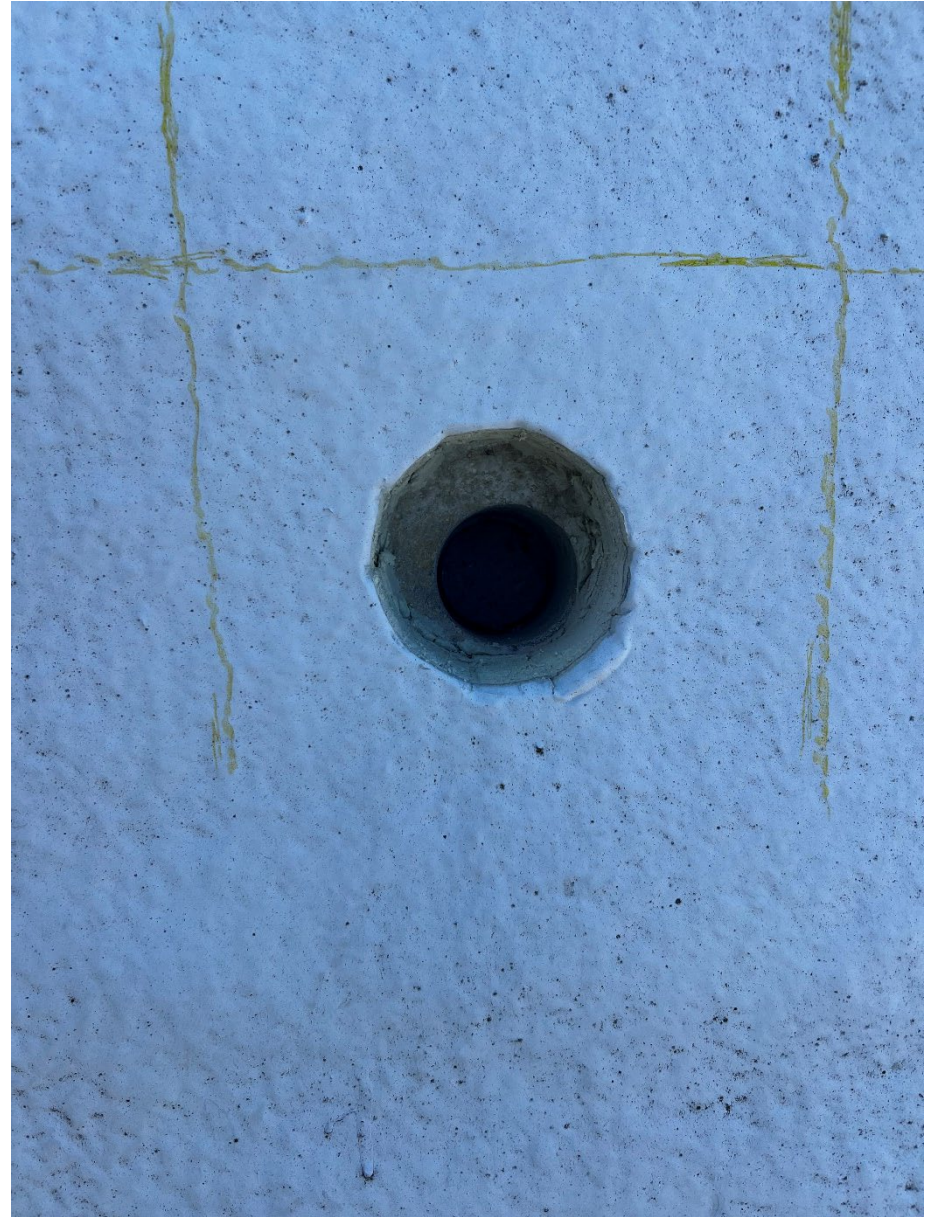
Roof membrane was cut with a hole saw and pried out.

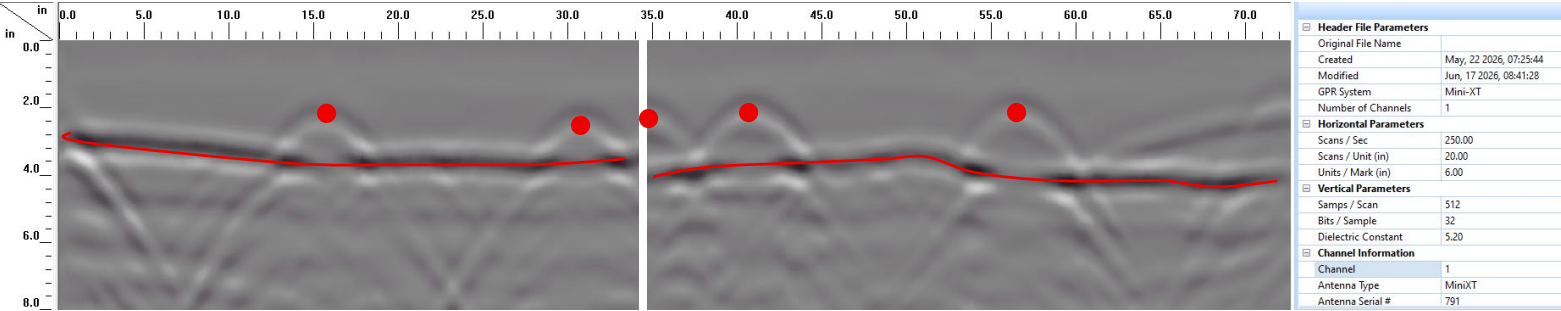
**Figure 2.** Cross-section image of GPR profile F2 of Location #2, the second clockwise from the entry. The embedded rebar are clearly shown and appear healthy. No evidence of corrosion to the rebar is evident; no delamination or voids in the concrete are indicated.

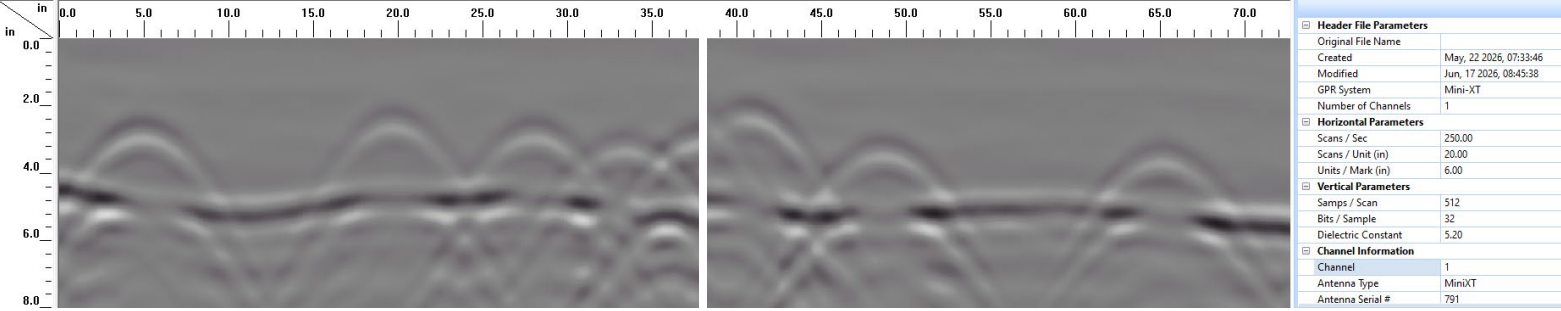
**Figure 3.** Cross-section image of GPR profile F3 of Location #3, the third clockwise from the entry. The embedded rebar are clearly shown and appear healthy. No evidence of corrosion to the rebar is evident; no delamination or voids in the concrete are indicated.

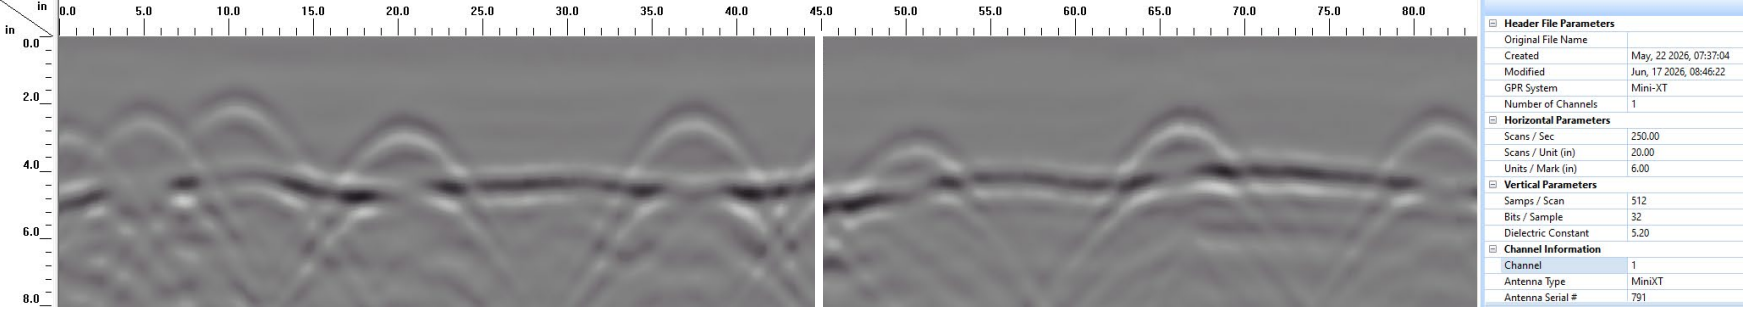
**Figure 4.** Cross-section image of GPR profile F4 of Location #4, the fourth clockwise from the entry. The embedded rebar are clearly shown and appear healthy. No evidence of corrosion to the rebar is evident; no delamination or voids in the concrete are indicated.

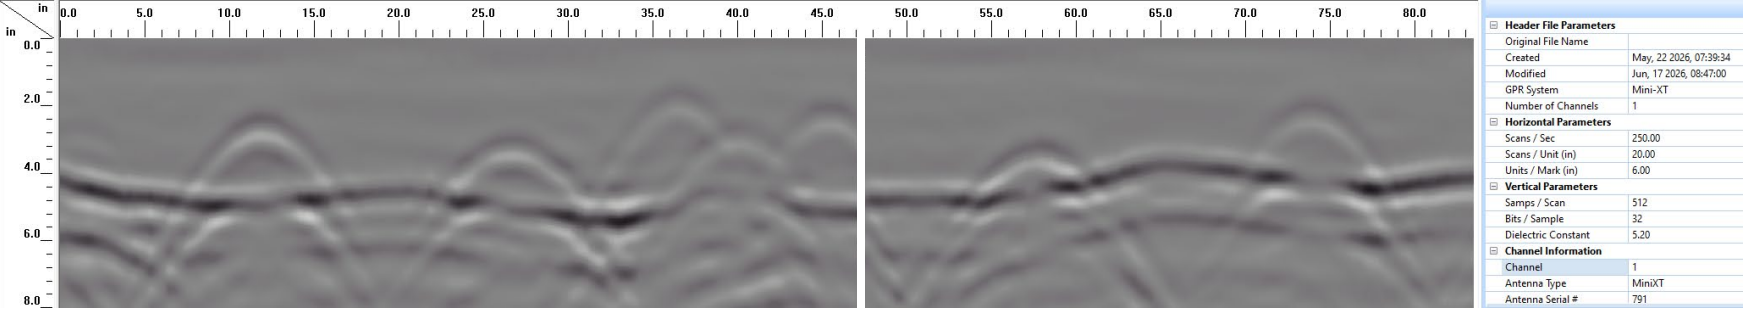
**Figure 5.** Cross-section image of GPR profile F5 of Location #5, the fifth clockwise from the entry. The embedded rebar are clearly shown and appear healthy. No evidence of corrosion to the rebar is evident; no delamination or voids in the concrete are indicated.

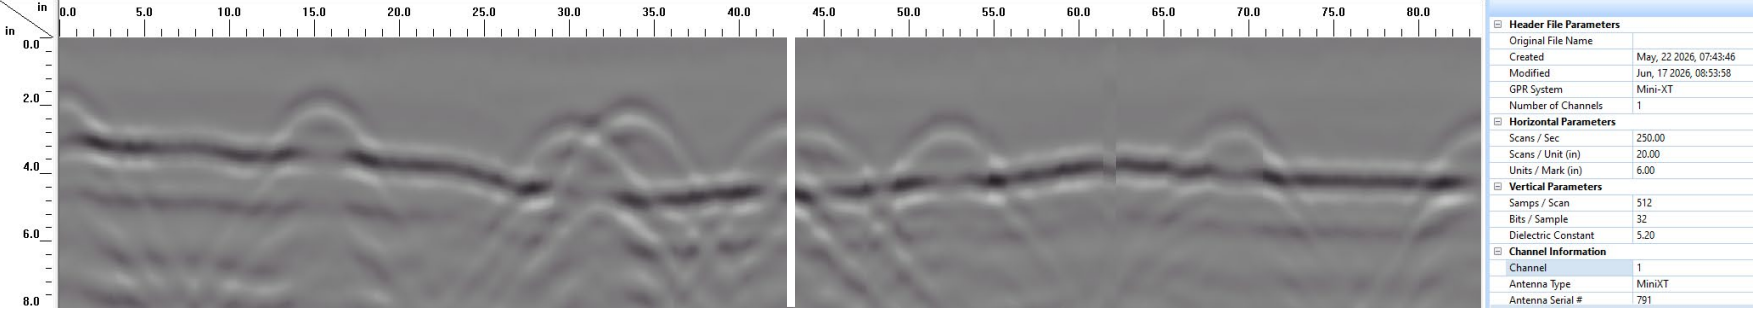
**Figure 6.** Cross-section image of GPR profile F6 of Location #6, the sixth clockwise from the entry. The embedded rebar are clearly shown and appear healthy. No evidence of corrosion to the rebar is evident; no delamination or voids in the concrete are indicated.

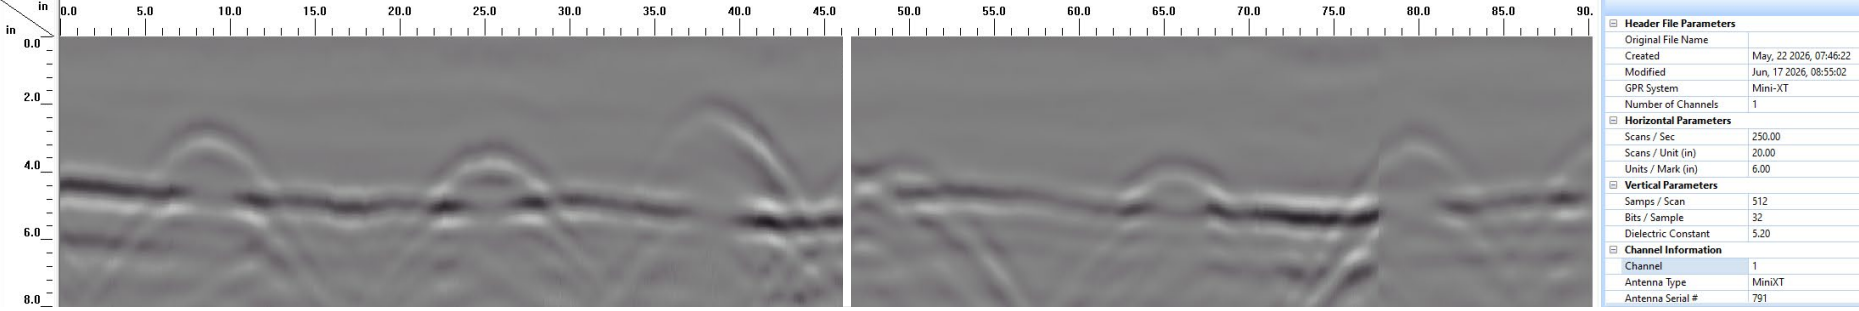
**Figure 7.** Cross-section image of GPR profile F7 of Location #7, the seventh clockwise from the entry. The embedded rebar are clearly shown and appear healthy. No evidence of corrosion to the rebar is evident; no delamination or voids in the concrete are indicated.

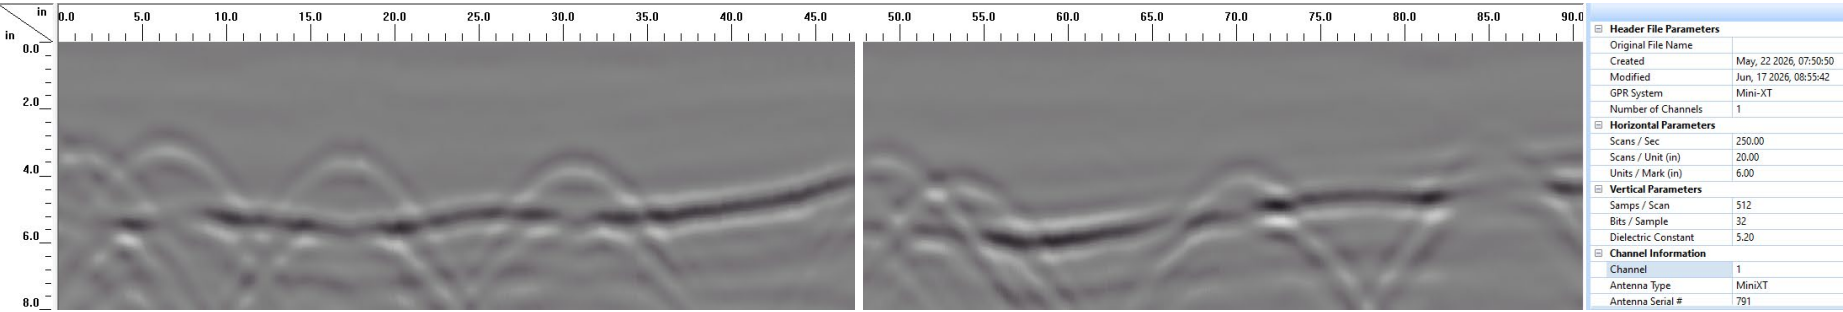
**Figure 8.** Cross-section image of GPR profile F8 of Location #8, the eighth clockwise from the entry. The embedded rebar are clearly shown and appear healthy. No evidence of corrosion to the rebar is evident; no delamination or voids in the concrete are indicated.

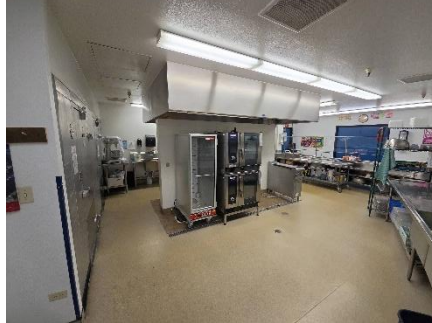
**FIGURE 1: MAIN PREPARATION**

- 1) Observation: The kitchen is smaller than typical spaces but well utilized

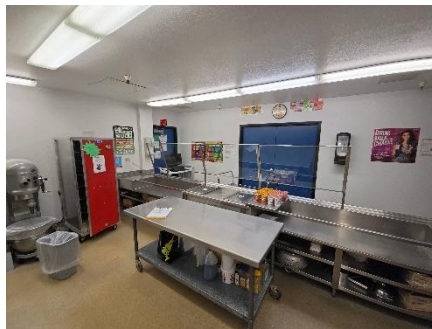
**FIGURE 2: SERVING AREA**

- 2) Observation: Serving area appears to be undersized for the amount of students served daily

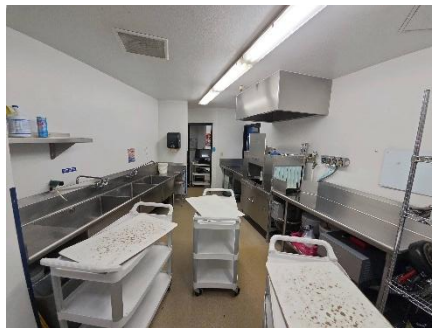
**FIGURE 3: DISHWASHING STATIONS**

- 3) Observation: Dishwashing space lacks immediate drying area for clean dishes

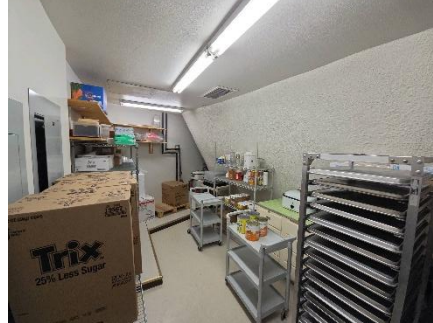
**FIGURE 4: DRY STORAGE**

- 4) Observation: Dry storage space is undersized for amount of students served

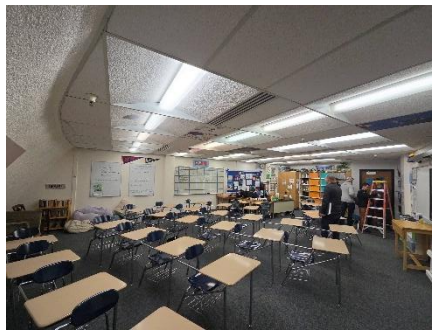
**FIGURE 8: TYPICAL CLASSROOM LAYOUT**

- 8) Observation: Trapezoid or pie-shaped classrooms create awkward layout and site line issues in the classrooms

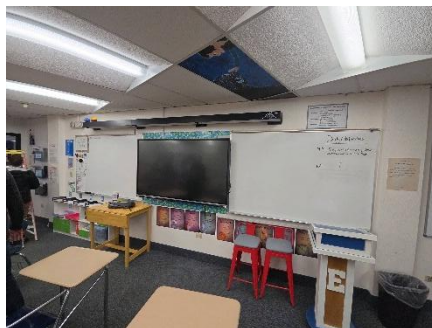
**FIGURE 9: TYPICAL TEACHING WALL LAYOUT**

- 9) Observation: Teaching wall site lines are challenging depending on room layouts

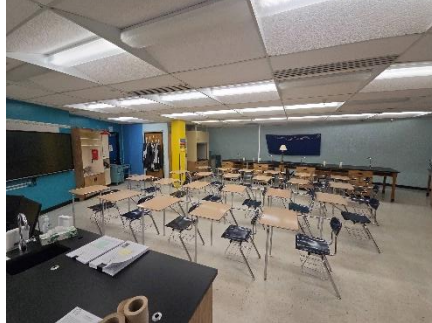
**FIGURE 10: LAB LAYOUT**

10) Observation: Classrooms that shift off the grid end up site line issues

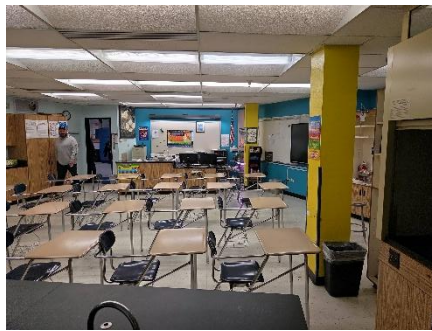
**FIGURE 11: COLUMN IN SITE LINES**

11) Observation: Column obscuring student and teacher site lines

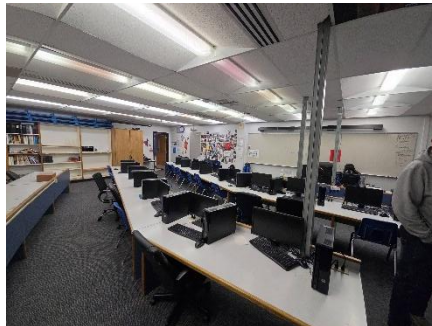
**FIGURE 12: BUSINESS ROOM LAYOUT**

12) Observation: Classrooms have been laid out to best use the space available
