# **Emmett High School – Facility Condition Assessment**

## *Observations & Assessments*

Compiled Document of Observations & Assessments

**July 10, 2026**

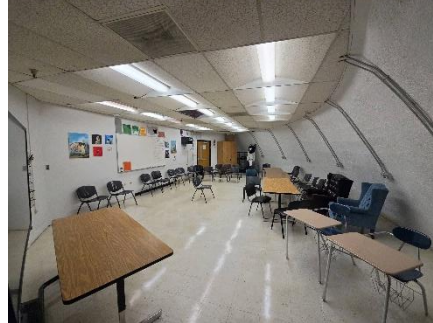
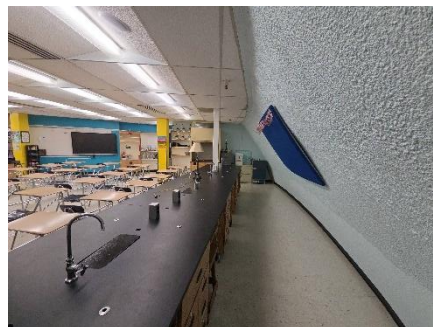
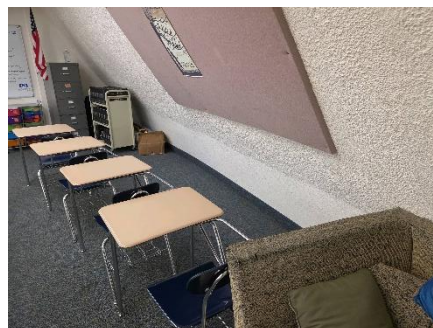
13) Observation: Dome curvature creates layout issues in all perimeter classrooms

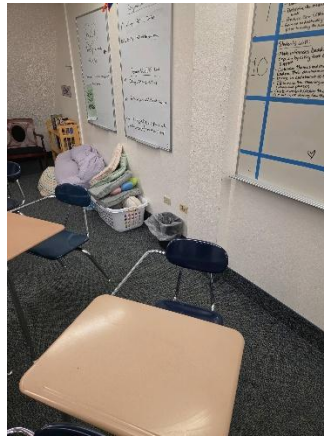
**FIGURE 16: TYPICAL CLASSROOM WALL**

- 14) Observation: There is limited power and data located along the perimeter walls of each classroom

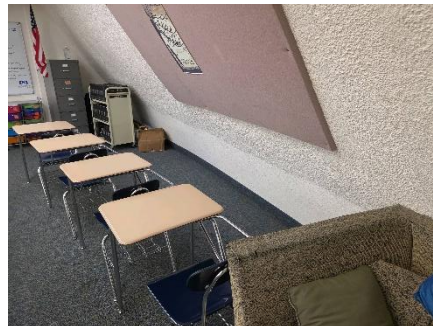
**FIGURE 17: TYPICAL PERIMETER WALL**

- 15) Observation: Exterior walls do not contain any power or data due to the dome's construction

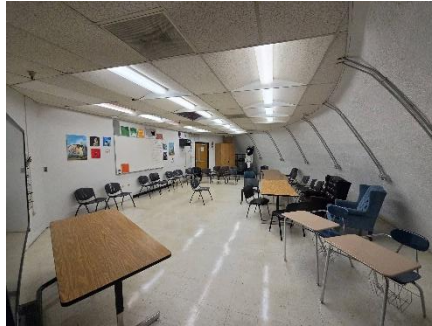
**FIGURE 18: AUXILIARY DOME CLASSROOM**

- 16) Observation: Several classrooms, primarily in the auxiliary domes, have had power added along the exterior wall and is surface mounted

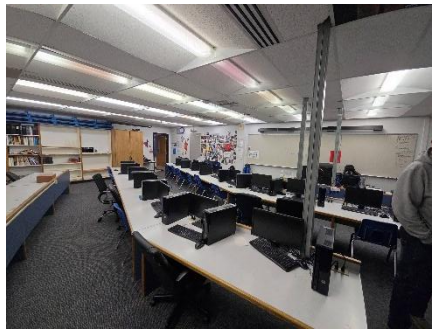
**FIGURE 19: BUSINESS CLASS WAP**

- 17) Observation: WAP's were limited to a few classroom locations

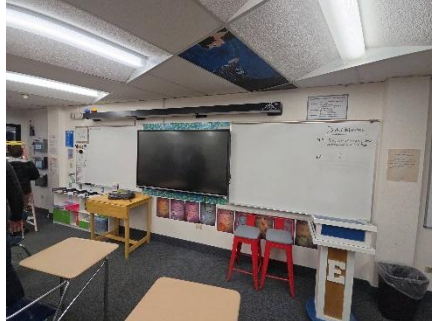
**FIGURE 20: TYPICAL TEACHING STATION**

- 18) Observation: Typical teaching stations consisted of an wall mounted monitor

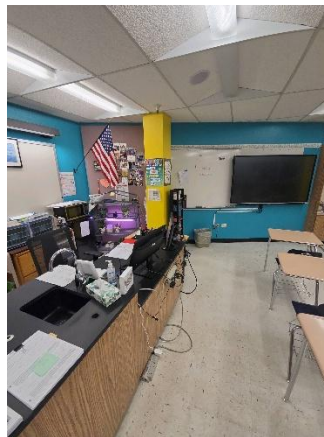
**FIGURE 21: TEACHING STATION IN LAB**

- 19) Observation: Teaching stations were paired with a teach workstation and desk

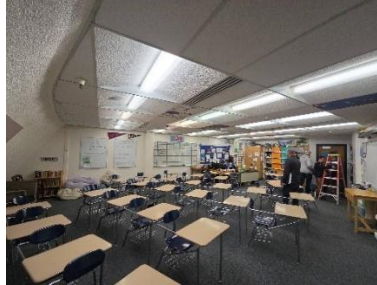
**FIGURE 22: TYPICAL CLASSROOM**

20) Observation: All interior spaces lack access to natural light

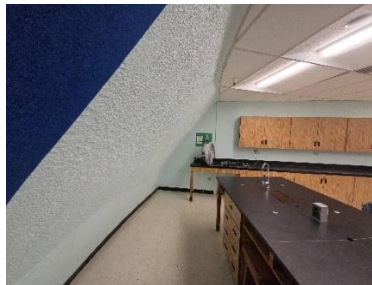
**FIGURE 23: DOME CURVATURE**

21) Observation: Lack of windows is due to the curvature of the dome and it's construction

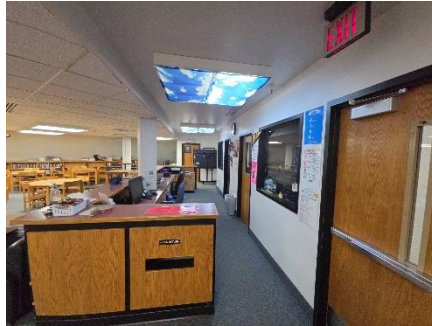
- 23) Observation: Staff have hung up drapes/coverings over window to approximate sunlight

**FIGURE 25: COVERINGS OVER LIGHTS IN THE LIBRARY**

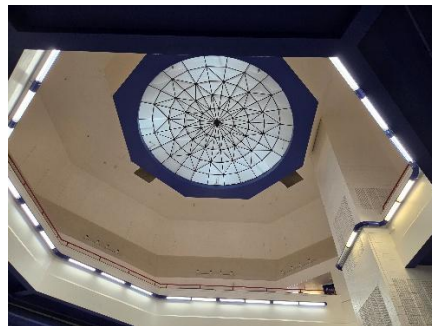
**FIGURE 26: ATRIUM SKYLIGHT**

- 24) Observation: Atrium skylight is backlit to provide “daylight” in the space

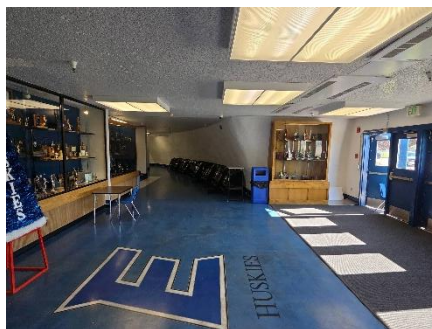
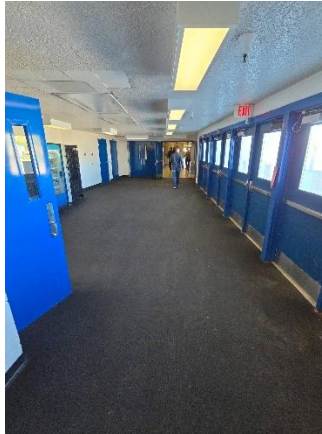
- 25) Observation: The most amount of natural daylight occurs in the building lobby’s and connecting corridor

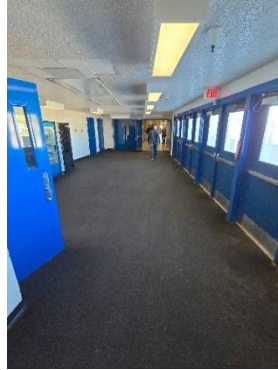
**FIGURE 29: WALK MATT**

26) Observation: Walk-off Matt in Vestibules appears in good condition

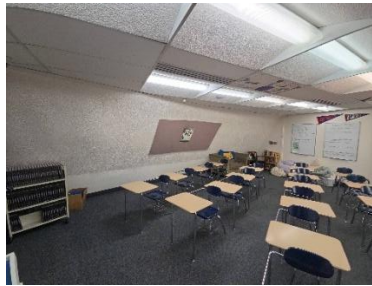
**FIGURE 30: CLASSROOM CARPET**

27) Observation: Overall, the carpet appears in good condition but nearing end of life

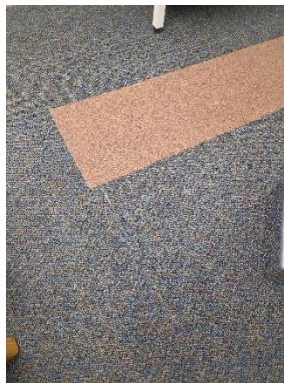
28) Observation: Carpet in the Library appears to be the oldest and has been patched several times

**FIGURE 31: LIBRARY CARPET PATCH**

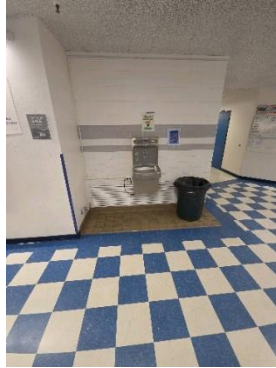
**FIGURE 32: TILE AT DRINKING FOUNTAINS**

29) Observation: There is a mixture of flooring in the corridors between tile and VCT

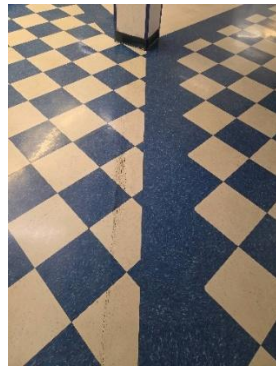
30) Observation: VCT is cracking in the main atrium along the column line

**FIGURE 33: CRACKED VCT AT THE ATRIUM**

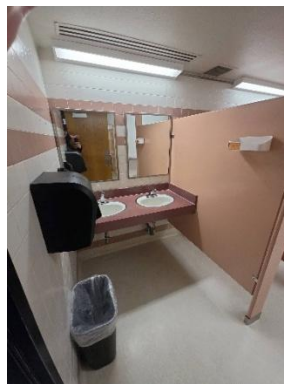
**FIGURE 34: BATHROOM SHEET VINYL**

31) Observation: Sheet Vinyl in the restrooms appears to be in good condition

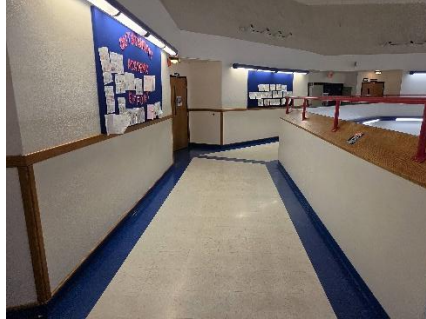
**FIGURE 35: HALLWAY VCT**

32) Observation: VCT throughout the building is showing its age and is worn with use

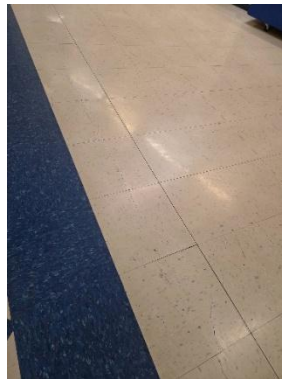
33) Observation: Cracked or spreading VCT noted in the corridors

**FIGURE 36: GAP IN VCT**

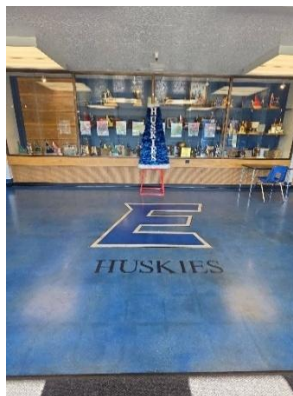
**FIGURE 37: FACED VCT**

34) Observation: VCT is showing age and is worn or faded in the building

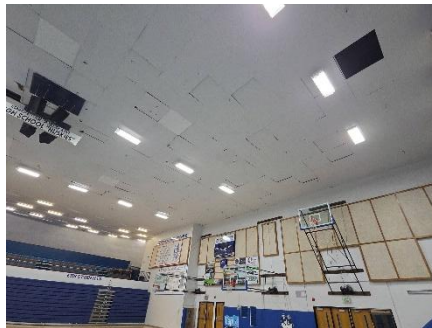
**FIGURE 38: GYM CEILING**

35) Observation: Multiples tiles unseated or damaged due to gym activities

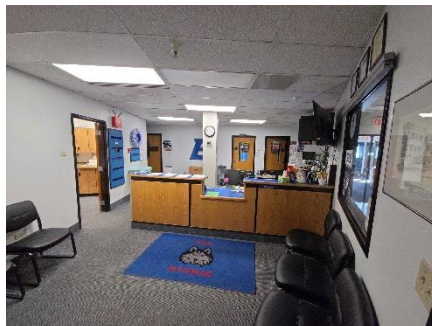
**FIGURE 39: ADMIN CEILING**

36) Observation: Individual ceiling tiles have been replaced as needed, creating a hodgepodge network of tiles

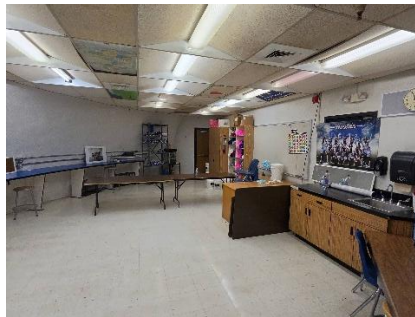
38) Observation: Ceiling tiles are showing their age and are collecting dust around diffusers/grilles

**FIGURE 41: AGED TILE IN CLASSROOM**

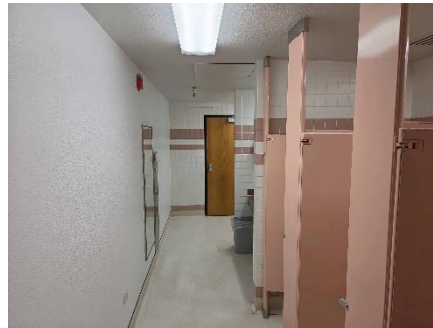
40) Observation: Pastel colors used throughout the school, providing a dated look

**FIGURE 43: PASTEL PINK TOILET PARTITIONS**

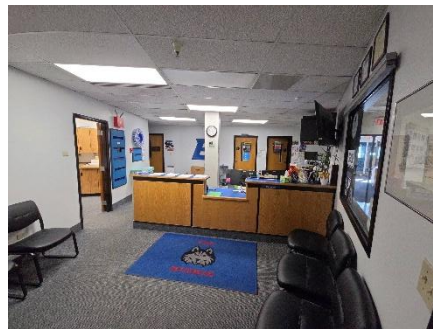
41) Observation: Dated colors used in casework and casework showing age

**FIGURE 44: RECEPTION DESK**

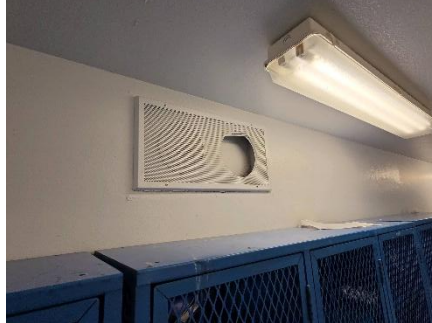
42) Observation: Missing or removed speakers throughout the school

**FIGURE 45: REMOVED SPEAKERS**

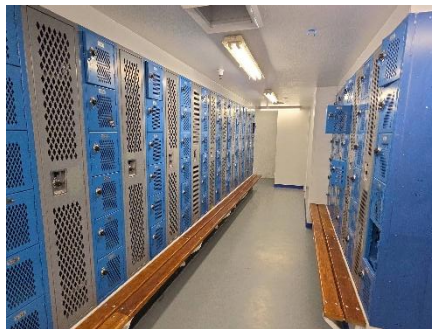
43) Observation: Dented/damaged lockers

**FIGURE 46: MEN'S LOCKER ROOM**

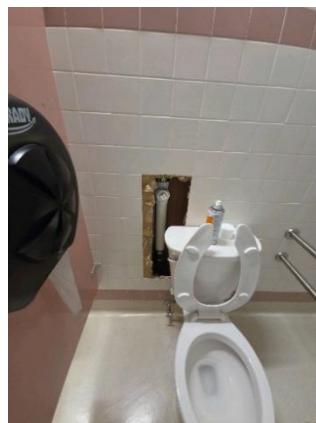
44) Observation: Missing wall and tile

**FIGURE 47: STAFF RESTROOM**

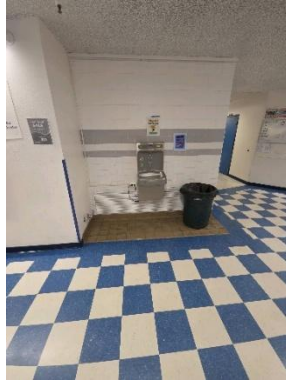
45) Observation: Mixture of flooring types in the corridors

**FIGURE 48: DRINKING FOUNTAIN FLOORING**

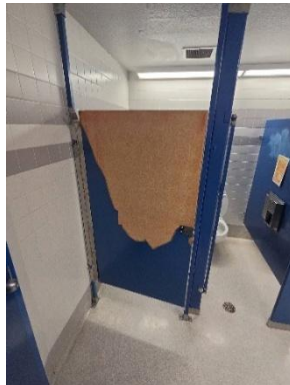
46) Observation: Damaged and missing toilet partitions around the school

**FIGURE 49: DAMAGED TOILET PARTITION**

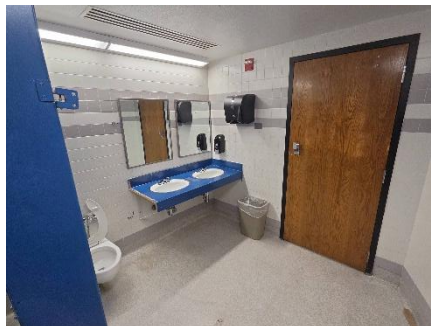
47) Observation: Missing or removed toilet partitions

**FIGURE 50: MISSING TOILET PARTITION**

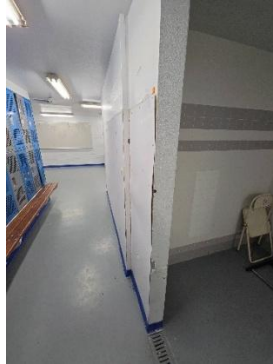
48) Observation: Wall protection delaminated off the wall in the locker rooms

**FIGURE 51: DAMMAGED WALL PROTECTION**

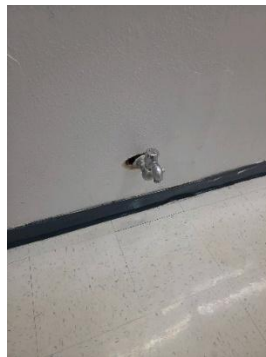
49) Observation: Missing escutcheons at plumbing fixtures

**FIGURE 52: MISSING ESCUTCHEONS**

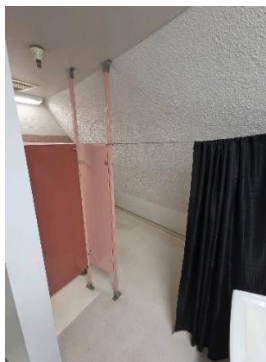
50) Observation: Incomplete toilet enclosures due to dome curvature

**FIGURE 53: MISSING STAFF PARTITION**

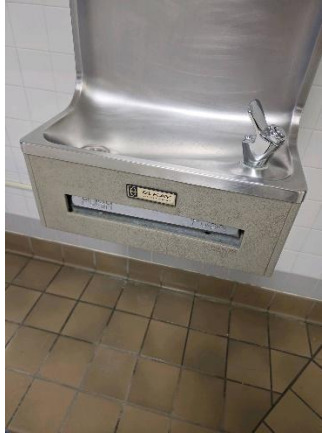
51) Observation: Damaged drinking fountains in several locations

**FIGURE 54: DAMAGED DRINKING FOUNTAINS**

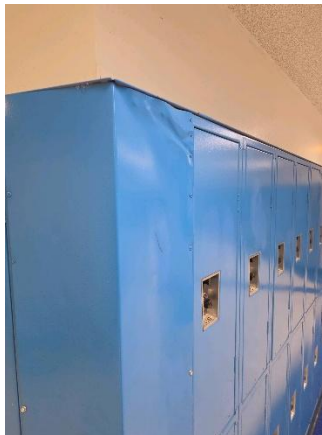
53) Observation: Damaged lockers around the corridors

**FIGURE 56: DAMAGED LOCKER**

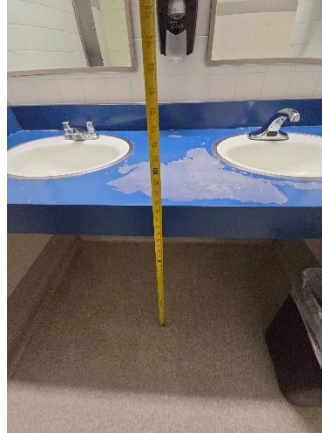
54) Observation: Bathroom countertops showing wear and tear

**FIGURE 57: WORN BATHROOM COUNTERTOPS**

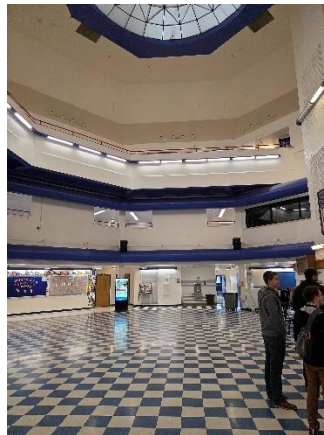
- 1) Observation: Atrium is located at the center of the building

**FIGURE 58: ATRIUM OVERVIEW FROM LEVEL 1**

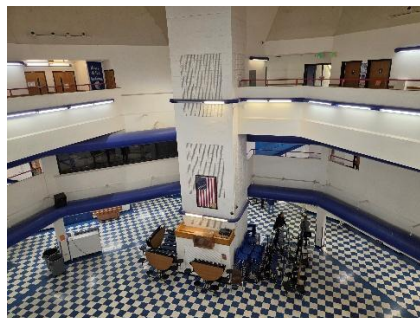
- 2) Observation: The Atrium connects three different levels of the building without separation

**FIGURE 59: ATRIUM AT LEVEL 02**

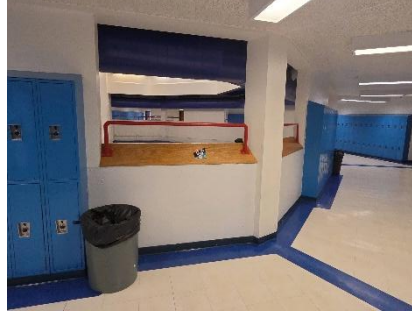
- 3) Observation: The Atrium lacks a fire separation from the rest of the building

**FIGURE 60: LEVEL 2 AT ATRIUM EDGE**

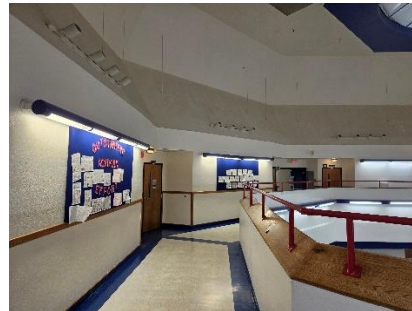
- 4) Observation: Atrium appears to lack any smoke control systems

**FIGURE 61: LEVEL 3 AT ATRIUM**

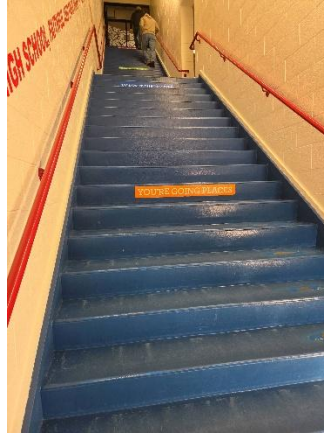
- 5) Observation: There is appears to be plenty of stair egress capacity

**FIGURE 62: TYPICAL STAIRS**

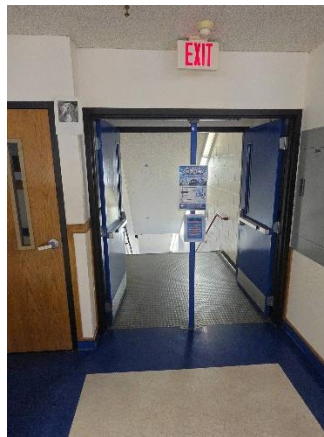
**FIGURE 63: TITLE**

- 6) Observation: Each level contains a pair of fire rated doors

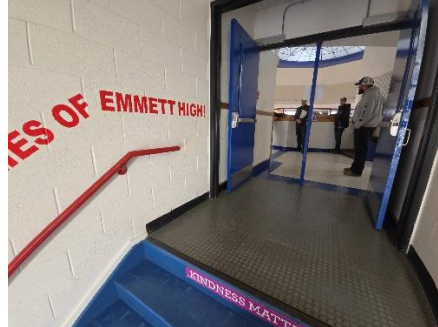
- 7) Observation: Each set of fire rated doors have hold-opens installed

**FIGURE 64: DOORS ON HOLD-OPENS**

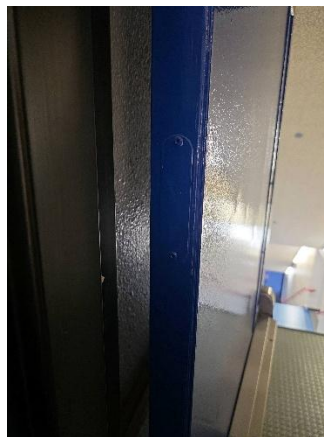
- 8) Observation: Fire rating tags on the stair doors have been painted over and rating can not be confirmed

**FIGURE 65: FIRE DOOR RATING TAG**

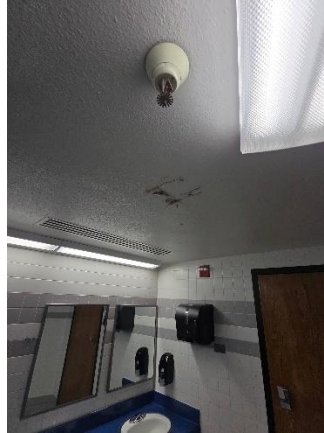
- 9) Observation: Fire sprinklers were noted in majority of the spaces but not all

**FIGURE 66: FIRE SPRINKLER FIXTURE**

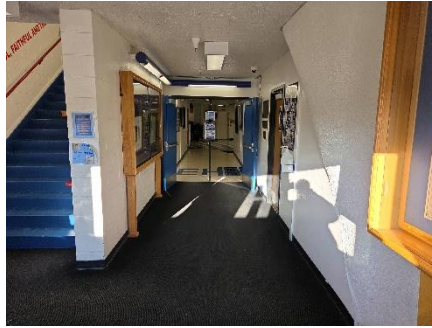
- 10) Observation: The entries all have a vestibule system but the doors are installed with hold-opens and are set in the open position.

**FIGURE 67: MAIN ENTRY VESTIBULE**

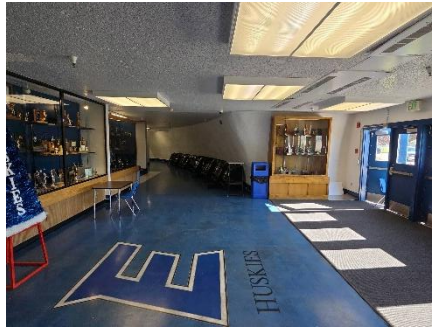
- 11) Observation: Several entries do not have a set of vestibule doors, like the main public entry to the Gym

**FIGURE 68: GYM PUBLIC LOBBY**

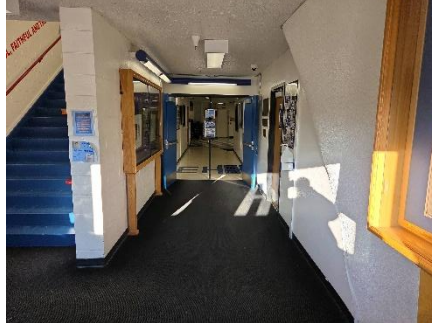
- 12) Observation: The building does not have a security vestibule at the main entry

**FIGURE 69: MAIN ENTRANCE LOBBY**

These existing conditions are generally grandfathered in and may remain as-is until a specific area of the building undergoes renovation or alteration. The extents of that the life safety systems are upgraded will be based on the requirements of the local Authorities having Jurisdiction and be at their discretion. It is recommended that as portions of the building are renovated, that these areas be brought up to current safety standards. It is recommended that the Security Vestibule system be constructed within the next five years.

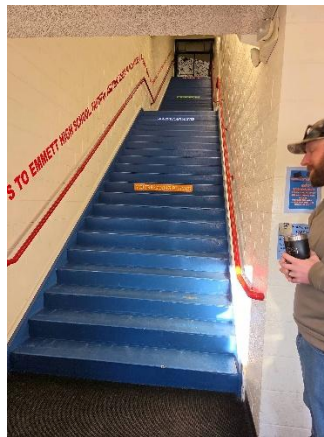
- 13) Observation: Several of the entries have stairs in the vestibules, allowing visitors to bypass the front reception

**FIGURE 70: STAIRS LOCATED IN MAIN ENTRY VESTIBULE**

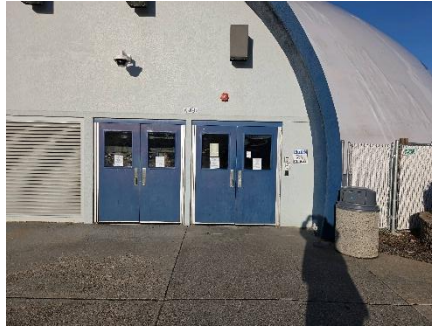
- 14) Observation: All exterior doors appear to have at least one card reader access for students and staff

**FIGURE 71: MAIN ENTRY DOORS**

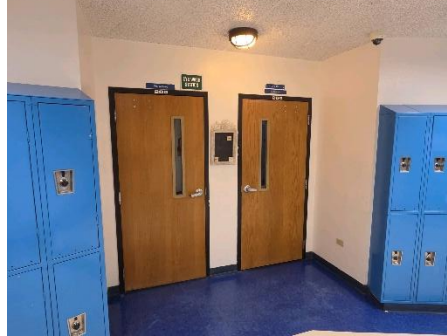
- 2) Observation: Exterior entry into the classrooms meet ADA requirements

**FIGURE 73: TYPICAL CLASSROOM HALL ENTRANCE**

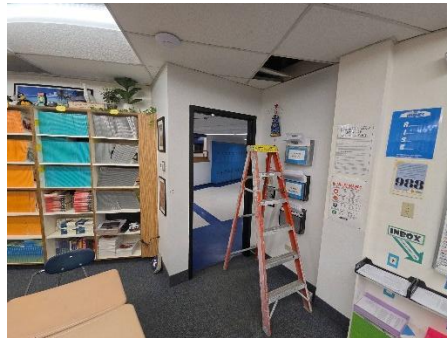
- 3) Observation: Interior side of the Classroom entries does not meet ADA requirements

**FIGURE 74: TYPICAL CLASSROOM INSIDE ENTRANCE**

- a. Correct door clearances issues where able. The remaining areas may be able to be fixed with door hardware changes.
- b. Renovate restrooms to include fully accessible stalls.
- c. Replace or modify handrails to meet height and extension requirements.
- d. Mitigate low-headroom areas where feasible or reconfigure spaces to avoid unusable zones.

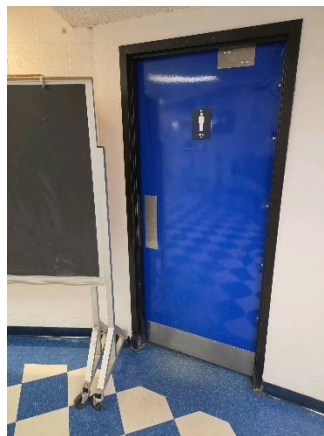
- 4) Observation: Exterior entries into some of the restrooms are not compliant

**FIGURE 75: ENTRY TO LEVEL 1 MEN'S RESTROOM**

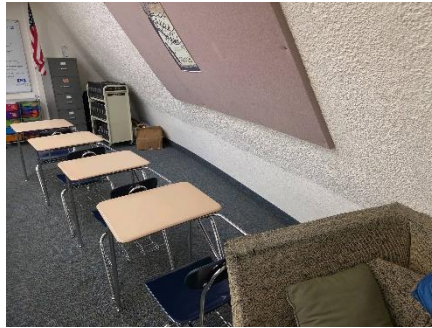
The dome creates headroom clearance issues along any perimeter space due to its curved nature. The head room clearance required by the ADA is 80" or 6'-8" clear. This affects every space located along the perimeter of the dome and creates an area of un-usable space per code. This zone extends approximately 3'-0" (Level 1) to 6'-0" (Level 3) out from the wall, depending on which level you're location. This represents approximately 13,500 sqft over the footprint of the building that cannot be utilized.

- 5) Observation: The domes curvature creates ADA clearance issues in all of the perimeter spaces

**FIGURE 76: DOME CURVATURE IN A CLASSROOM**

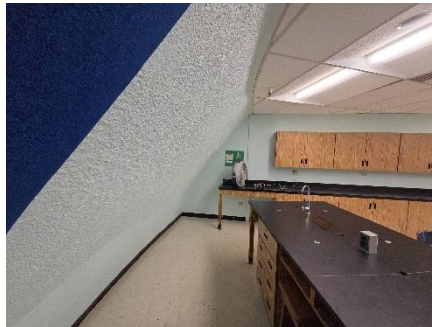
- 6) Observation: The domes curvature creates ADA clearance issues in all of the perimeter spaces

**FIGURE 77: DOME CURVATURE IN A LAB**

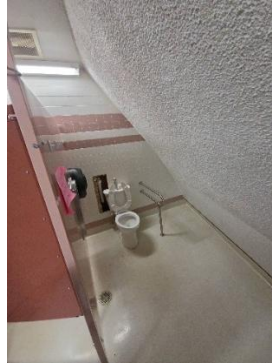
- 7) Observation: The dome curvature creates head clearances issues inside toilet stalls

**FIGURE 78: HEADROOM CLEARANCE AT STAFF RESTROOM**

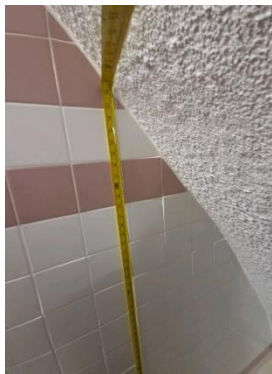
- 8) Observation: There is approximately 58" of clearance adjacent to the toilet

**FIGURE 79: HEADROOM CLEARANCE HEIGHT**

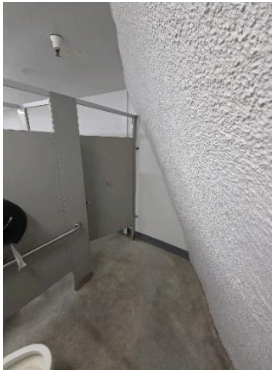
- 1) Observation: here are head clearance issues in the publicly accessible stalls by the Gym.

**FIGURE 80: DOME CURVATURE AT MEN'S PUBLIC RESTROOM**

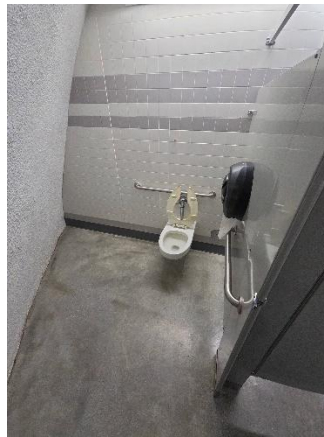
- 2) Observation: Incomplete grab bars and a lack of true accessible side clearance

**FIGURE 81: “ADA” STALL IN MENS PUBLIC GYM RESTROOM**

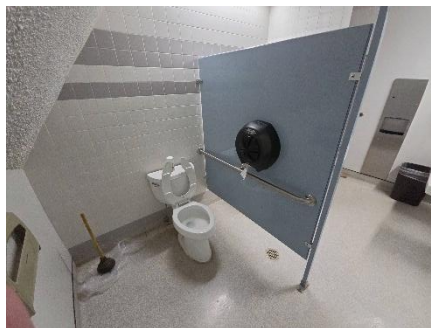
- 3) Observation: A majority of the “ADA” stalls have a partial grab bar and some clearance but lack the complete system

**FIGURE 82: TYPICAL PROVISIONS PROVIDED**

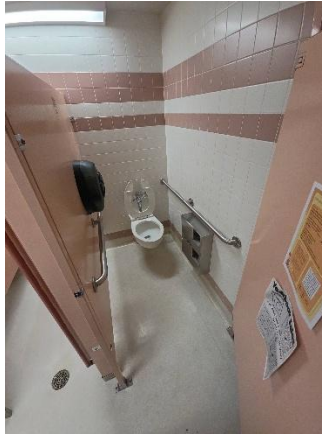
- 4) Observation: The building's restroom does provide ambulatory stalls in majority of the group restrooms

**FIGURE 83: TYPICAL AMBULATORY STALL**

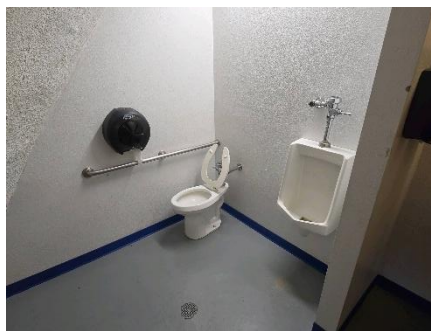
- 5) Observation: A majority of the single user restrooms do not provide a fully compliant ADA restroom

**FIGURE 84: INCOMPLETE ADA COMPLIANCE**

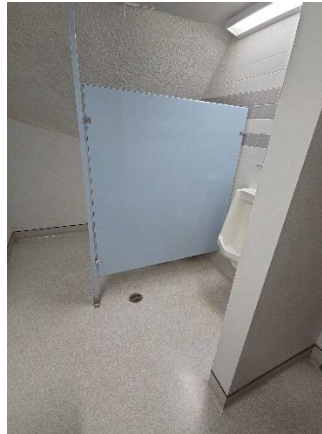
- 6) Observation: Many of the single user restrooms appear to be both a single and multi fixture restroom. They contain incomplete partitions for privacy for multi user layouts.

**FIGURE 85: MEN'S STAFF RESTROOM**

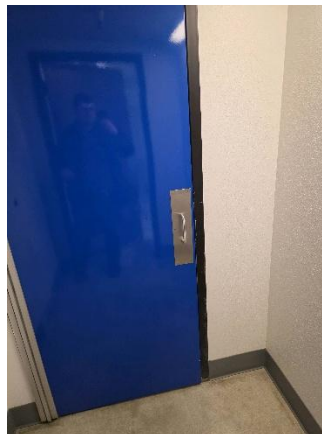
The entry vestibules into each group restroom in the Classroom Dome do not meet the spacing requirements between doors. This can hinder or prevent users with disabilities from using the restroom. To meet the building code and ADA guidelines, there needs to be a minimum of 4'-0" from the swing of the door to the adjacent wall.

- 7) Observation: Bathroom vestibule doors are too close together and are not compliant

**FIGURE 86: LOCATION OF BATHROOM VESTIBULE DOORS**

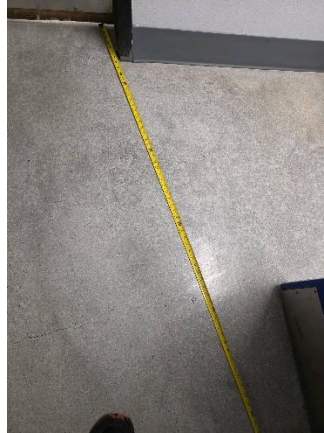
- 8) Observation: Doors are approximately 40"-46" apart

**FIGURE 87: LOCATION OF BATHROOM VESTIBULE DOORS**

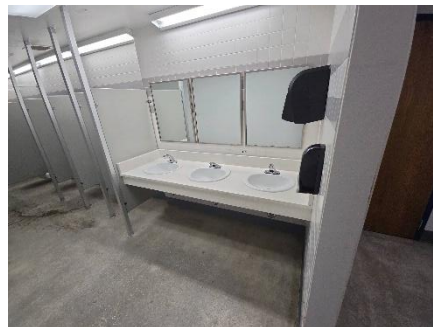
- 9) Observation: Several of the restrooms have been renovated

**FIGURE 88: RENOVATED RESTROOMS**

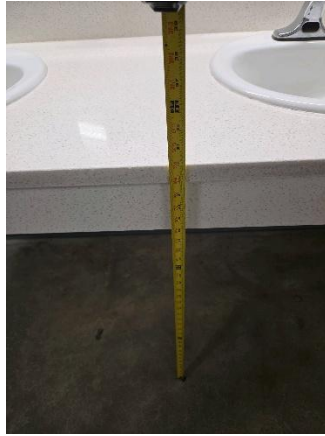
- 10) Observation: The renovated bathroom counters are 33" tall and provide the required clearance

**FIGURE 89: RENOVATED BATHROOM COUNTEROPS**

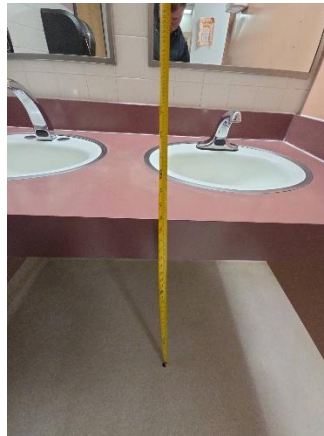
- 11) Observation: The existing bathroom counters are 33" tall and provide the required clearance.

**FIGURE 90: EXISTING BATHROOM COUNTERTOPS**

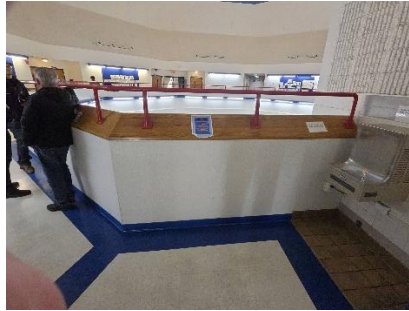
- 12) Observation: The guardrails at the Atrium are built walls with a railing type. They're height exceeds ADA requirements.

**FIGURE 91: TYPICAL ATRIUM GUARDRAIL**

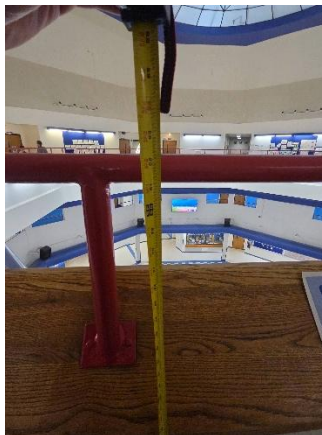
- 13) Observation: The guardrails at the Atrium area are 60" in height and are compliant

**FIGURE 92: ATRIUM GUARDRAIL HEIGHT**

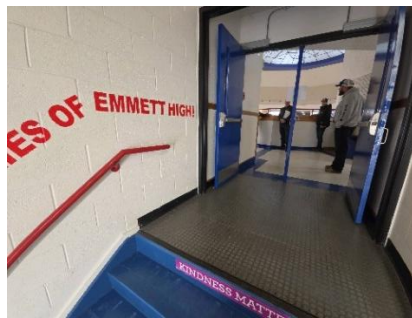
- 15) Observation: Handrail extensions consistently occur at the main stairs that serve all three levels

**FIGURE 94: STAIR HANDRAIL EXTENSION**

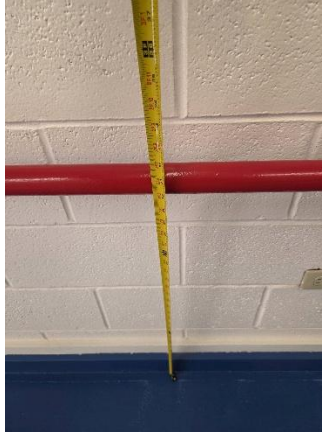
- 17) Observation: The handrail heights are at 30" above floor and do not meet current ADA requirements

**FIGURE 96: HANDRAIL HEIGHT AT MAIN STAIRS**

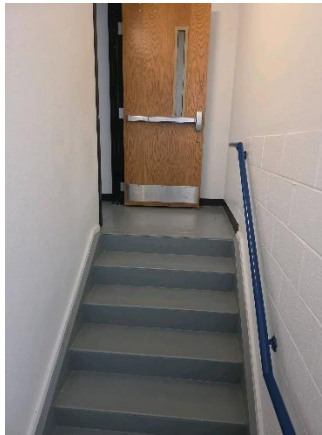
- 18) Observation: Several stairs are missing handrails on both sides of the stair

**FIGURE 97: MISSING HANDRAIL**

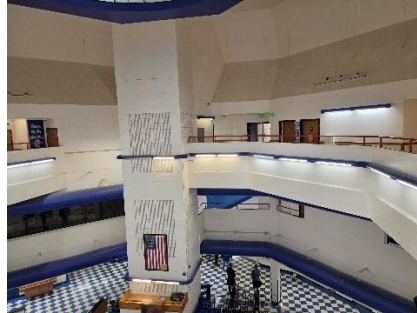
The Classroom Dome contains an elevator that's located in the central Atrium. It serves all three levels of the school and appears accessible to everyone that requires it. The age of the elevator is unknown. The size of the elevator indicates that the cab has a clear inside width of 5'-8" x 4'-3". This size would not fit a stretcher in an emergency, however, that capability is not required when the building is 3 stories or less.

19) Observation: The elevator is centrally located and accessible at all levels

**FIGURE 98: ELEVATOR SHAFT LOCATION**

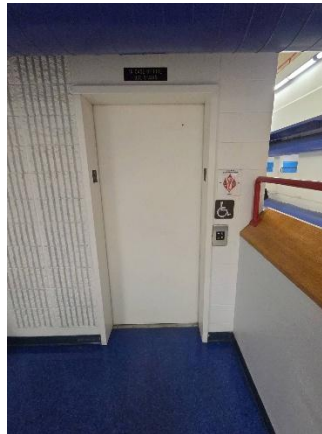
20) Observation: The elevator entrances are signed for ADA access

**FIGURE 99: ELEVATOR ENTRANCE AT LEVEL 3**

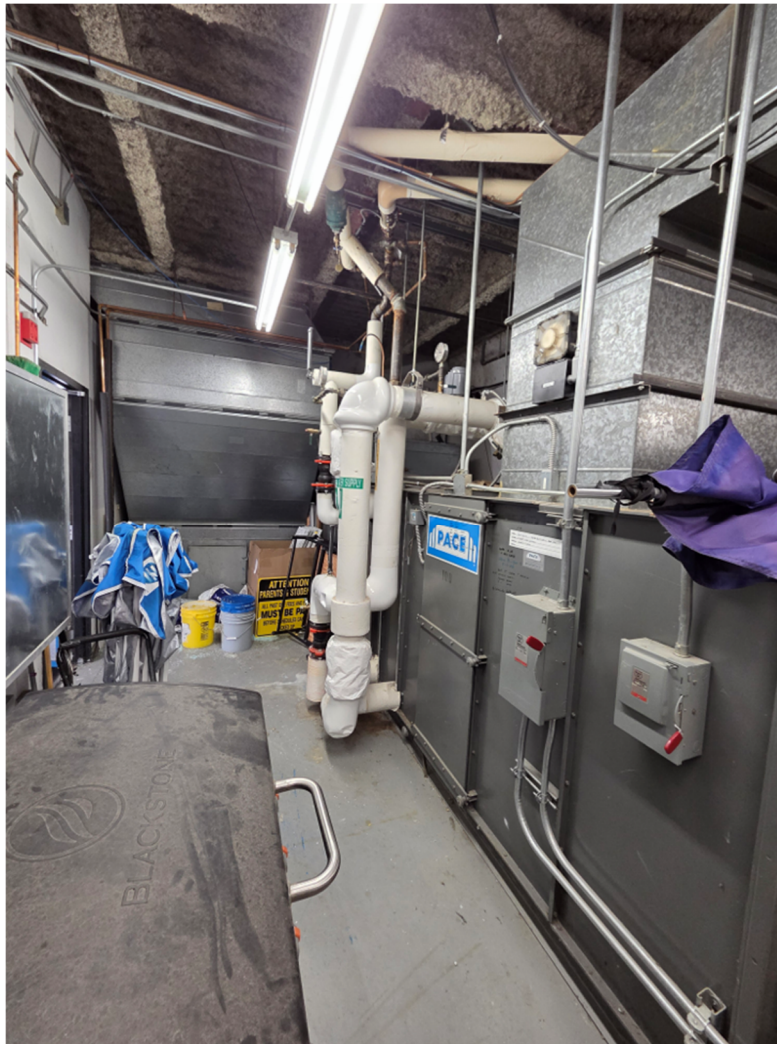
The heating and cooling requirements of the classrooms are satisfied by three (3) large air handlers. There is one (1) air handler on each floor. Each air handler has a hot water heating coil and a chilled water cooling coil. The air handlers are original to the building with the exception of the cooling coils which were added in 2010.

- 1) Observation: Typical Air Handler in Classroom Dome and Fresh air ducting  
Source: First floor Air Handler

**FIGURE 1: CLASSROOM LEVEL 1 AIR HANDLER**

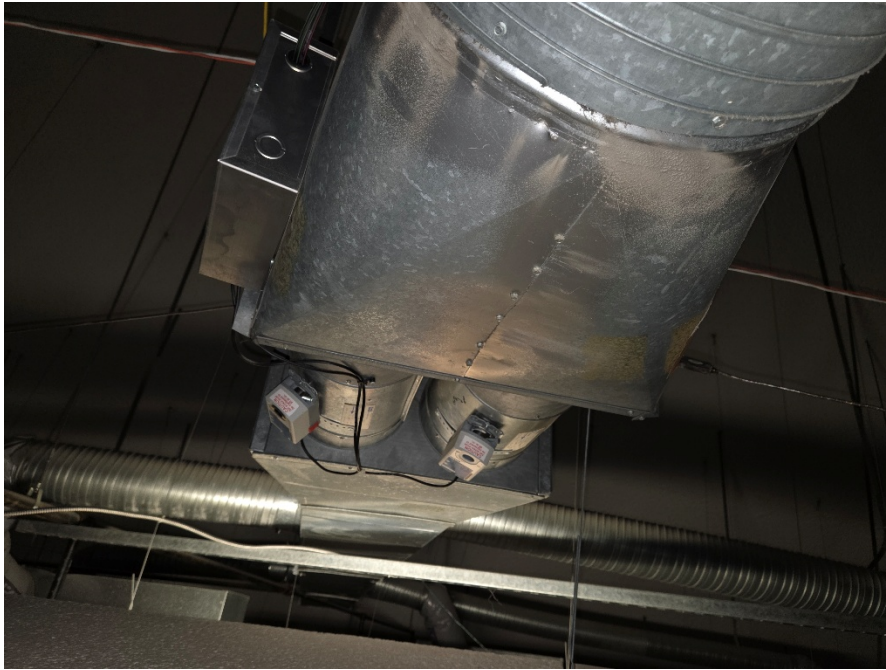
The air handlers supply air to individual VAV boxes with electric re-heat coils that serve the various spaces throughout the building. There is typically one (1) VAV box per classroom. There are approximately 60 total VAV boxes. The VAV boxes supply air to each zone and there is a return plenum at each floor which routes return air back to each respective air handler.

- 1) Observation: Typical VAV Box  
Source: Third floor classroom

**FIGURE 2: TYPICAL VAV BOX**

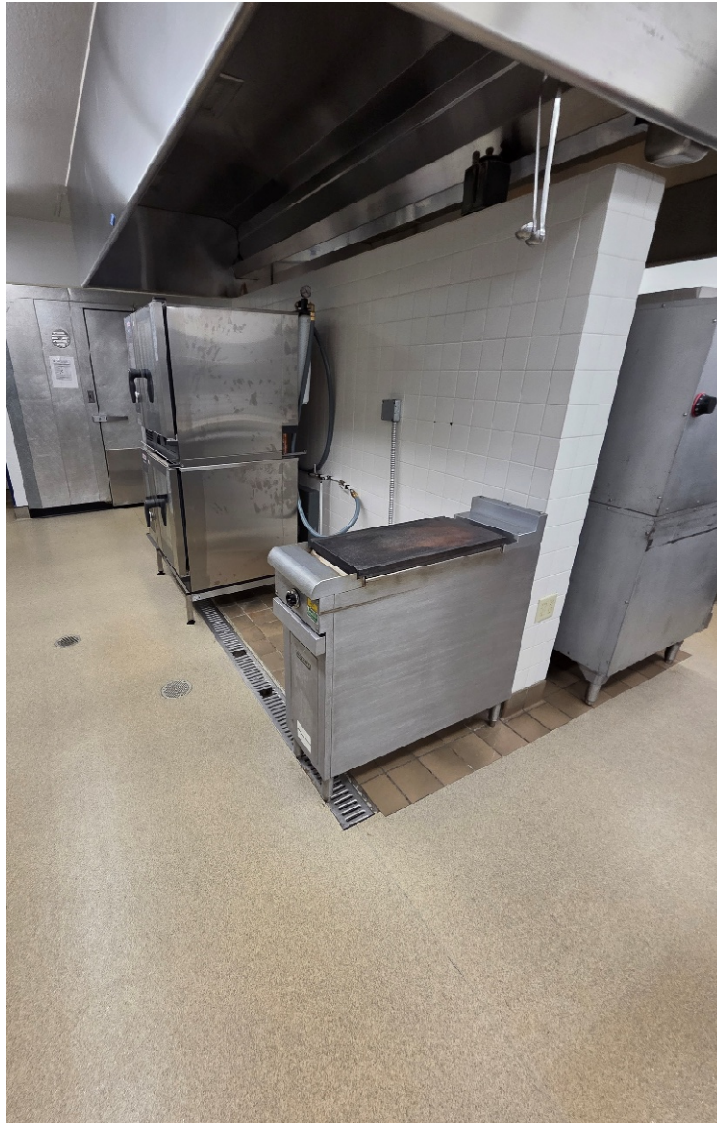
The kitchen is a “full” cooking kitchen with Type 2 hoods and walk-in freezer and cooler. All systems appeared to be building original.

- 1) Observation: Kitchen Hood with Cooking equipment below  
Source: Kitchen

**FIGURE 3: KITCHEN COOK LINE**

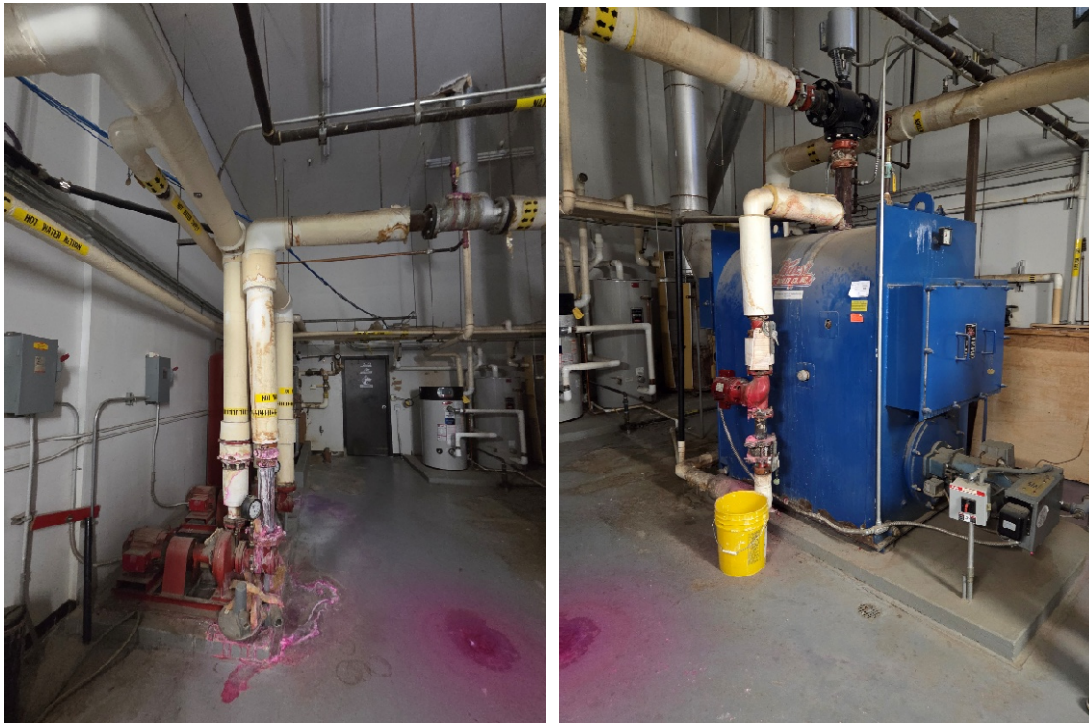
- 1) Observation: Boiler and heating water pumps with domestic hot water heaters in background

**FIGURE 4: BOILER ROOM EQUIPMENT**

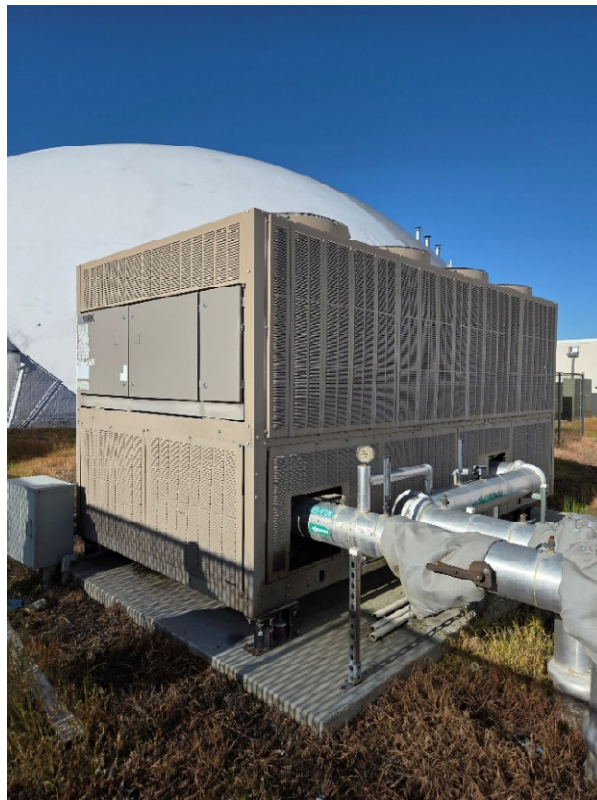
The chilled water plant provides chilled water to all the cooling coils located throughout the two main building domes. The chilled water system consists of one (1) air-cooled chiller, two (2) primary pumps, and two (2) secondary pumps. The chiller is located outside between the domes and the chilled water accessories are located on a skid within and insulated enclosure near the chiller between the two domes. The chiller system was added in 2010.

- 1) Observation: Outdoor Chilled water system  
Source: Outdoor Mechanical yard

**FIGURE 5: CHILLER**

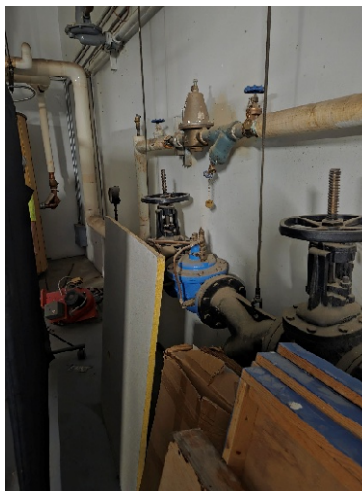
The building's domestic water service does not have a "typical" backflow prevention valve, but does have a pressure reducing valve in conjunction with a check valve. The domestic water piping system is mainly comprised of galvanized piping that is building original. There are a few areas that have been replaced and upgraded with copper pipe.

- 1) Observation: Domestic water Riser  
Source: Boiler Room

**FIGURE 6: MAIN DOMESTIC WATER RISER**

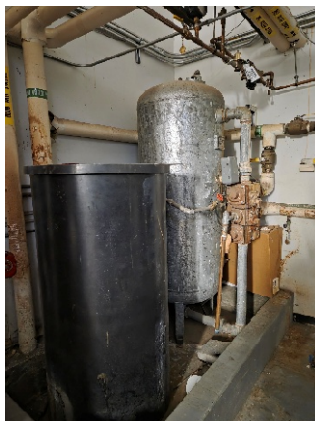
The building has a water softener that serves the entirety of the facility's domestic water needs including make up water to the boiler system. This system is also building original.

1) Observation: Water Softener  
Source: Boiler Room

**FIGURE 7: WATER SOFTENER**

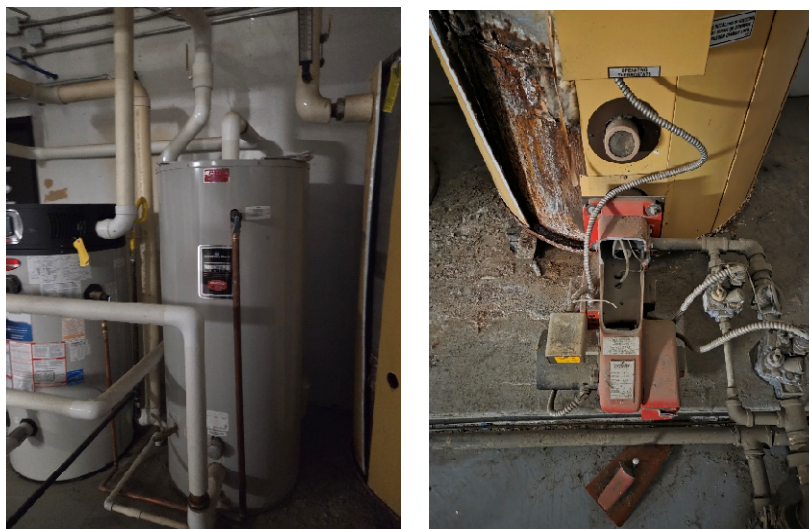
The domestic hot water system consists of two (2) gas fired water heaters and one (1) storage tank. One water heater is building original, one water heater was replaced in 2024, and the storage tank was replaced in 2012.

1) Observation: Domestic water heaters  
Source: Boiler Room

**FIGURE 8: DOMESTIC WATER HEATER EQUIPMENT**

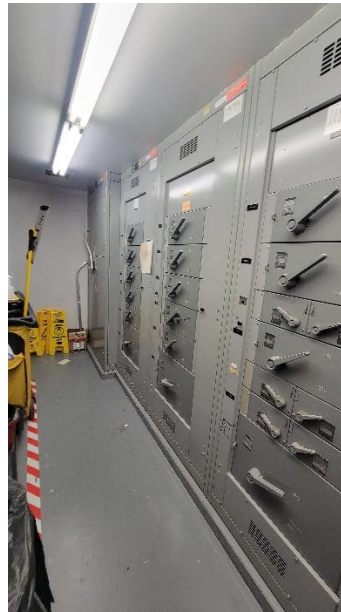
Figure 1: Existing switchboard M

The three smaller domes share a separate existing electrical service. The main panel, 'M2', is located in the north most dome of the three domes and consists of: 208Y/120V, 3Phase, 600A, distribution board, with a 600A main and original to the building. Panel M2 distributes power to approximately (6) branch panels located throughout the (3) domes. The existing branch panels appear to have roughly 10% remaining spares.

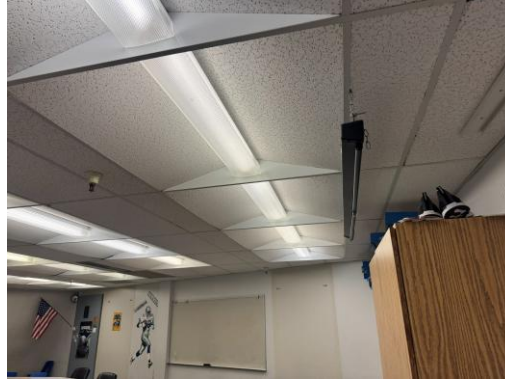
The existing lighting appears to be original fluorescent type fixtures. A mixture of single and multi-bulb configurations with surface mounted, wall mounted, and recessed fixtures. Classrooms have unique light fixtures that contain ceiling tiles integrated into the fixtures.

Lighting controls are original to the building with single level switching throughout the campus. Automatic controls are used in common areas however no occupancy sensor control is included in the building. The existing lighting and corresponding controls would need to be replaced to meet current energy code requirements.

Figure 2: Classroom lighting with integral ceiling tiles

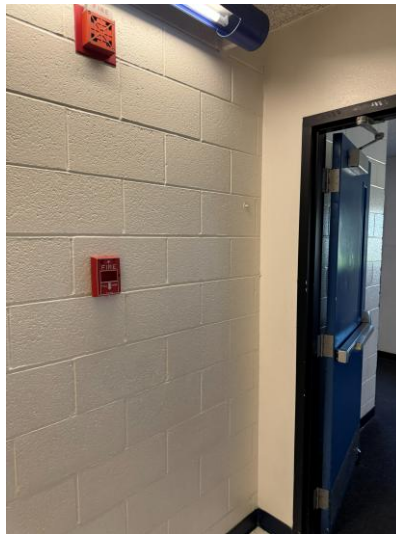
The existing fire alarm system is a horn/strobe based system with a cellular dialer in the administrative office and manual pull stations through the campus. The fire alarm control panel appears to have been upgraded from the original installation but does not meet current E occupancy requirements of voice evacuation. It also appears a majority of pull stations have been mounted above ADA requirements.

Figure 3: Existing pull stations

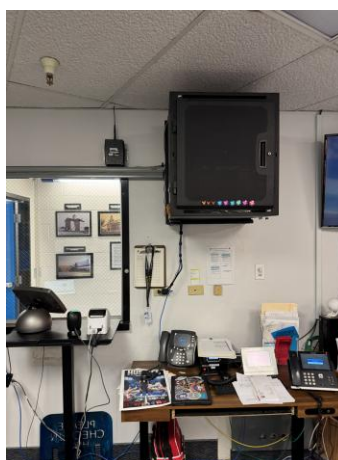
The existing low voltage cabling infrastructure reached maximum capacity along the way as intermediate, wall mounted data racks have been added in non-dedicated spaces. Full intercom coverage seems minimal throughout the campus as it doesn't appear to have a dedicated system. The campus does appear to have adequate security camera coverage. The majority of exterior doors are already equipped with card readers with minimal access control coverage inside the buildings.

Figure 4: Wall Mtd. IT Rack in Administration Office

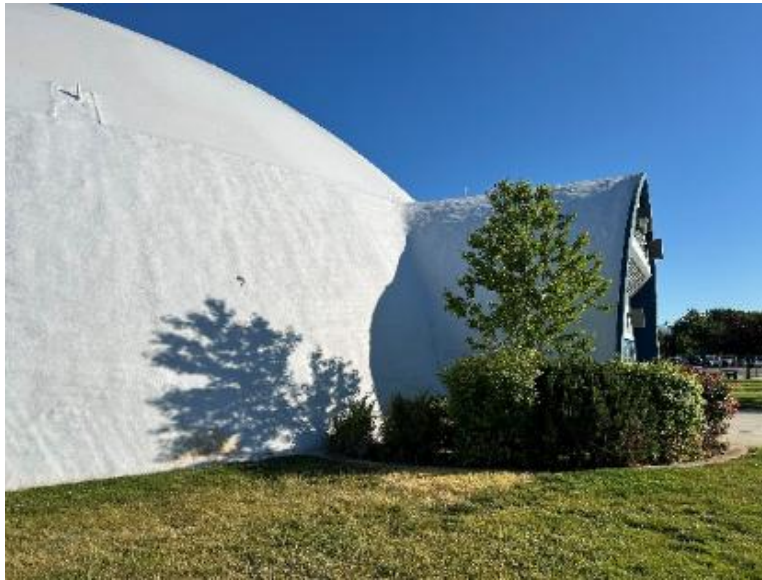
**FIGURE 2: REPAIRED ROOF SYSTEM AT BASE OF DOME #2.**

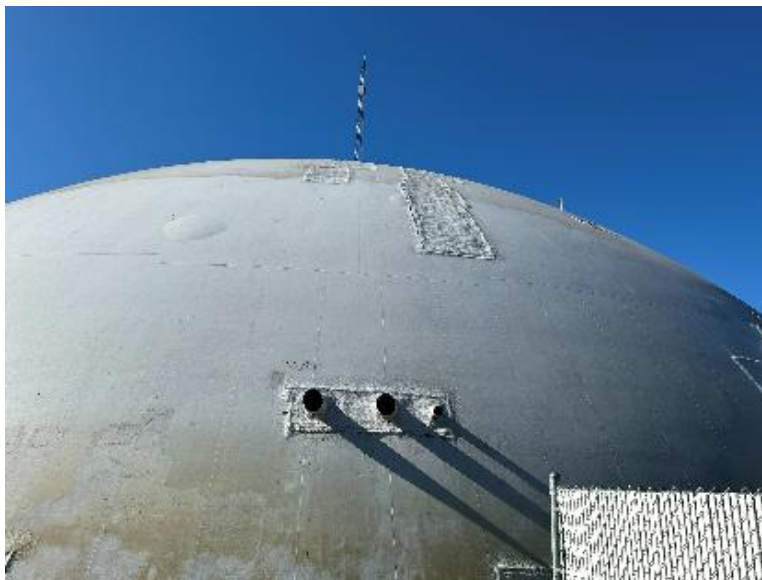
**FIGURE 3: ROOF REPAIRS AT PENETRATIONS AND THE UPPER PORTION OF DOME #1.**

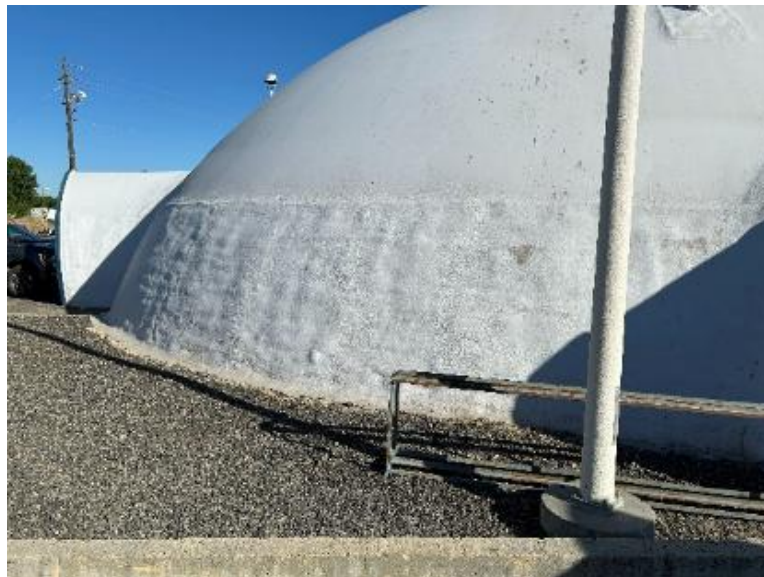
The IR photos taken revealed several areas of temperature anomalies. These anomalies were typically located at the repaired roof areas and at the interfaces between the roof repair and the original roof system (See Figures 4 through 11). The temperature anomalies possibly indicate moisture has infiltrated roof area repair locations, either into the repaired portion of the roof system or into roof system portion that abuts to repairs. There is the possibility that the temperature anomalies observed are the result of wrinkles or air pockets in the spray foam repaired areas. Regardless of the cause of the temperature anomalies, the repair appears to be inefficient and not able to provide adequate thermal and watertight performance.

**FIGURE 5: IMAGE OF SAME AREA AS FIGURE 4.**

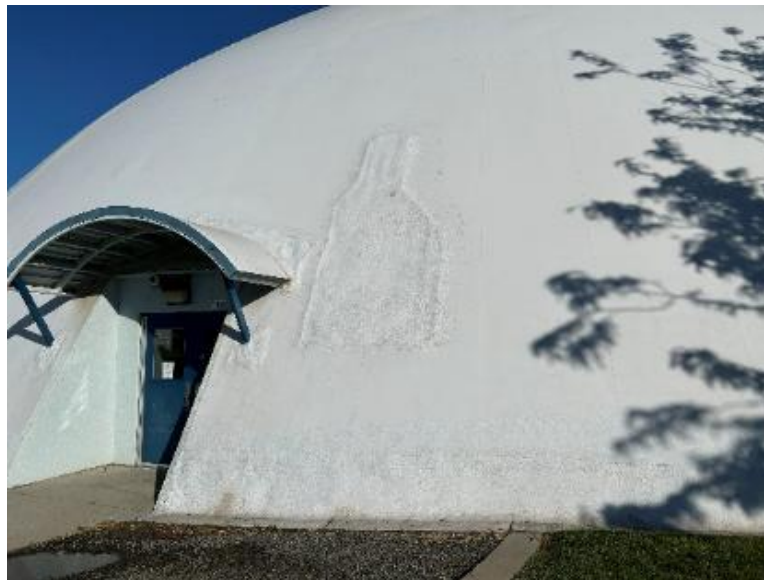
**FIGURE 6: REPAIRED ROOF AREA ON DOME #1.**
