# **Emmett High School – Facility Condition Assessment**

## *Observations & Assessments*

Compiled Document of Observations & Assessments

**July 10, 2026**

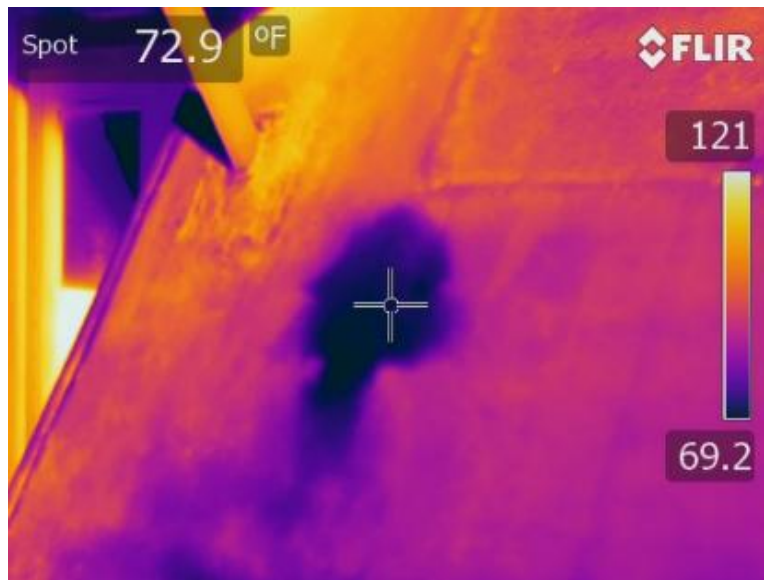
The IR photos taken revealed several areas of temperature anomalies. These anomalies were typically located at the repaired roof areas and at the interfaces between the roof repair and the original roof system (See Figures 4 through 11). The temperature anomalies possibly indicate moisture has infiltrated roof area repair locations, either into the repaired portion of the roof system or into roof system portion that abuts to repairs. There is the possibility that the temperature anomalies observed are the result of wrinkles or air pockets in the spray foam repaired areas. Regardless of the cause of the temperature anomalies, the repair appears to be inefficient and not able to provide adequate thermal and watertight performance.

**FIGURE 8: CLOSE UP OF BOTTOM LEFT CORNER OF PATCHED ROOF AREA ON DOME #1  
SHOWING TEMPERATURE ANOMALY.**

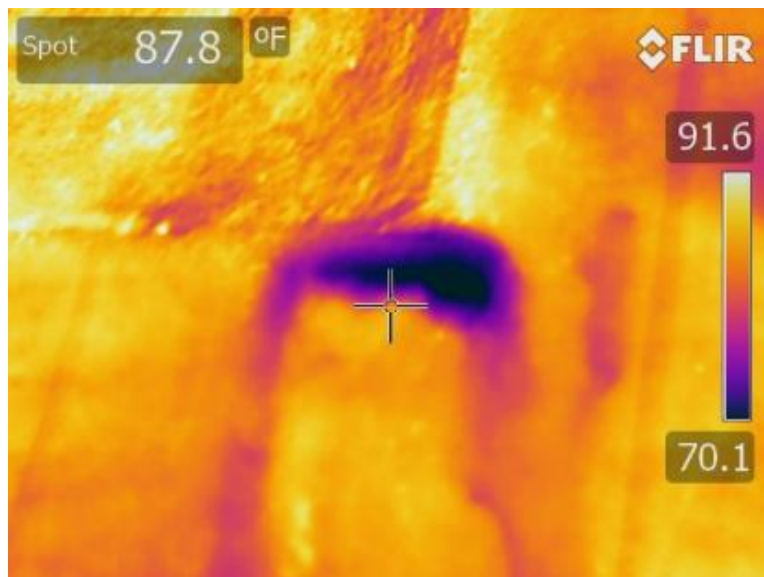
**FIGURE 9: CLOSE UP OF BOTTOM RIGHT CORNER OF PATCHED ROOF AREA ON DOME #1  
SHOWING TEMPERATURE ANOMALY.**

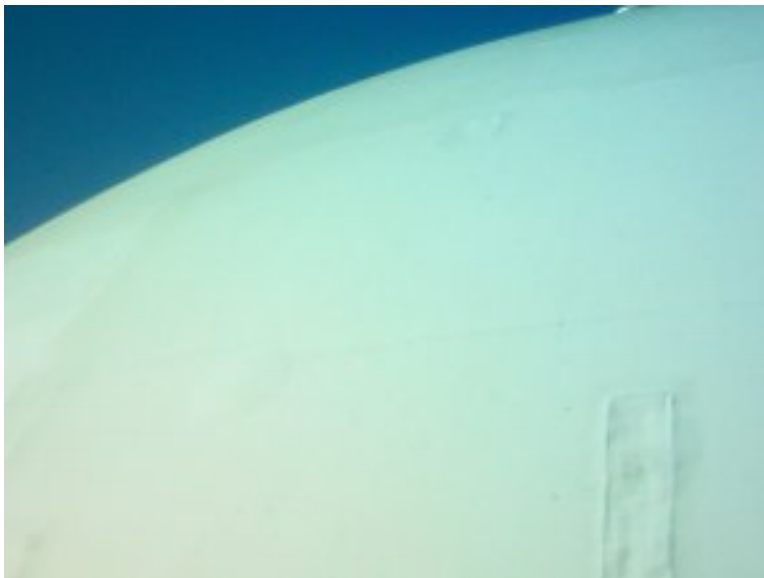
**FIGURE 10: AREA OF DOME #1 WITH PATCHED AREA OF ORIGINAL ROOF MEMBRANE.**

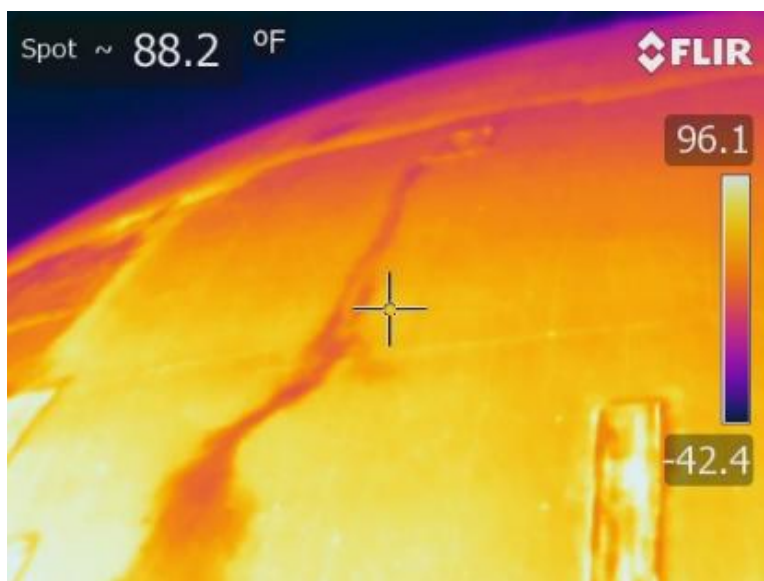
**FIGURE 11: IR IMAGE OF SAME AREA AS FIGURE 10 SHOWING TEMPERATURE ANOMALIES RUNNING DOWN FROM BOTTOM CORNER OF PATCHED AREA.**

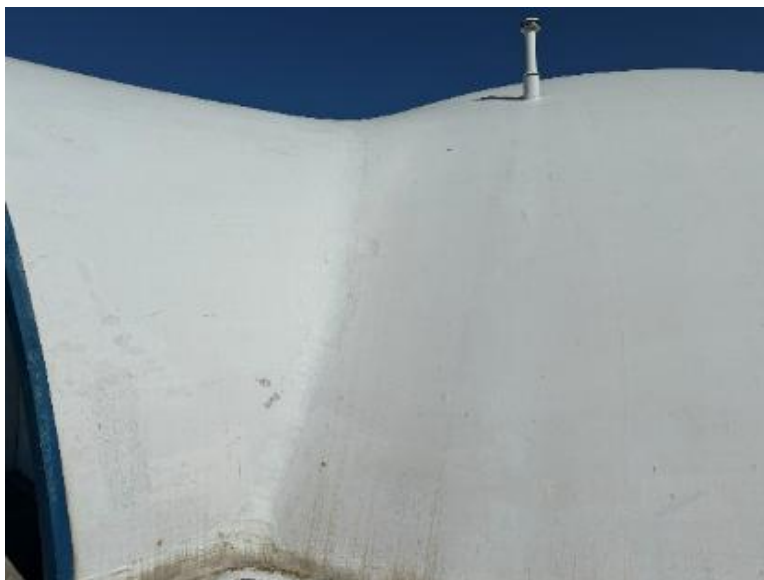
Temperature anomalies were also observed at areas of the original roof system, possibly indicating breaches in the roof membrane, allowing moisture to enter the roof system. See Figures 12 and 13. Note that the darker purple areas indicate colder temperatures.

**FIGURE 12: AREA OF DOME #5 WITH ORIGINAL ROOF MEMBRANE.**

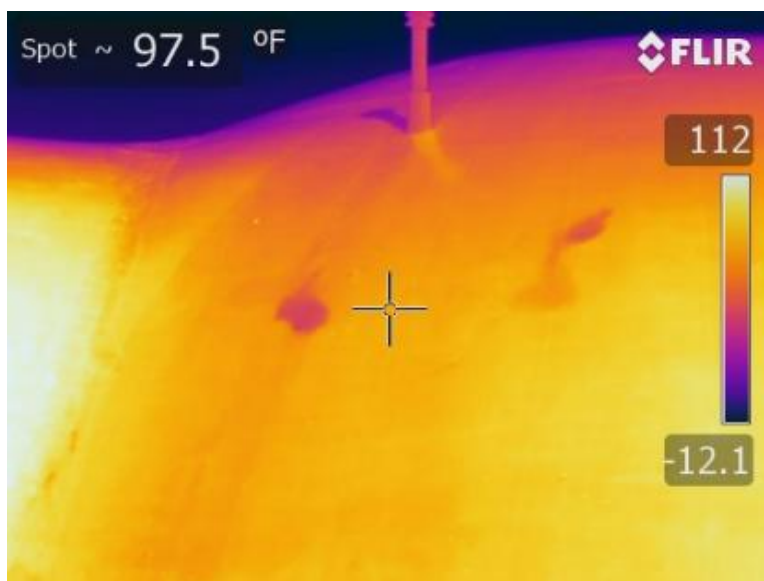
**FIGURE 13: IR IMAGE OF SAME AREA AS FIGURE 11 SHOWING AREAS WITH TEMPERATURE ANOMALIES.**

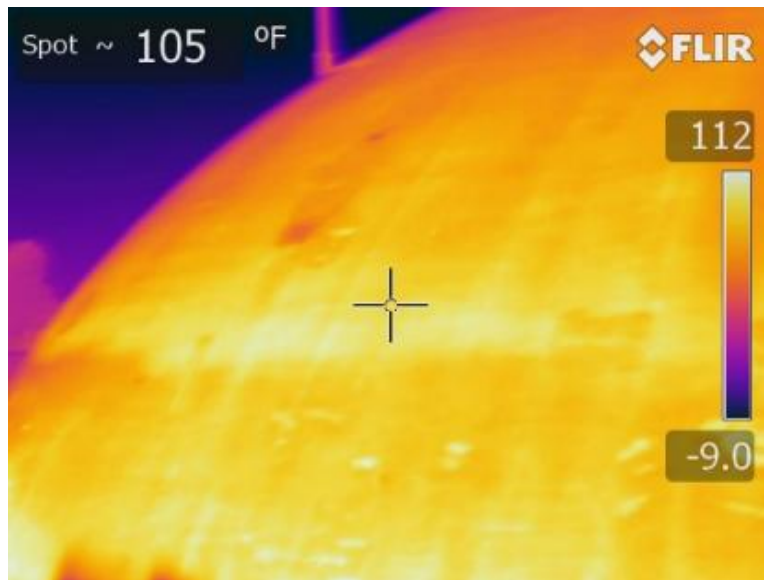
**FIGURE 12: AREA OF DOME #1 SHOWING TEMPERATURE ANOMALY.**

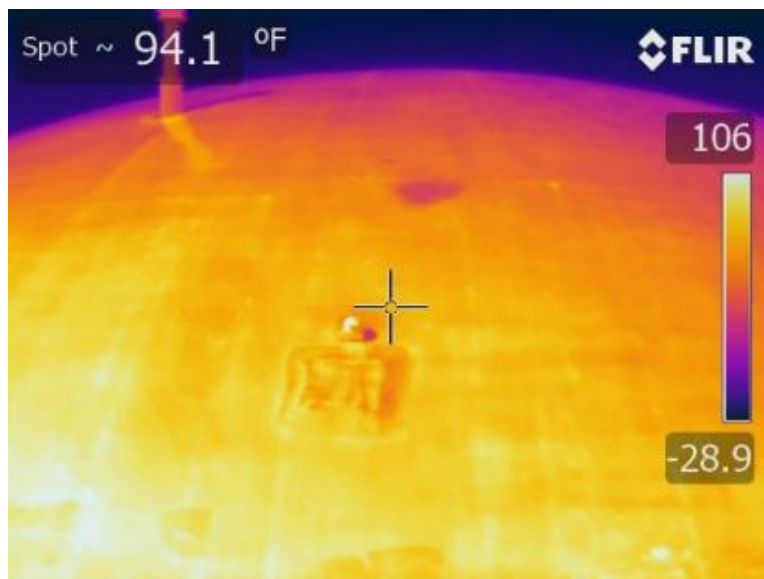
**FIGURE 135: AREA OF DOME #1 SHOWING TEMPERATURE ANOMALY.**

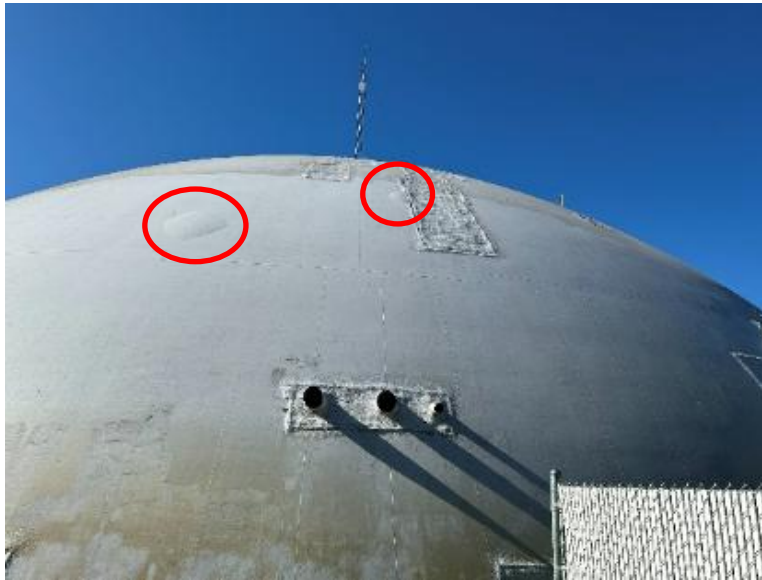
Bubbles beneath the roof membrane were observed primarily on dome #1. See Figures 16 and 17. This can be an indication of moisture beneath the roof membrane that turns to vapor when heated and expands, creating a bubble. These locations were photographed with the IR camera but did not indicate temperature anomalies.

**FIGURE 157: BUBBLES IN ROOF MEMBRANE AT DOME #1.**

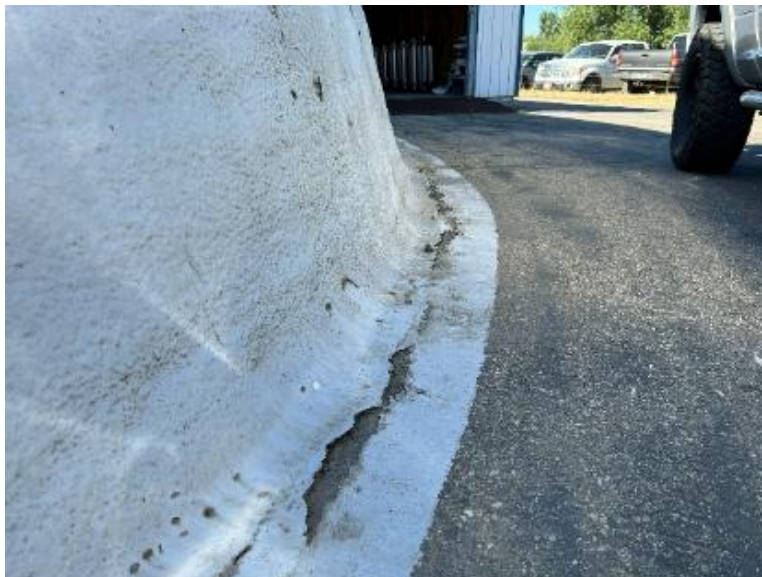
areas were observed where the coating lapping onto the concrete has debonded (peeled away) from the concrete. This has resulted in the exposure of the underlying foam insulation to moisture, and at some locations organic growth is present in the foam insulation. See Figures 18 through 21.

**FIGURE 168: ROOF COATING AT REPAIRED ROOF AREA ON DOME #5 DEBONDED FROM HORIZONTAL CONCRETE.**

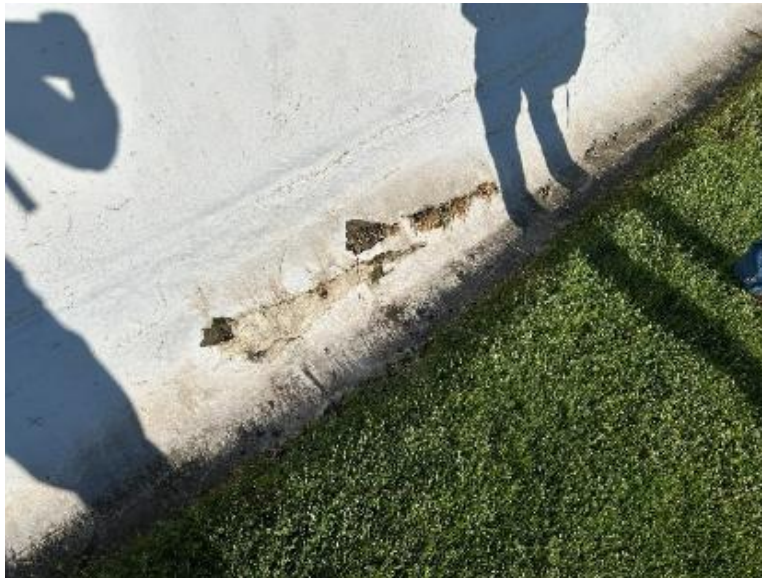
**FIGURE 21: ROOF COATING AT REPAIRED ROOF AREA ON DOME #2 DEBONDED FROM HORIZONTAL CONCRETE, ALLOWING ORGANIC GROWTH TO OCCUR.**

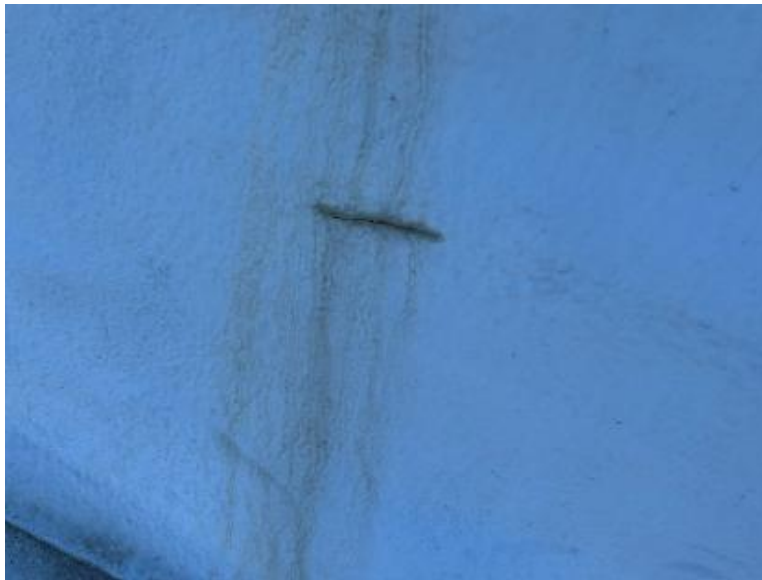
Minor holes and voids in both the repaired roof coating and the original roof membrane were present at all domes. These voids will allow moisture to enter the roof system and saturate the foam insulation in isolated areas. This will reduce the thermal effectiveness of the spray foam and increase the rate of degradation of the roof system. See Figures 22 through 27.

**FIGURE 22: SPLIT IN ROOF COATING AT REPAIRED ROOF AREA ON DOME #4.**

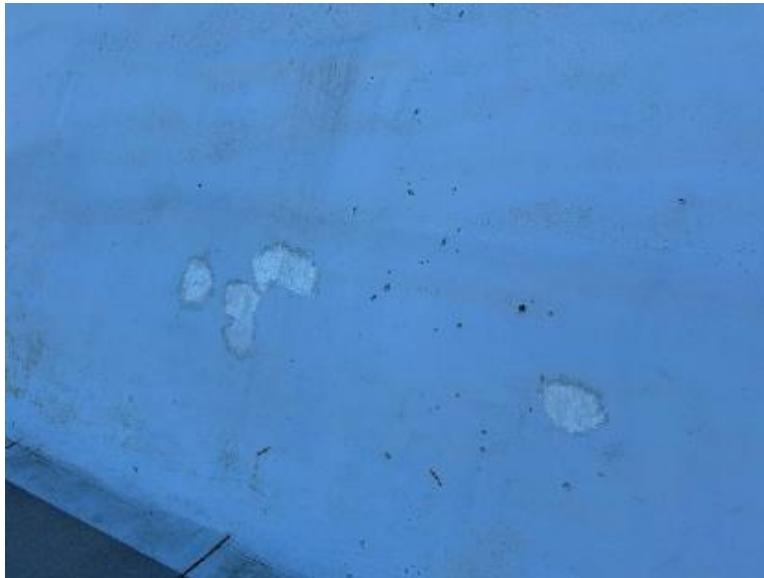
**FIGURE 23: SEVERAL HOLES THROUGH THE ORIGINAL ROOF MEMBRANE WITH EVIDENCE OF PREVIOUS REPAIRS AT DOME #4.**

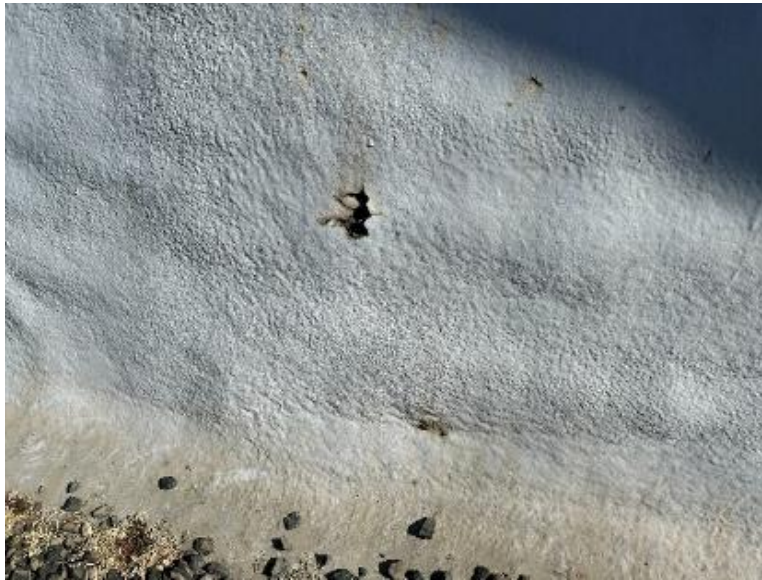
**FIGURE 27: HOLE THROUGH ROOF COATING AT REPAIRED ROOF AREA ON DOME #4.**

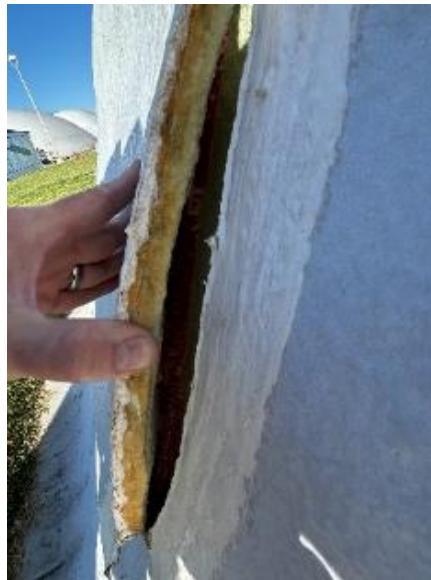
An exploratory opening had been previously created on the south side of Dome #2. The opening was the result of a split in the coating and foam of a repaired area of the roof that had been expanded and a section of foam removed during our time on site. The spray foam added during the repair appeared to have debonded from the spray foam of the original roof system. Evidence of an attempted repair of the split insulation was observed in the form of additional spray foam added between the layers. The split between the layers of insulation was apparent adjacent to the exploratory opening where the foam moved when pressed. The total depth of the insulation outboard of the concrete was approximately 2 inches. There appeared to be approximately 1 ½ inches of foam from the original roof assembly and approximately ½ inch of foam from the repair conducted in 2012. See Figures 28 through 33.

**FIGURE 29: SPLIT BETWEEN LAYERS OF FOAM INSULATION.**

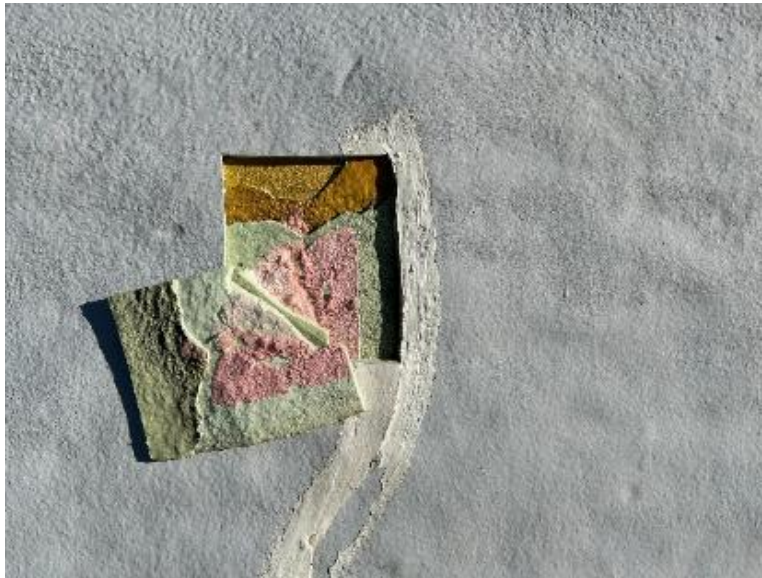
**FIGURE 30: OUTER LAYER OF FOAM REMOVED, REVEALING EVIDENCE OF PREVIOUS REPAIR WITH ADDED SPRAY FOAM.**

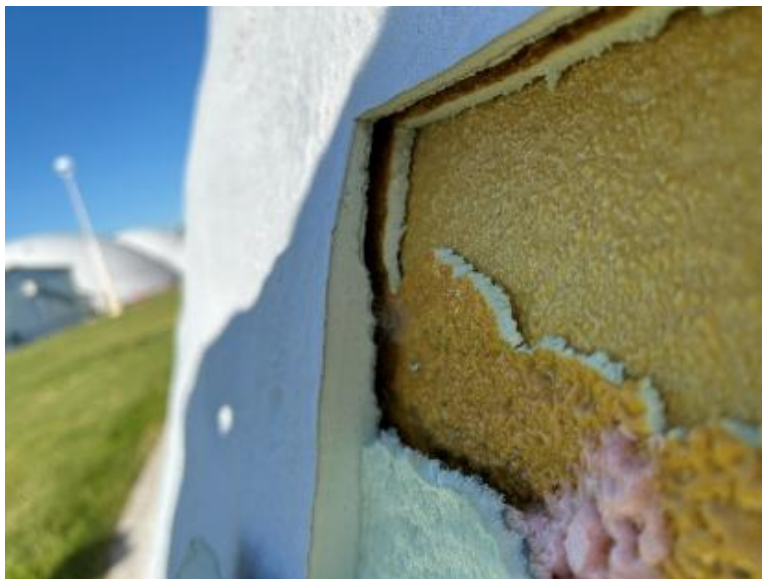
**FIGURE 31: LAYERS OF FOAM INSULATION AT EXPLORATORY OPENING.**

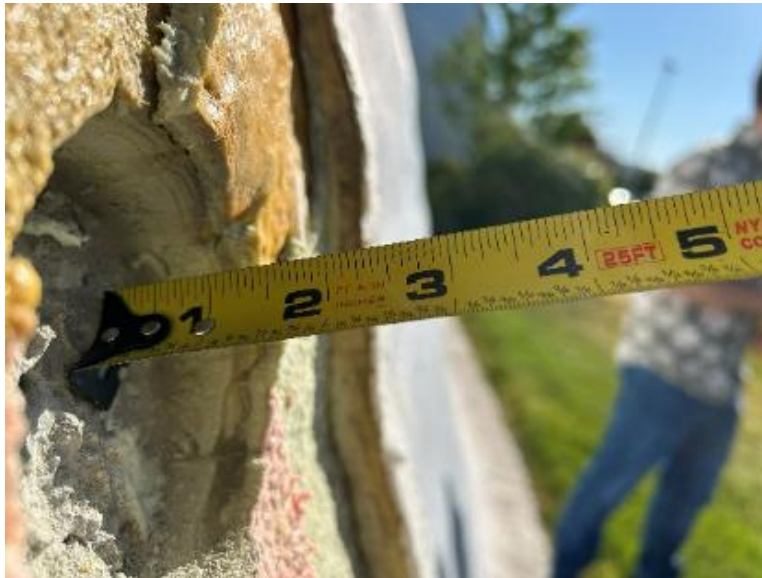
**FIGURE 32: DEPTH OF FOAM INSULATION AT EXPLORATORY OPENING.**

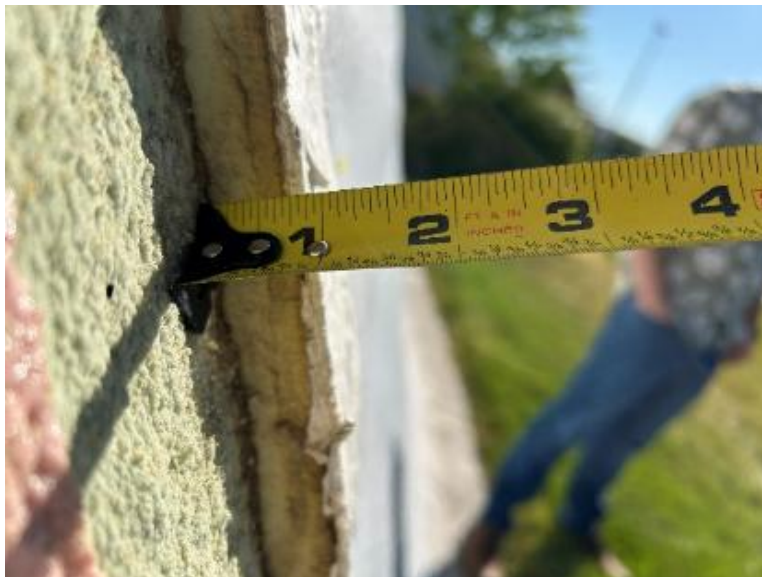
**FIGURE 33: FOAM INSULATION ADDED DURING 2012 REPAIR.**

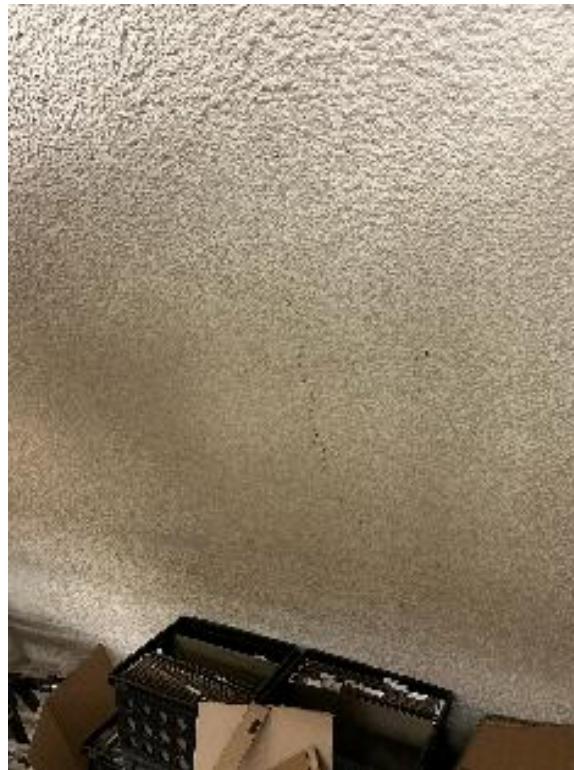
No evidence of water ingress through the concrete domes was observed in any of the dome interiors reviewed. No staining that would indicate water leakage, or temperature anomalies in the IR images were observed during the interior review. Several cracks in the concrete interior wall of the dome were observed in Dome #1. See Figures 34 through 36.

**FIGURE 34: CRACK IN CONCRETE OBSERVED IN CLASSROOM 108.**

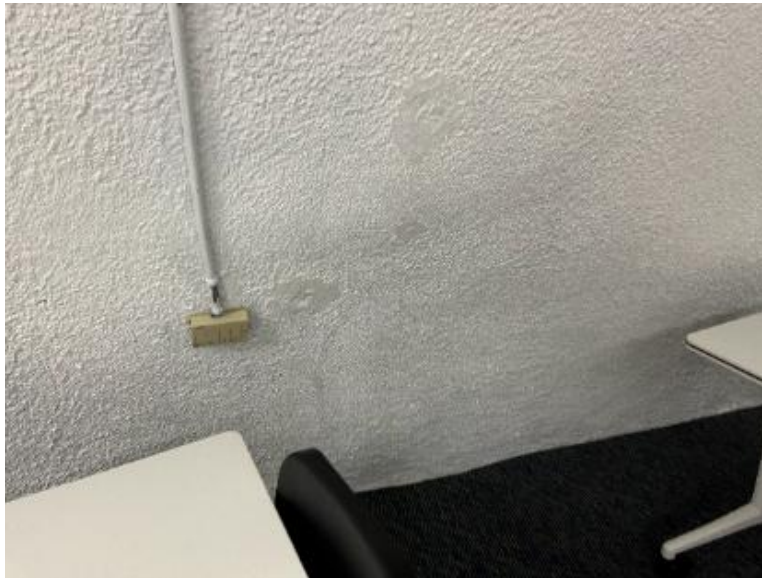
**FIGURE 35: CRACKS IN CONCRETE THAT HAD RECENTLY BEEN PAINTED OVER, ROOM 110.**

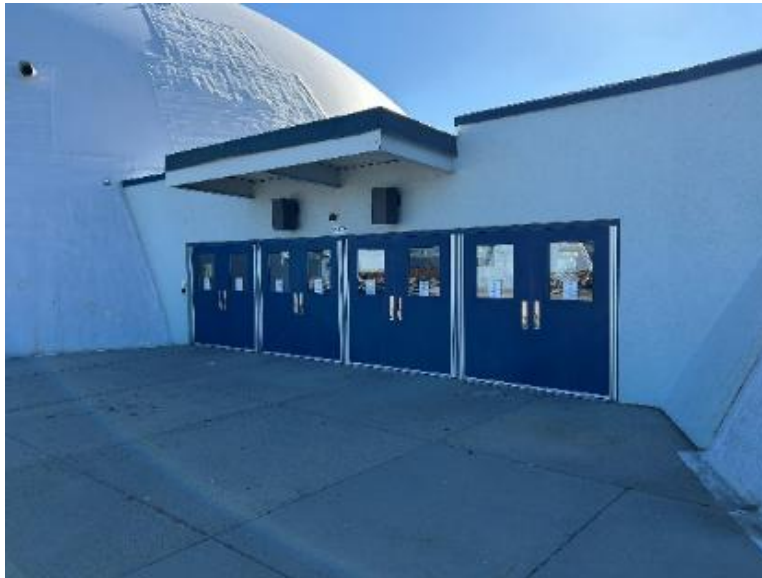
**FIGURE 39: ENTRANCES AT CORRIDOR BETWEEN DOMES #1 AND #2. NOTE THAT CANOPY DOES NOT COVER ALL DOORS.**

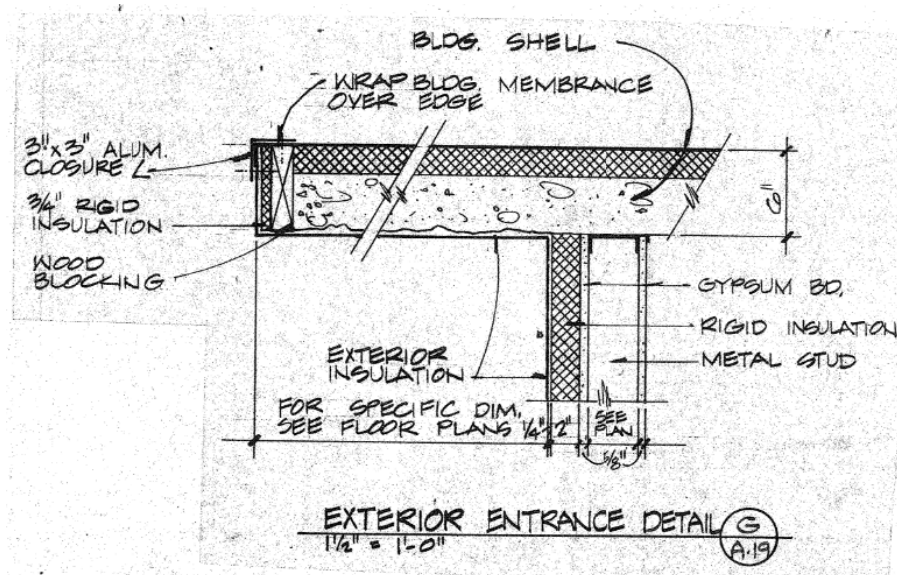
The EIFS cladding does not appear to be from the original construction, but appeared to be a face-sealed system, as there was no accommodation for draining the system observed. Whether a weather resistant membrane is provided on the exterior sheathing beneath the EIFS cladding was not known; the original architectural drawings do not show a sheathing membrane. See Figure 43. Face-sealed EIFS systems are problematic, as they do not account for moisture entering behind the face seal, and don't provide a method of draining incidental moisture. They also typically don't provide a weather resistant barrier on the exterior sheathing that would protect the wall assembly from moisture-related deterioration. There is also an area at the enclosed corridor between Domes #1 and #2 where the EIFS system interfaces directly with the roof system and is not vertical, with a portion of the EIFS clad wall being skyward facing. EIFS is not intended to be installed on walls that aren't vertical.

**FIGURE 43: WALL/ROOF DETAIL AT ENTRANCE.**

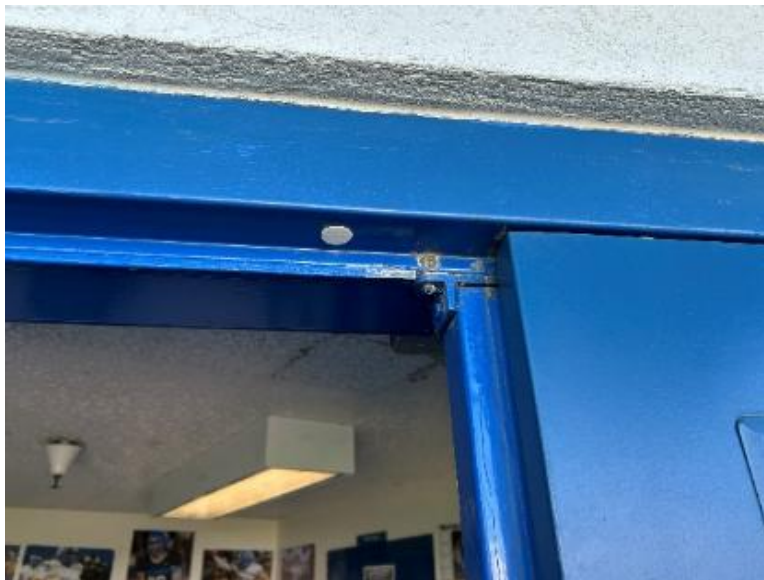
Entrance doors are typically non-thermally broken hollow metal framed units with glass of varying in size throughout. Gaskets provided at the perimeters of the doors are in bad condition with damage, gaps and painted gaskets observed, which will limit the ability for the gaskets to seal. Gaskets at overhead coiling doors are similarly in bad condition, with many gaps and damaged gaskets observed. Hollow metal framed doors typically have brush sweeps over aluminum thresholds at the sills.

**FIGURE 45: HOLLOW METAL FRAME SHOWING LACK OF THERMAL BREAK.**

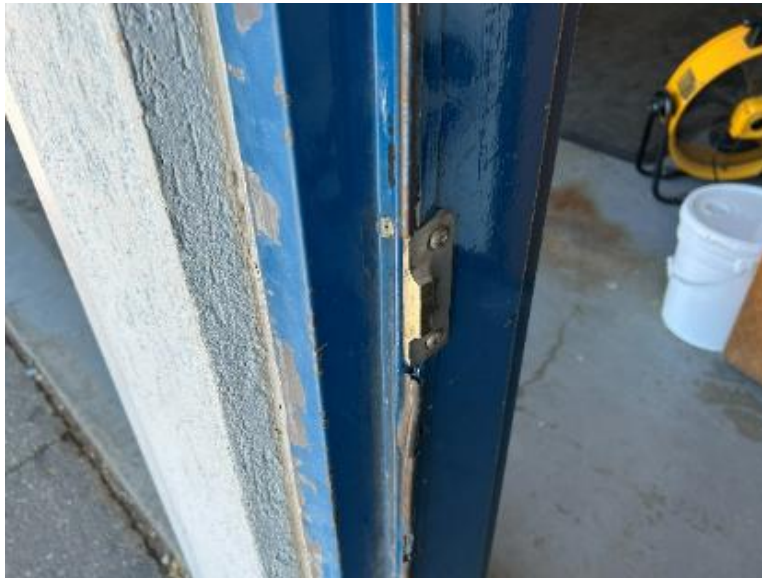
**FIGURE 46: DAMAGED GASKETS AT HOLLOW METAL DOOR.**

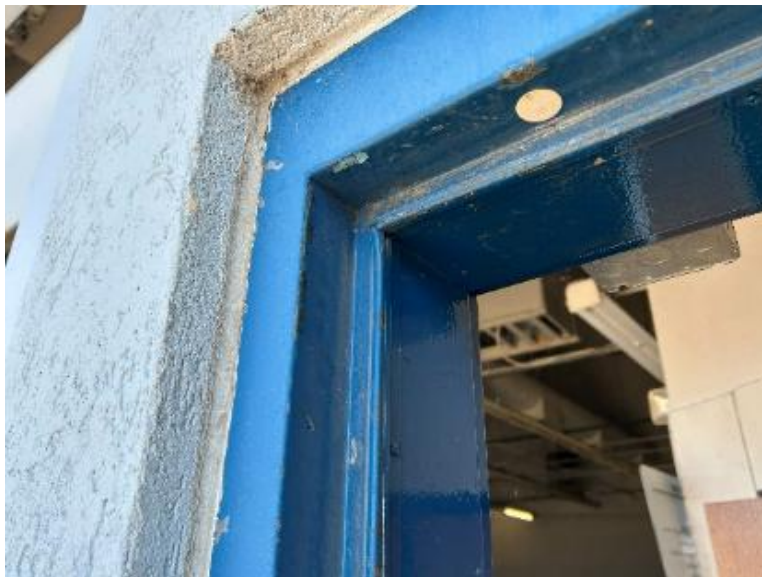
**FIGURE 47: PAINTED GASKETS AT HOLLOW METAL DOOR, WHICH LIMITS THE ABILITY FOR THE GASKETS TO SEAL.**
